Appendix J – Cultural Resources Information

Job No. 100512, Walnut Ridge – Missouri State Line (Future I-57) P.E.

**ARCHITECTURAL RESOURCES SURVEY FOR
FUTURE INTERSTATE 57 (JOB 100512),
LAWRENCE, RANDOLPH, GREENE, AND CLAY COUNTIES,
ARKANSAS**

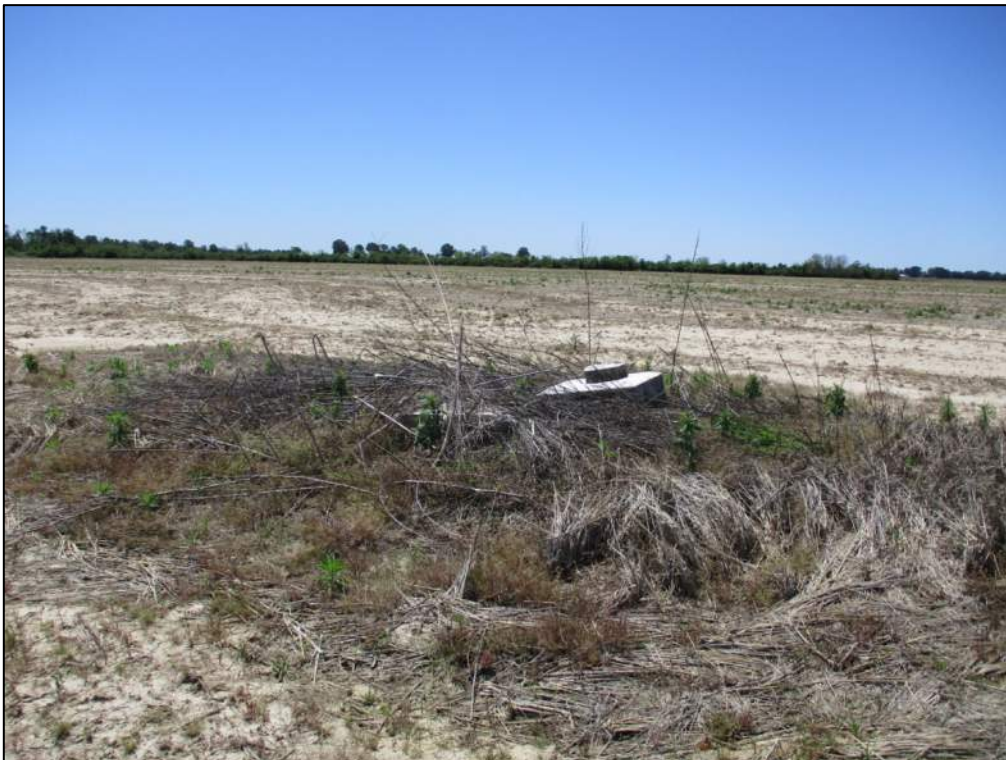
In the opinion of the consultant, the Gilchrist Cemetery near Knobel and Alternate 3 is considered not eligible for the National Register of Historic Places (NRHP). The site contains two toppled monuments for Adelle L. Gilchrist 1873-1915 and Richard Gilchrist 1866-1932, and is located within a portion of an agricultural field that is plowed around (Figures 1, 2 and 3). This cemetery has not made a significant contribution to broad patterns of our history (Criteria A), nor is it associated with lives of significant/prominent persons (Criterion B), nor is it the work of a master craftsman or exhibit high artistic values (Criteria C), nor is it likely to contribute any significant information to history in the future. Additionally, the Gilchrist Cemetery does not meet any of Potter and Boland's (1992) Special Requirements Criteria Considerations for cemeteries (Criteria D).

Figure 1. General view of the Gilchrist Cemetery (IMG_0285).

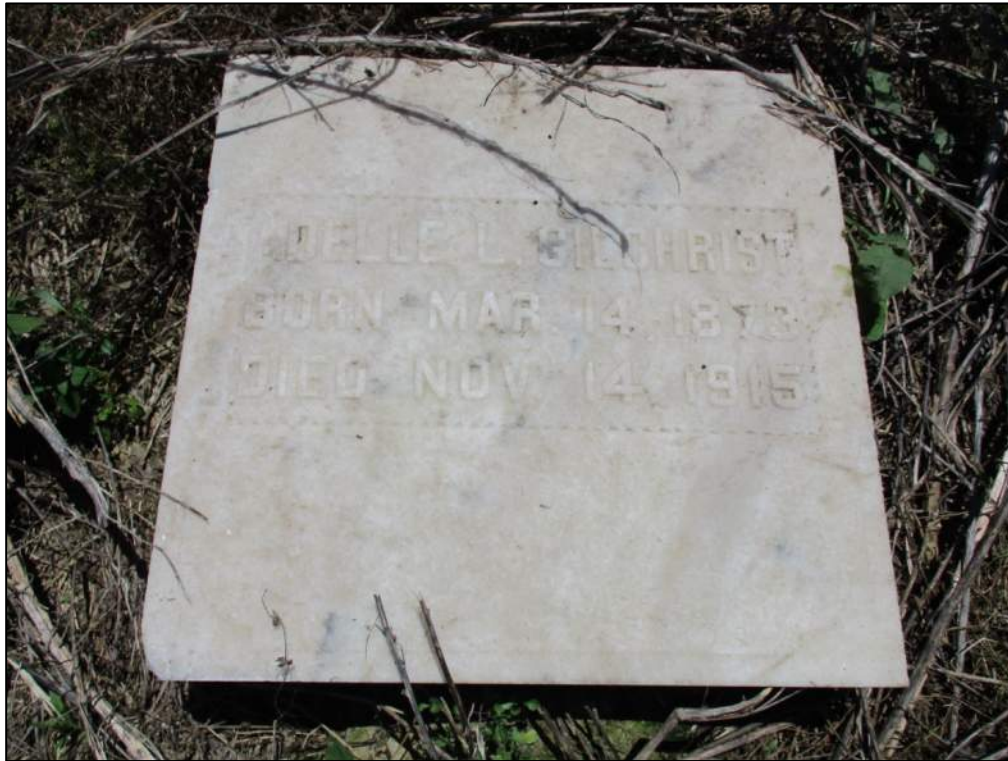
Figure 2. Adelle Gilchrist monument (IMG_0286).

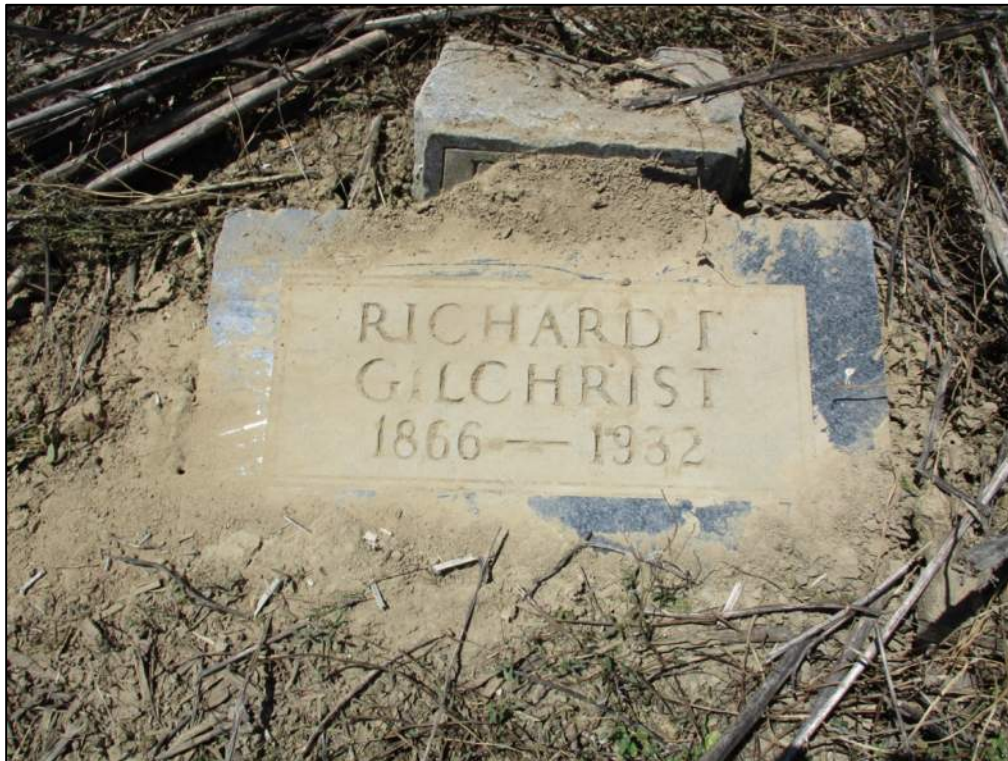
Figure 3. Richard Gilchrist monument (IMG_0287).

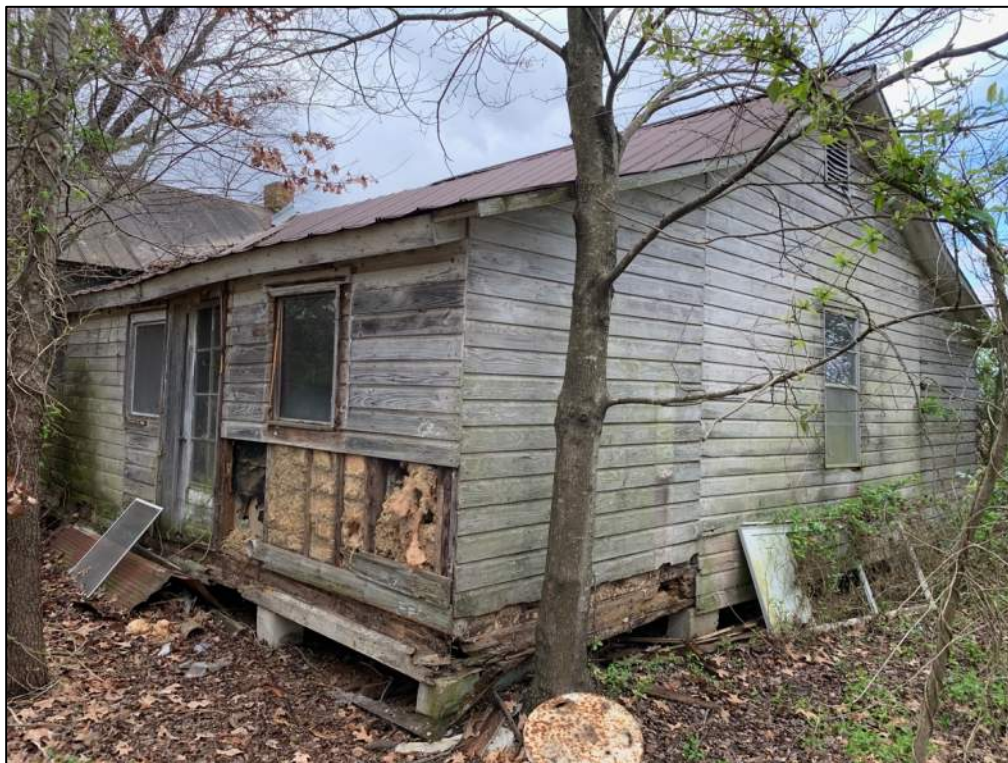
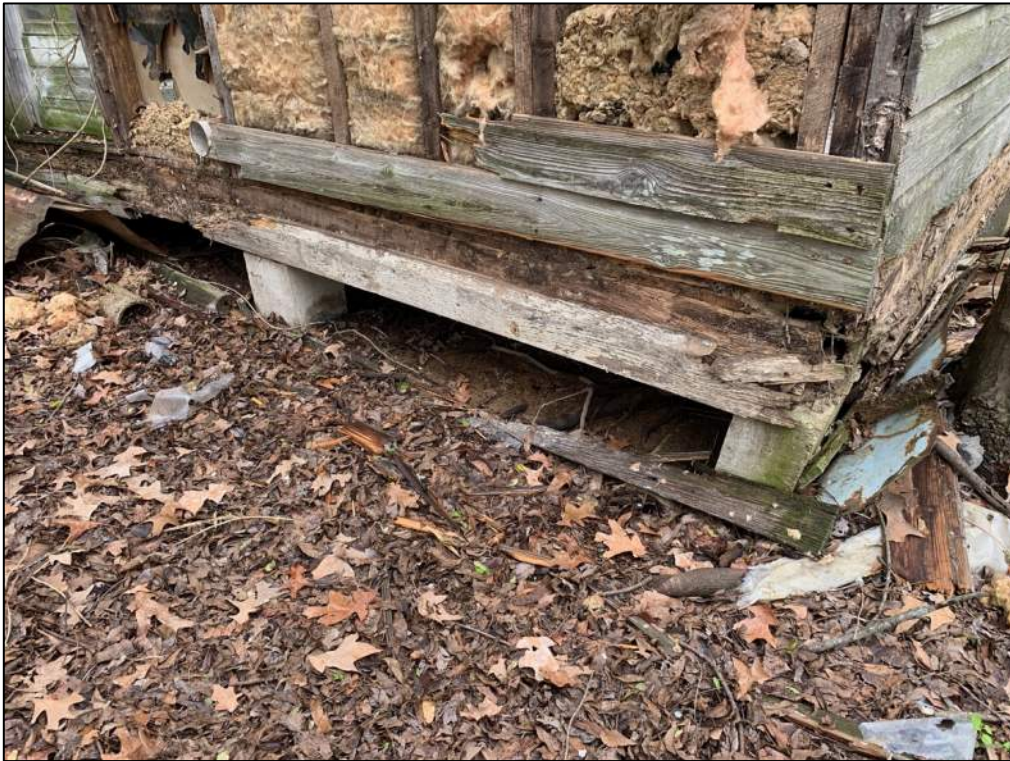
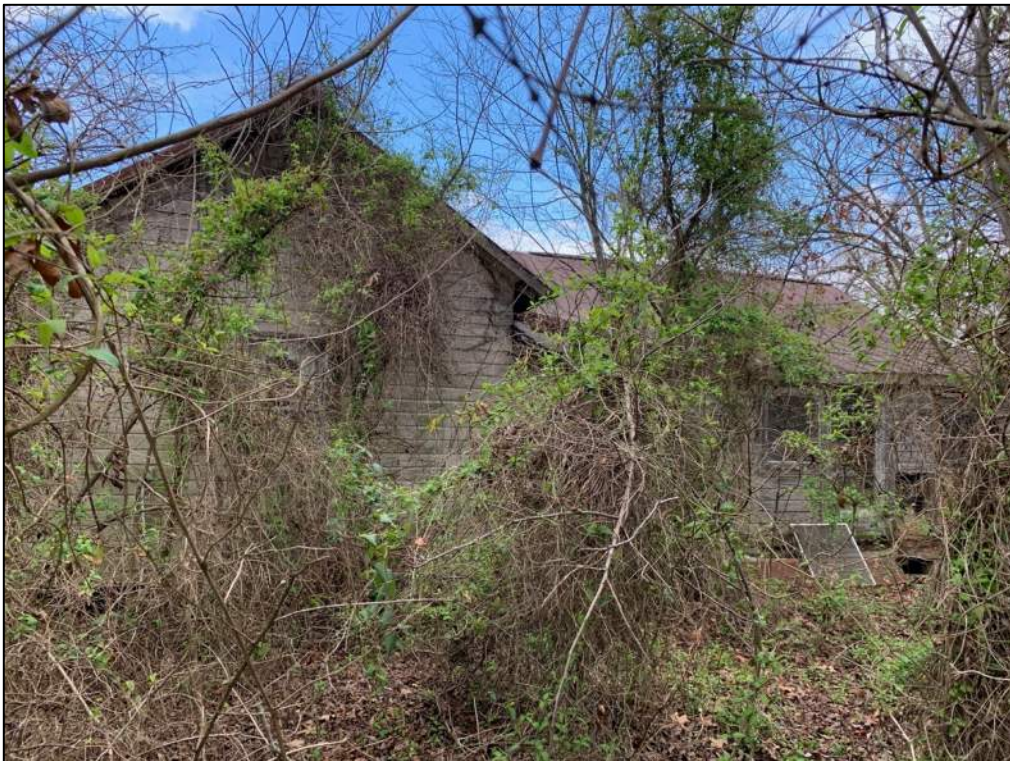
northeast sides of rear portion of the house were enclosed and insulated with fiberglass (Figures 7, 8 and 9).

Figure 7. Property 21 view southwest (IMG_2534).

Figure 8. Property 21 view southwest (IMG_2535).

Figure 9. Property 21 view west (IMG_2536).

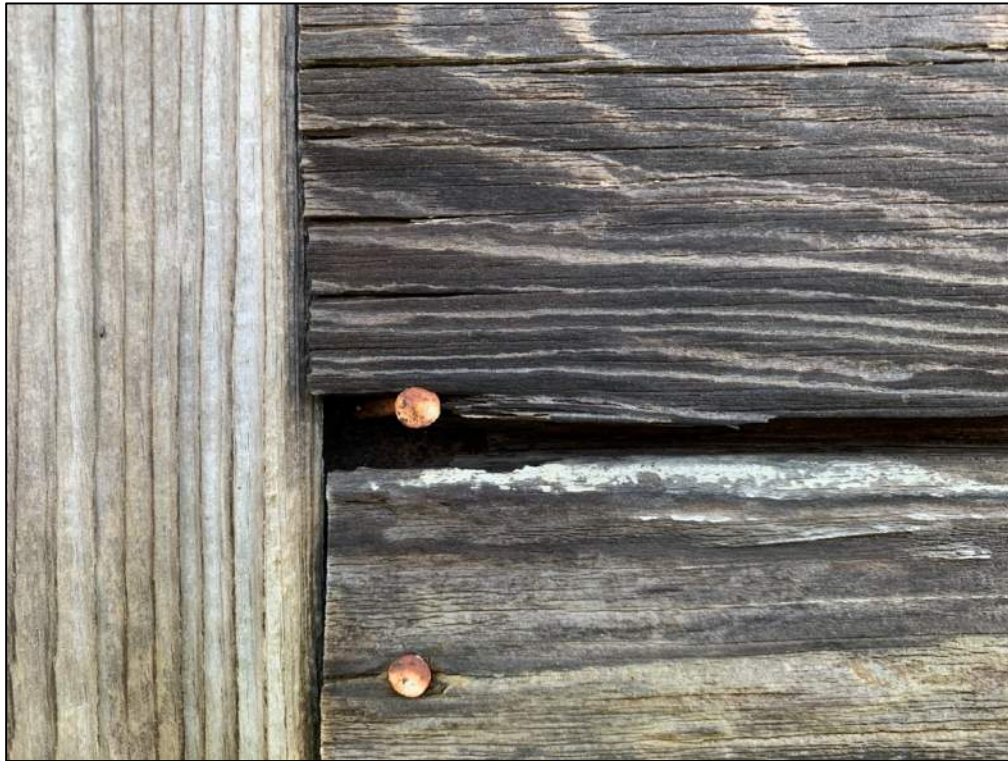
Figure 14. Property 21 exterior detail showing wire nails (IMG_2552).

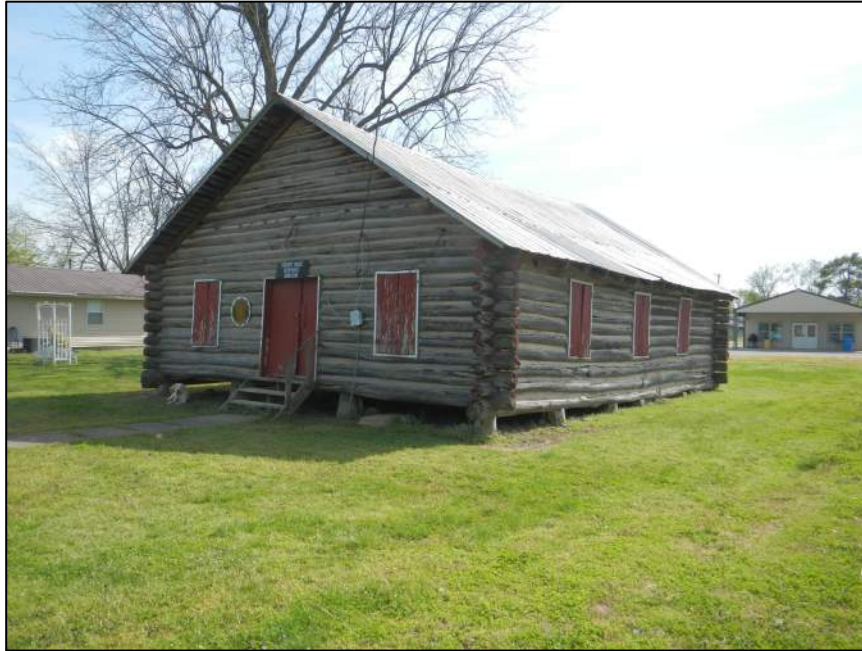
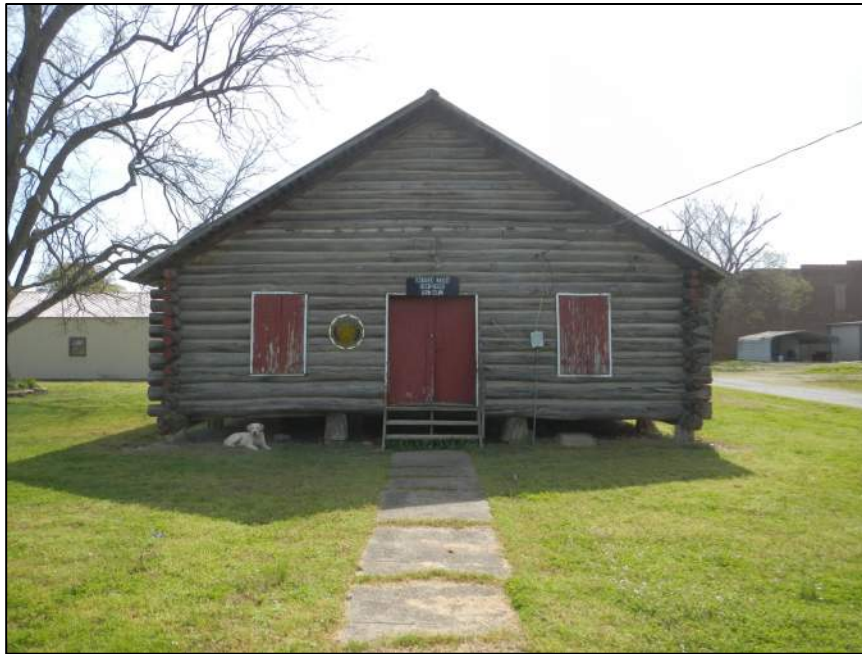
Figure 1-08. NRHP-listed American Legion Post No. 72 (CY0071) in Knobel, view southeast (DSCN 1623).

Figure 1-09. NRHP-listed American Legion Post No. 72 (CY0071) in Knobel, front façade, view southwest (DSCN 1625).

The AHPP records describe CY0071 as the American Legion Post No. 72; alternate data on the structure and signage on the building identify it as Sinks-Crumb Post No. 72 (Figures 1-08–1-12). The building is located at 582 2nd Street at the intersection of Cherry in Knobel (the AHPP GIS map location is incorrect).

The log building has cypress walls and a skip-decked, corrugated sheet metal roof. The interior was not examined. Sinks-Crumb Post No. 72 was listed in the National Register of Historic Places (NRHP) in 2008 (Federal Register Vol. 73, No. 170). The structure would not be directly impacted by the alignment alternatives (see Figure 1-05).

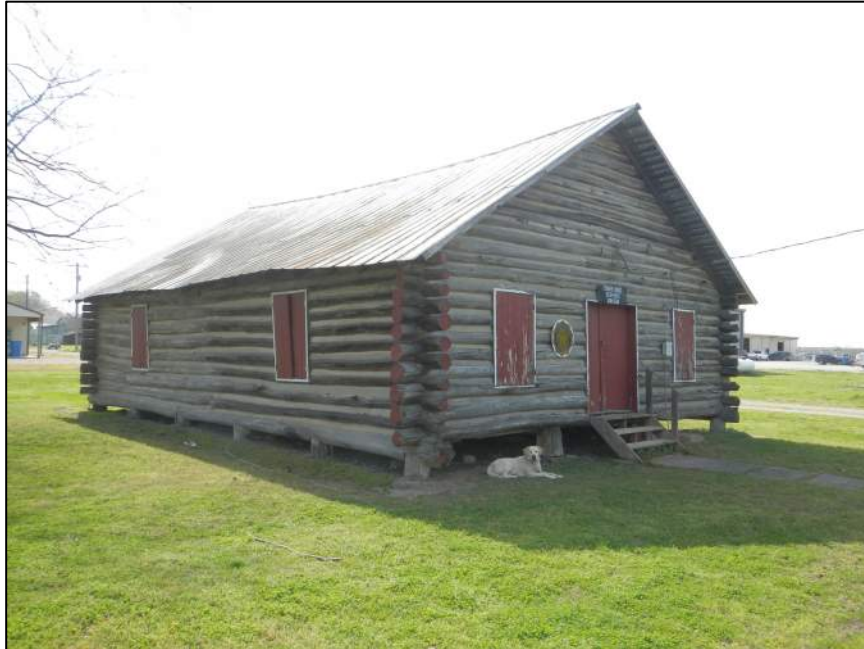
Figure 1-10. NRHP-listed American Legion Post No. 72 (CY0071) in Knobel, view west (DSCN 1627).

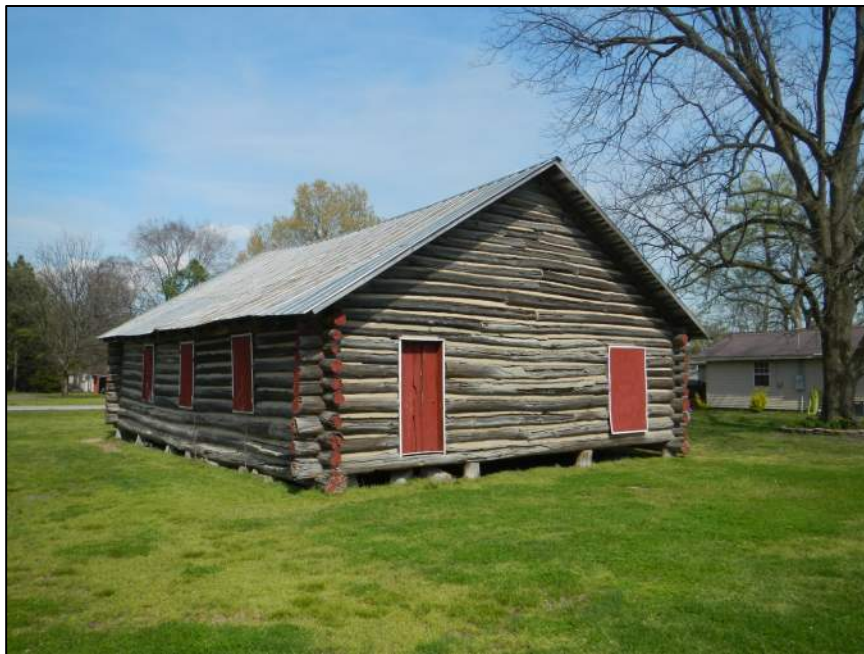
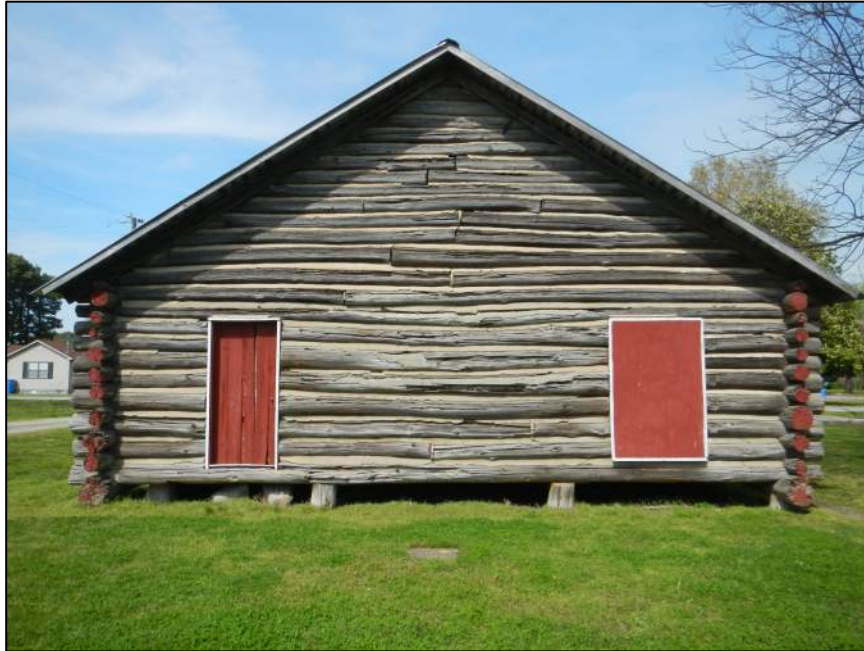
Figure 1-11. NRHP-listed American Legion Post No. 72 (CY0071) in Knobel, view northeast (DSCN 1628).

Figure 1-12. NRHP-listed American Legion Post No. 72 (CY0071) in Knobel, rear façade, view southwest (DSCN 1631).

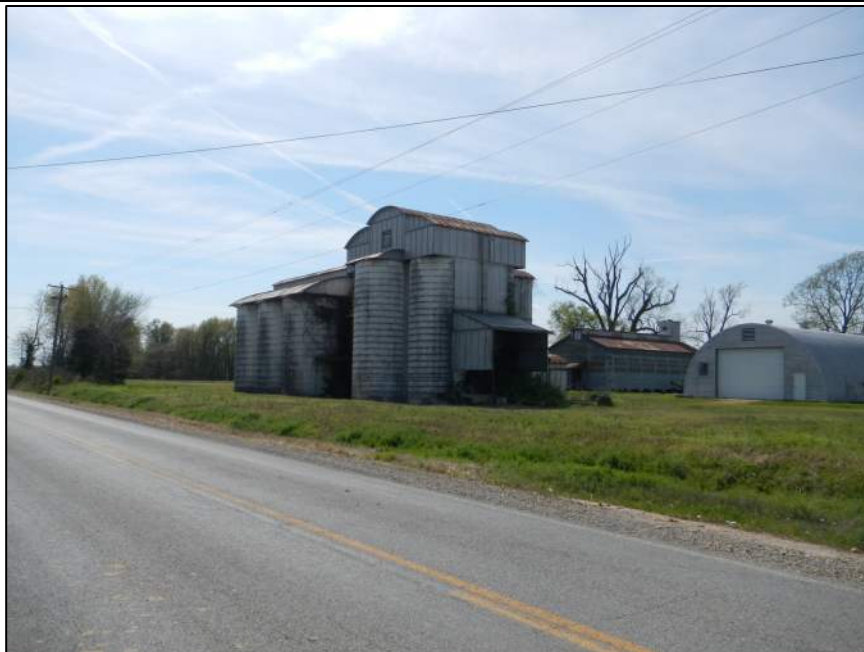
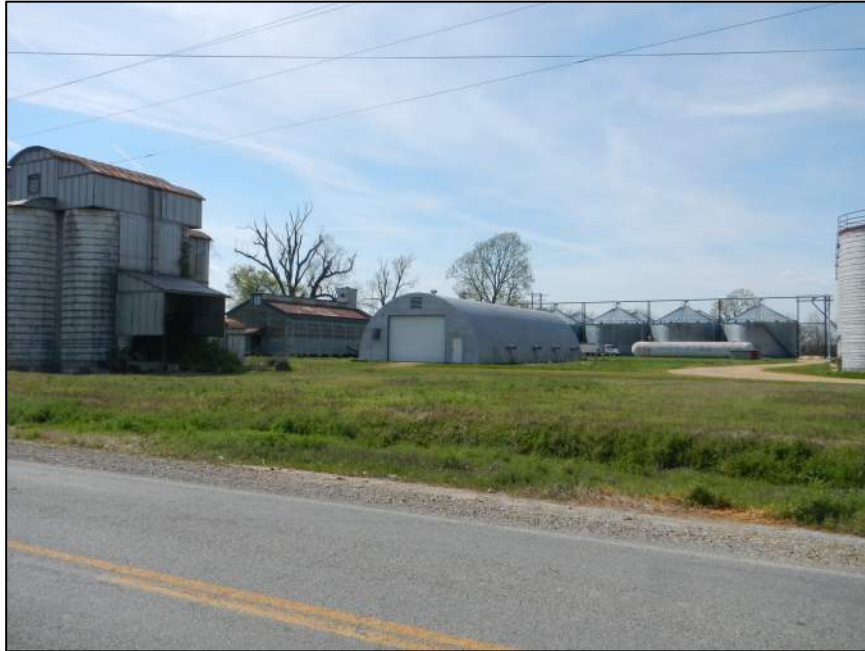
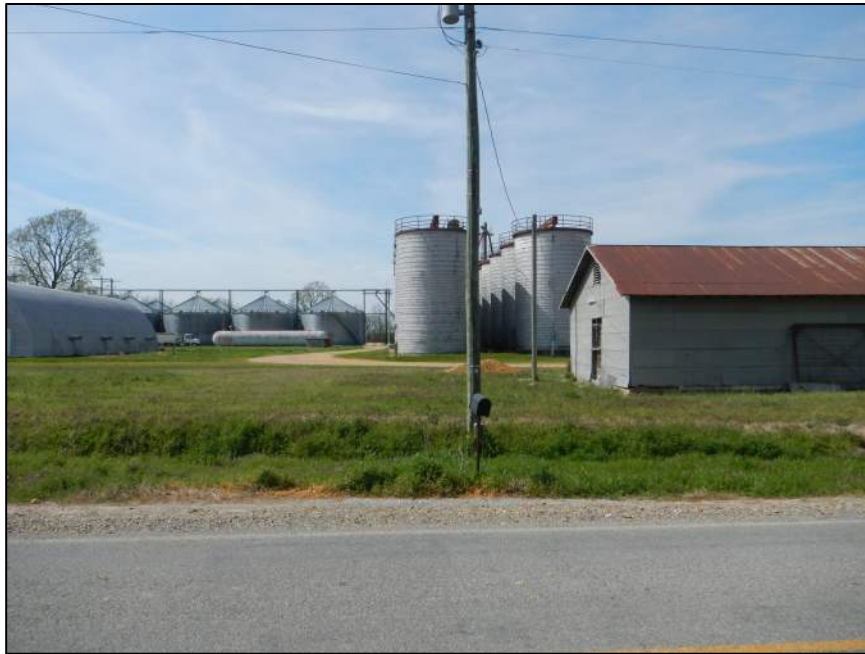
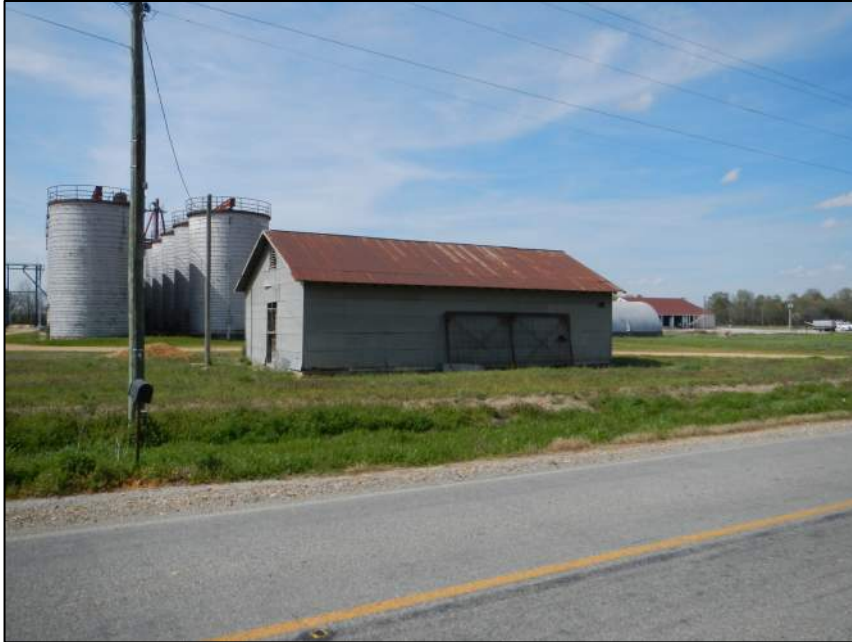
Figure 1-13. NRHP-eligible Knobel Grain facility (CY0079) in Knobel, view southwest (DSCN 1619).

The AHPP records describe CY0079 as the Knobel Grain facility (Figures 1-13–1-16). The buildings are located along the western side of main Street/Highway 90 in Knobel.

The structures would not be directly impacted by the alignment alternatives (see Figure 1-05).

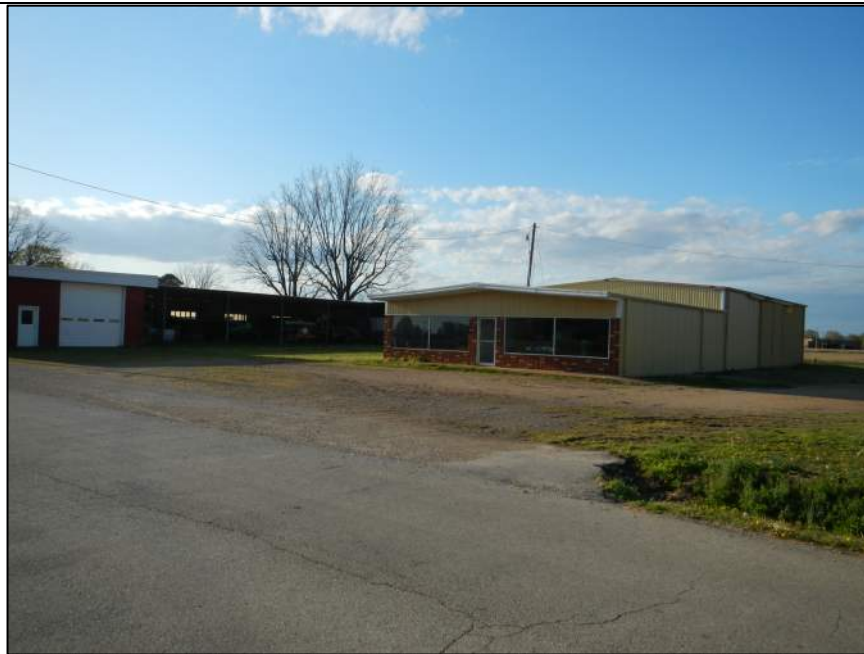
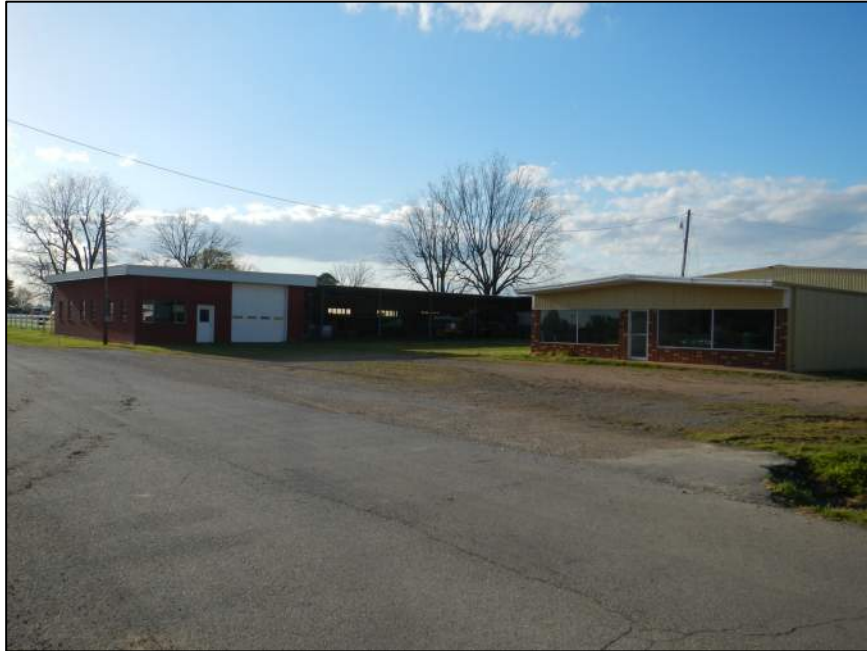
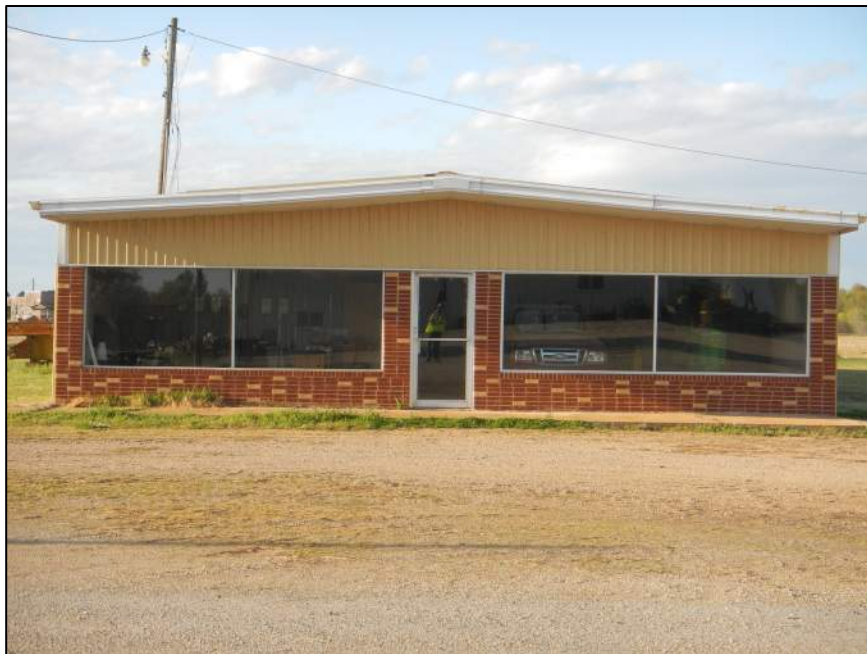
Figure 1-17. NRHP-ineligible MOARK Depot (CY0080) north of Corning, view northwest (DSCN 1796).

The AHPP records describe CY0080 as the MOARK Depot building(s) (Figures 1-17–1-19). The facility is located along the northern side of Clay County Road 148 at the intersection of AR-67 north of Corning.

The available information on the facility is somewhat vague and it is unclear if the buildings shown in the photographs are both considered part of CY0080 (the AHPP map location dot is in the paved area between the two buildings). There is no associated signage and the yellow sheet metal building with the front façade of brick appears to be used for storage.

The structures would not be directly impacted by the alignment alternatives (see Figure 1-06).

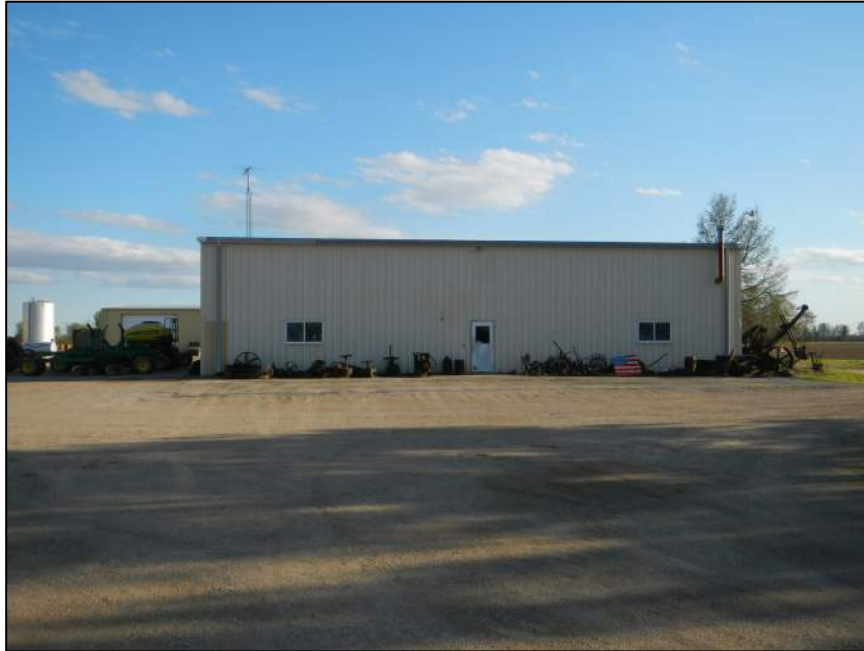
The available information on the facility is somewhat vague and it is unclear if the buildings shown in the photographs are considered part of CY0075 (the AHPP map location dot is in the agricultural field west of the existing buildings, suggesting that an older building may have been located here). The Advance-Rumely moniker dates to the post-1915 period; the company was acquired by Allis-Chalmers Manufacturing in 1931. There is no associated signage identifying this as Advance-Rumely Tractor, and the commercial/industrial buildings appear to be too recent and anodyne to warrant a recommendation of eligibility for listing in the NRHP.

Figure 1-22. NRHP-eligible Advance-Rumely Tractor (CY0075) north of Corning, view south (DSCN 1804).

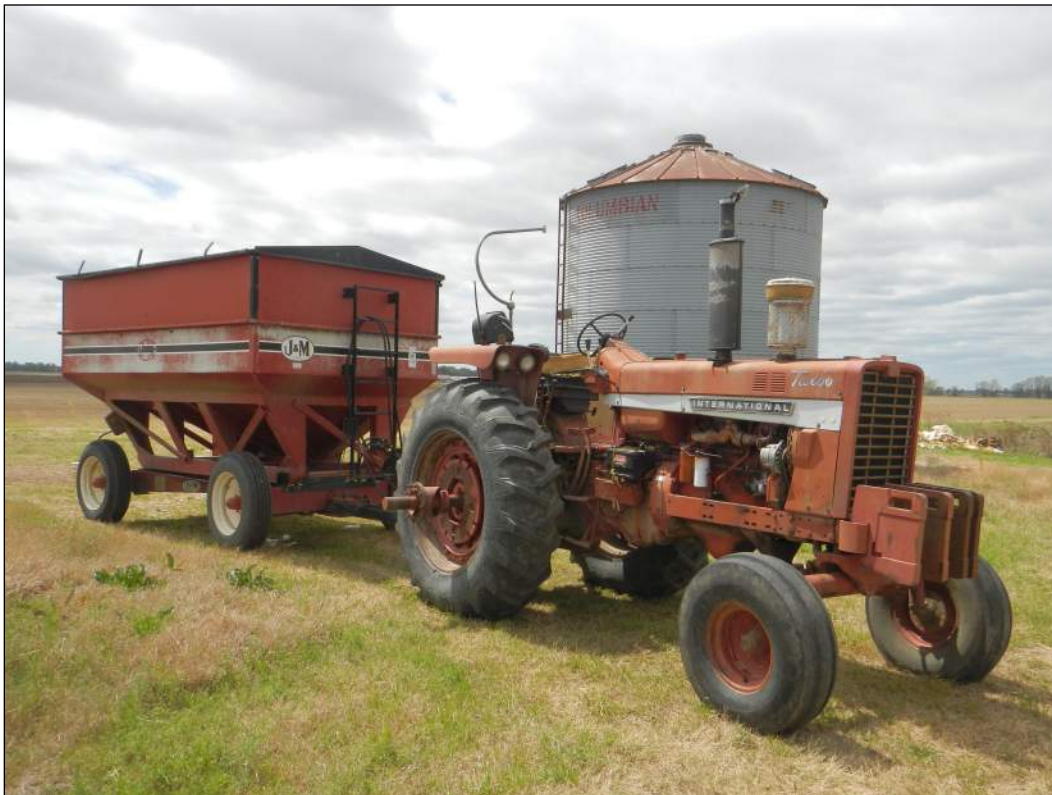
Figure 2-11. Columbian grain silo and International Harvester rig along Alex Road, Randolph County, view northwest (DSCN1728).

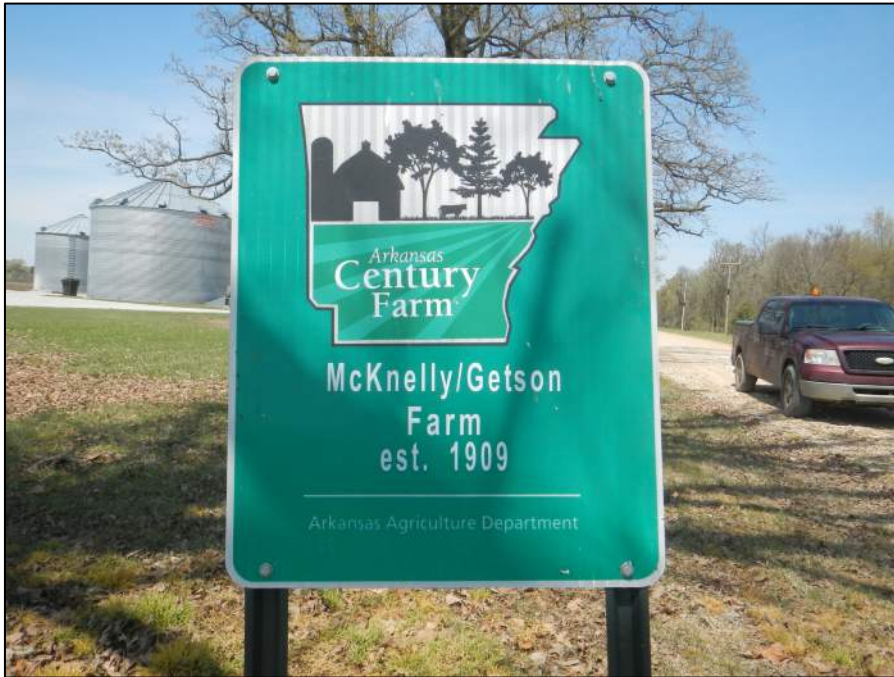
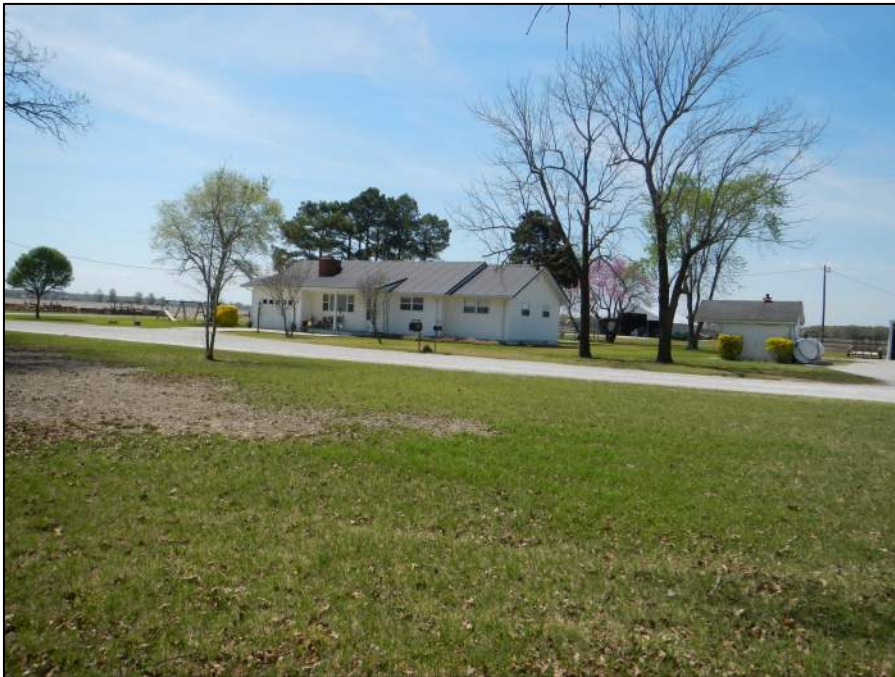
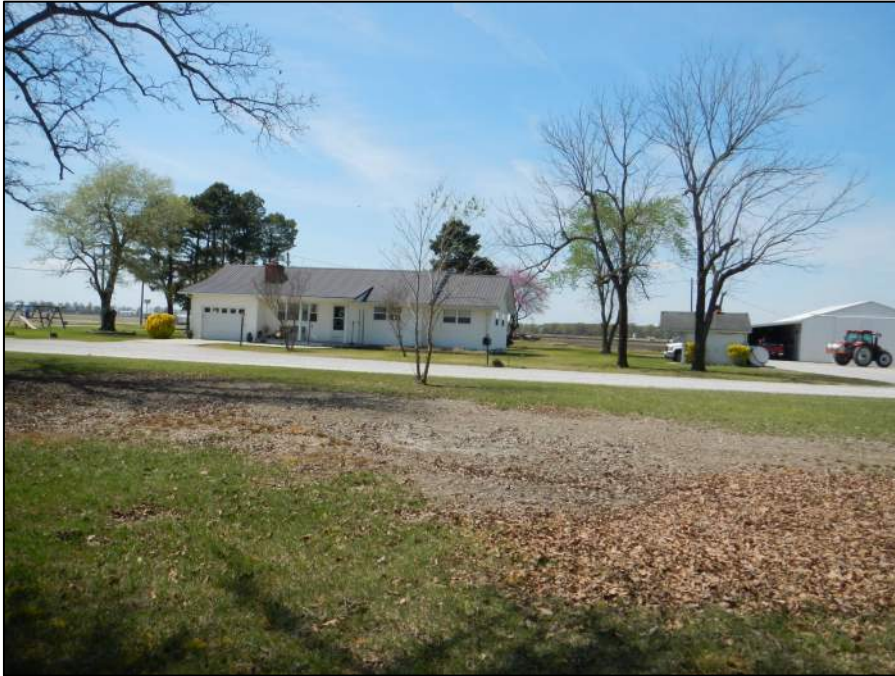
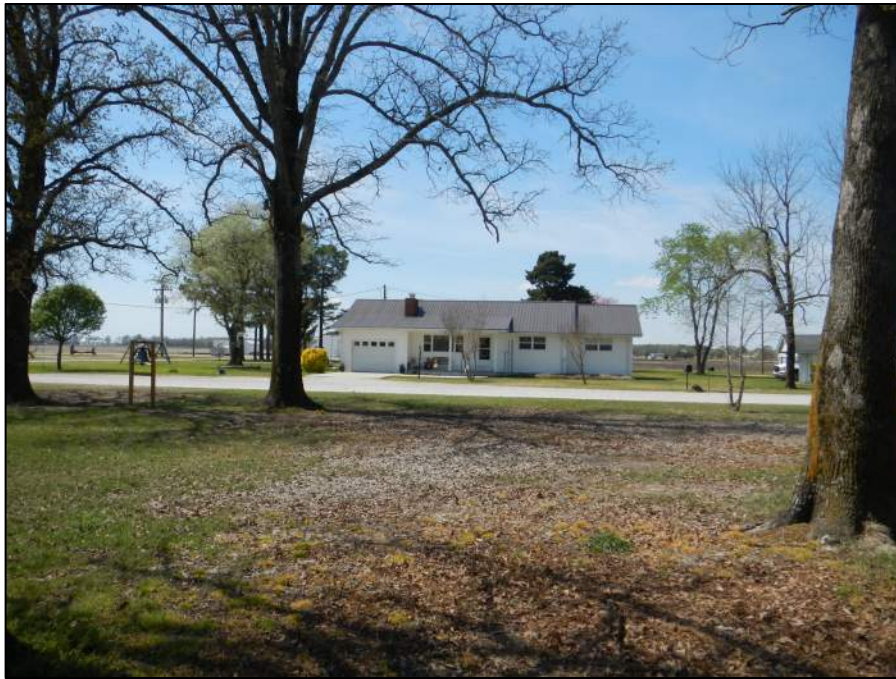
Property 1 (McKnelly/Getson Farm), located at 436 Greene 225 Road (ID 0005-30300-002), is a farm complex on the outskirts of O’Kean in the southwestern corner of rural Greene County (Figures 2-01 and 2-12-2-17). The principal buildings are situated on 4.23 acres and are surrounded by an additional 75.47 acres of cultivated land and a small woodlot (the more extensive acreage of Getson Farm includes 492.8 acres).

7.5-minute USGS O’Kean quadrangle place the construction date in the late 1950s to early 1960s. Upgrades to the house include the addition of vinyl siding and a fairly recent asphalt shingle roof. The small, detached well house is from the same period as the main residence. The older quadrangle map shows this as one of the earliest cleared agricultural tracts in the immediate area.

In the opinion of Panamerican, Property 1 is undetermined for listing in the NRHP. AHPP recommended documenting this resource with an archaeological site form.

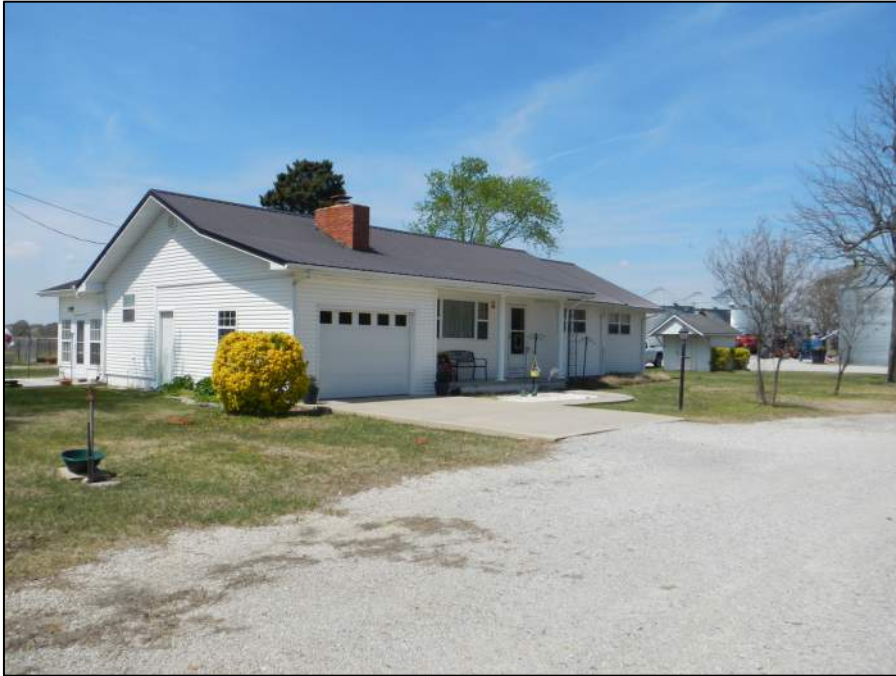
Figure 2-16. Property 1 main house, well spigot, grain silos, view northwest (DSCN1603).

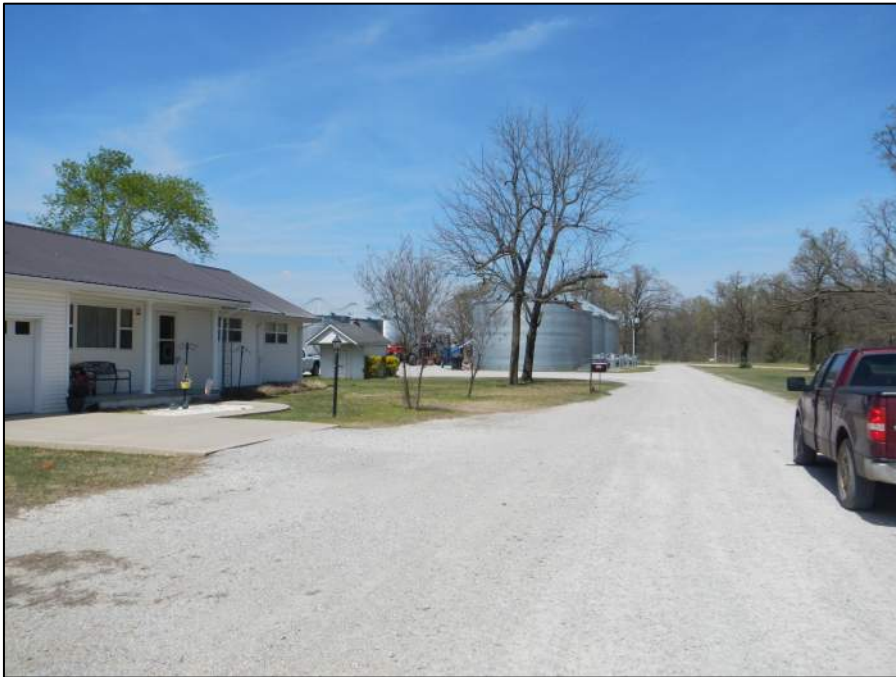
Figure 2-17. Property 1 main house, grain silos, view north (DSCN1603).

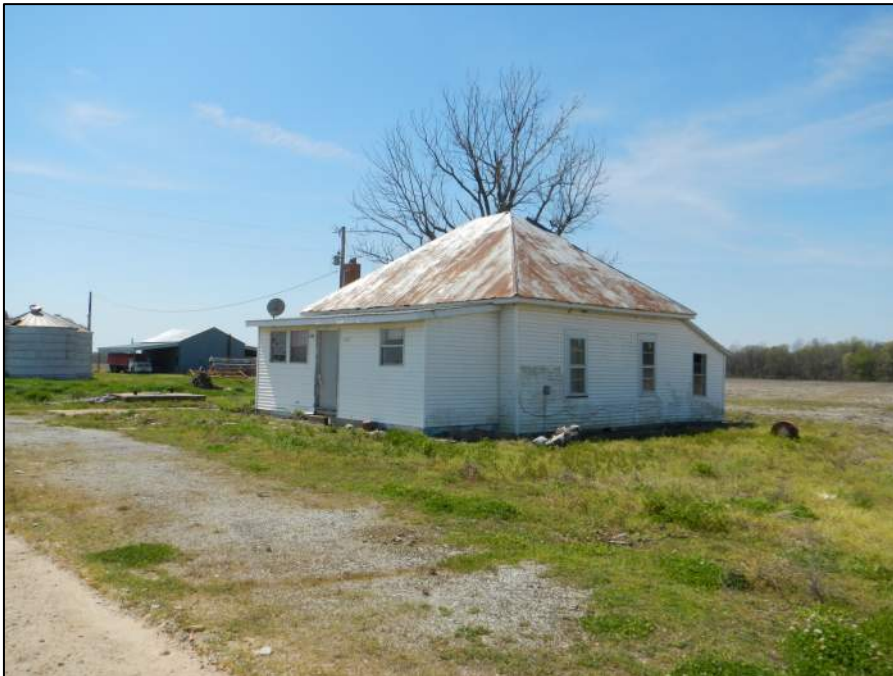
Figure 2-19. Property 2, oblique view southwest (DSCN1585).

Property 2, located at 629 Main Extended (ID 001-02346-000), is a 1930 standard frame one-story residence (Figures 2-01 and 2-19-2-21). South of the house are a number of more recent agricultural buildings and a doublewide trailer. The structure is immediately adjacent to a planned interchange along the “orange” corridor.

No historic association under Criterion A or B was found. The house has a corrugated sheet metal-covered hipped roof and a rectangular plan covering about 916 ft². Shed roof additions are located on the front, rear, and southern sides of the main house, and a storm shelter is described in the property records. The 1-over-1 aluminum windows, vinyl siding, and the pre-hung front door are clearly post-Depression era additions. A single brick chimney is on the south façade. The interior of the structure was not examined. The house is currently unoccupied.

In the opinion of Panamerican, Property 2 is not eligible for listing in the NRHP because it meets none of the established criteria. It is not known to be associated with any significant persons or event, thus Criteria A (association) and B (prominent individuals) do not apply. The building does not represent the distinctive characteristics of a type, the work of a master, nor does it possess any high artistic value (Criterion C Design/Construction). While Criterion D (Information Potential) can be applied to buildings, Property 2 appears to offer little future research potential, thus Criterion D is not applicable.

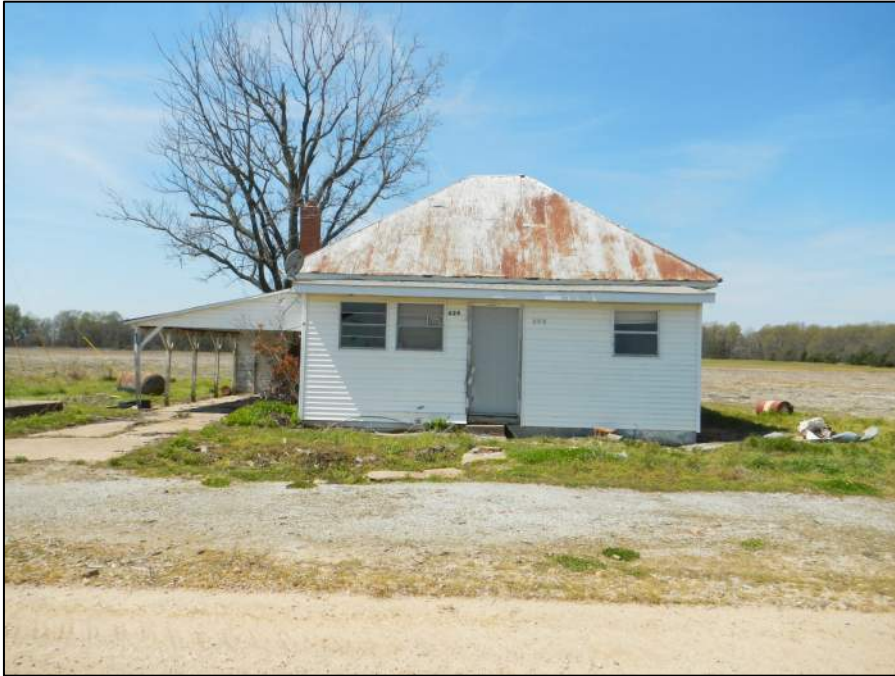
Figure 2-20. Property 2, front façade, view west (DSCN1587).

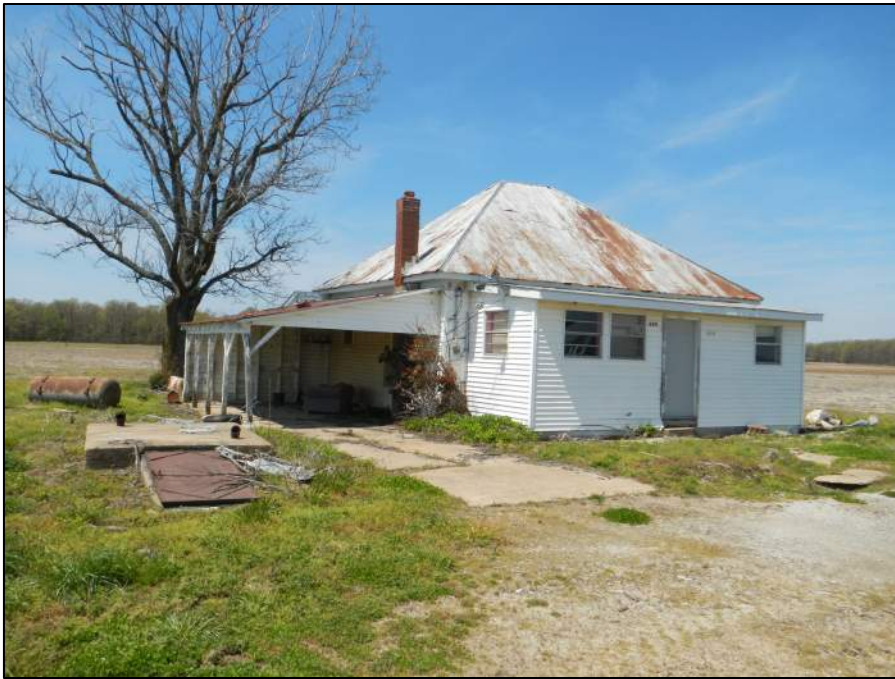
Figure 2-21. Property 2, oblique view northwest (DSCN1588).

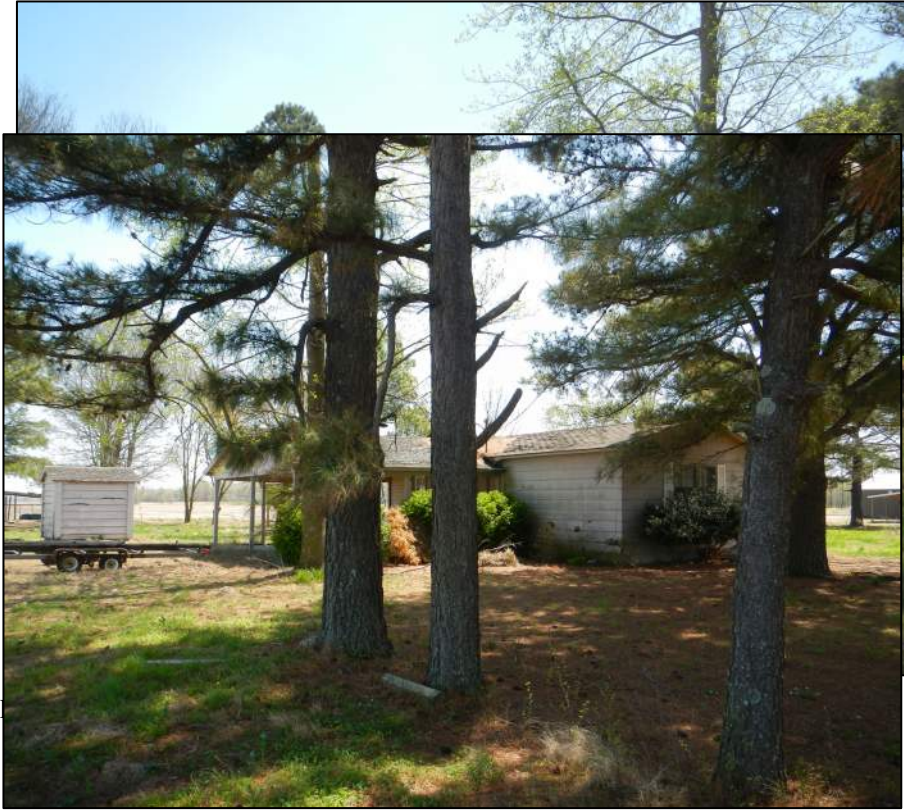
Figure 2-23. Property 3, oblique view east-southeast (DSCN1590).

Property 3, located at 1174 Main Extended (ID 001-02355-000), is a 1955 standard frame one-story residence (Figures 2-01 and 2-22–2-28). South of the house is a sheet metal barn or equipment shed. Two small outbuildings and an outdoor patio cover are in the rear yard. The structure is immediately north of a recently constructed (2018) retail establishment (Elk River Outfitters) and adjacent to a planned interchange along the “orange” corridor.

In the opinion of Panamerican, Property 3 is not eligible for listing in the NRHP because it meets none of the established criteria. It is not known to be associated with any significant persons or event, thus Criteria A (association) and B (prominent individuals) do not apply. The buildings do not represent the distinctive characteristics of a type, the work of a master, nor do they possess any high artistic value (Criterion C Design/Construction) and integrity of design materials and feeling have been compromised. While Criterion D (Information Potential) can be applied to buildings, Property 3 appears to offer little future research potential, thus

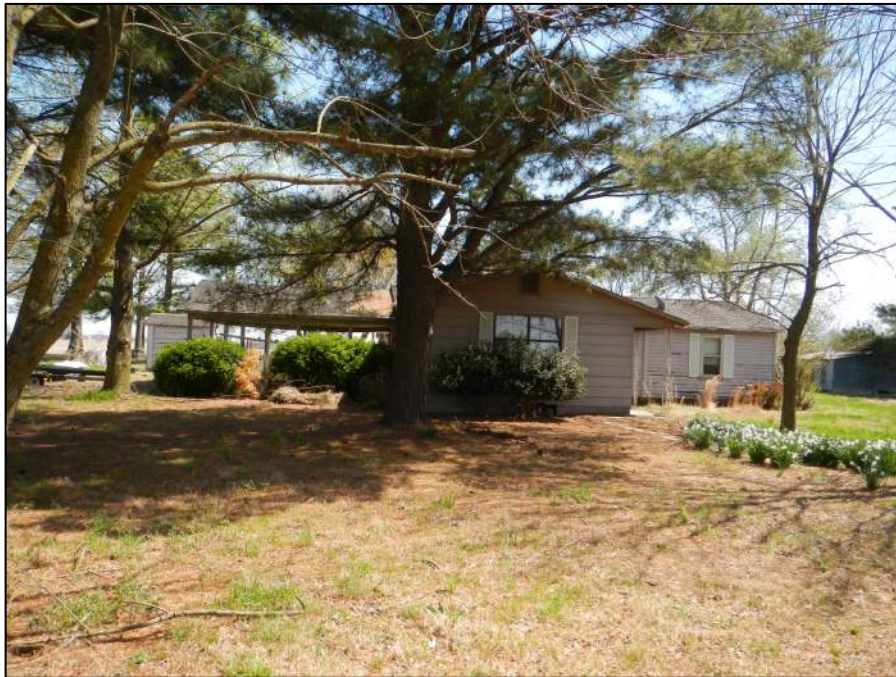
Figure 2-24. Property 3, front façade and yard, view east (DSCN1591).

The house has an asphalt shingle-covered cross gabled roof and a cross-rectangular floor plan. An open carport is on the north end of the house. The windows are 1-over-1 aluminum with faux shutters. Two different widths of exterior siding are present, suggesting the addition of wing after the original construction. The interior of the structure was not examined. The house is currently unoccupied.
