Appendix J – Cultural Resources Information

Job No. 100512, Walnut Ridge – Missouri State Line (Future I-57) P.E.

**ARCHITECTURAL RESOURCES SURVEY FOR
FUTURE INTERSTATE 57 (JOB 100512),
LAWRENCE, RANDOLPH, GREENE, AND CLAY COUNTIES,
ARKANSAS**

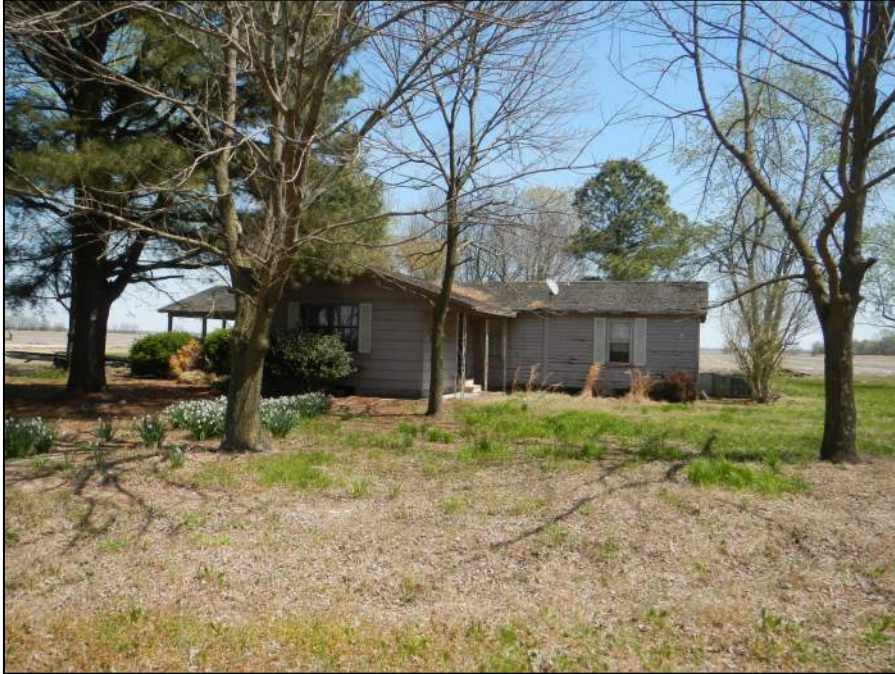
Figure 2-25. Property 3, front façade and yard, view east-northeast (DSCN1592).

The house has an asphalt shingle-covered cross gabled roof and a cross-rectangular floor plan. An open carport is on the north end of the house. The windows are 1-over-1 aluminum with faux shutters. Two different widths of exterior siding are present, suggesting the addition of wing after the original construction. The interior of the structure was not examined. The house is currently unoccupied.

In the opinion of Panamerican, Property 3 is not eligible for listing in the NRHP because it meets none of the established criteria. It is not known to be associated with any significant persons or event, thus Criteria A (association) and B (prominent individuals) do not apply. The buildings do not represent the distinctive characteristics of a type, the work of a master, nor do they possess any high artistic value (Criterion C Design/Construction) and integrity of design materials and feeling have been compromised. While Criterion D (Information Potential) can be applied to buildings, Property 3 appears to offer little future research potential, thus

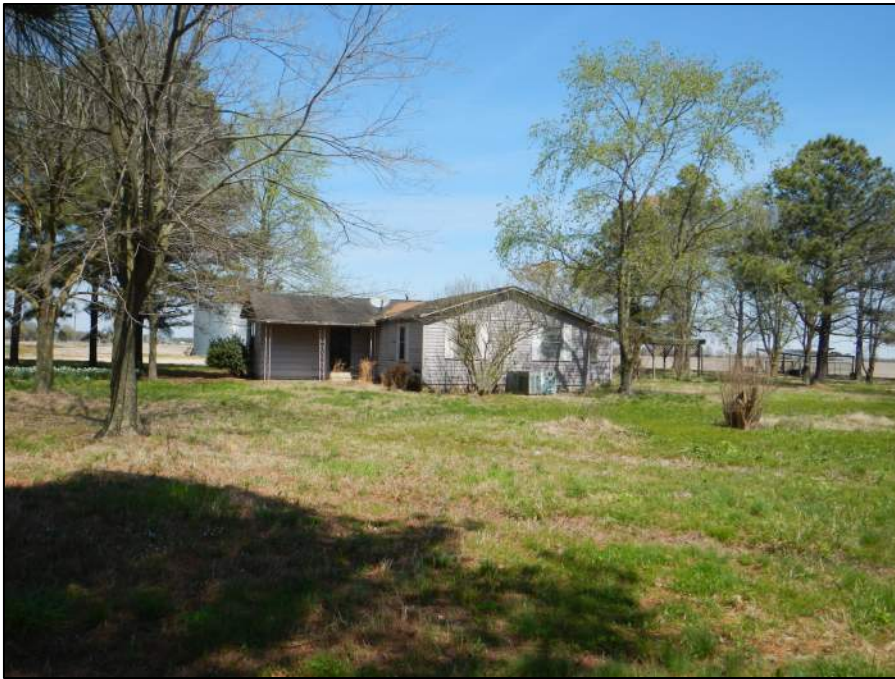
Figure 2-26. Property 3, south façade and yard, view north (DSCN1594).

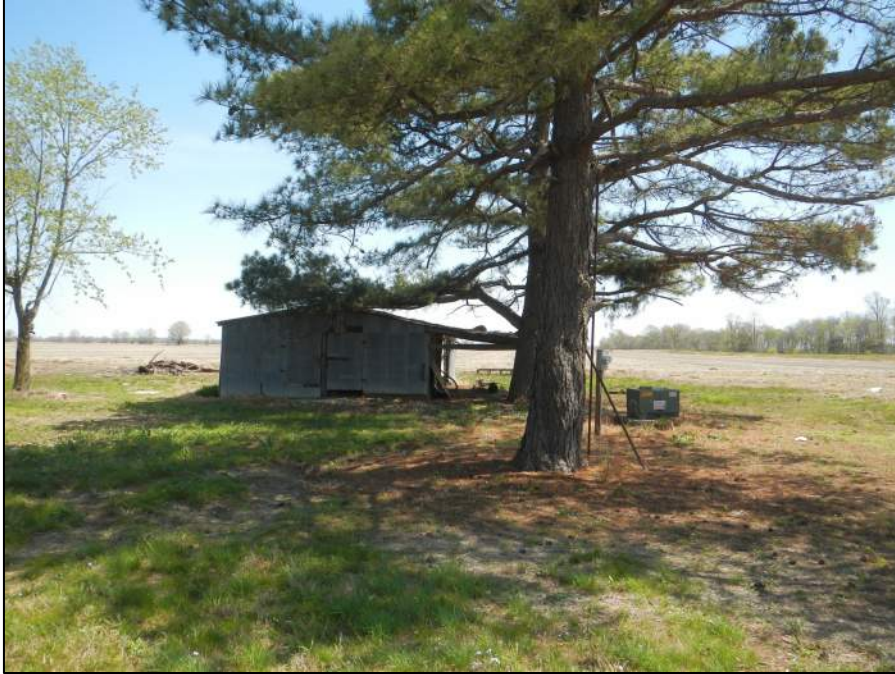
The barn or equipment shed is a simple frame structure with a corrugated sheet metal façade and roof. A “dog-trot” pass-through is located in the center of the shed.

Figure 2-27. Property 3, barn/shed, view east (DSCN1595).

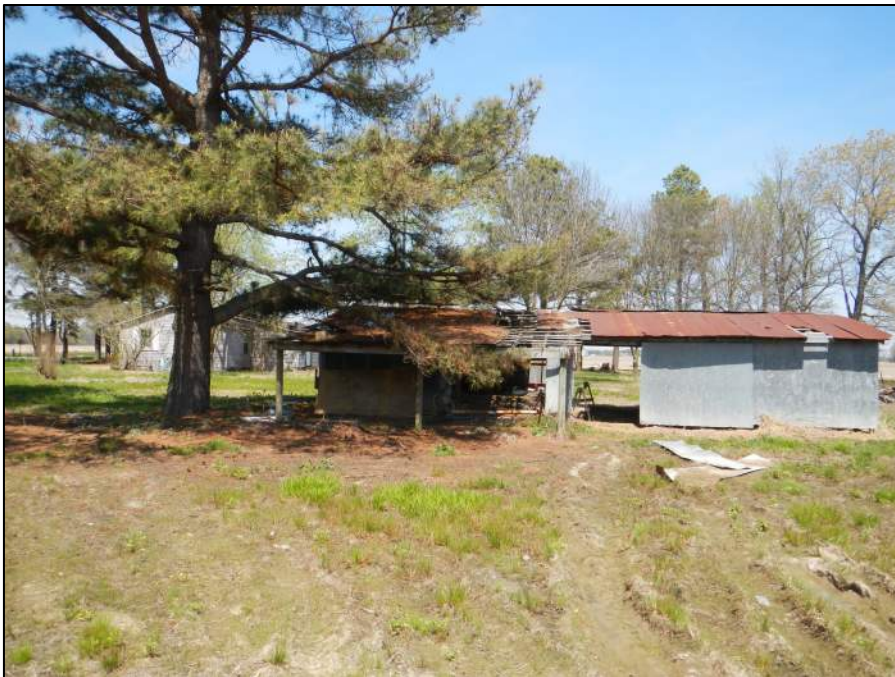
Figure 2-28. Property 3, barn/shed and main house, view north (DSCN1597).

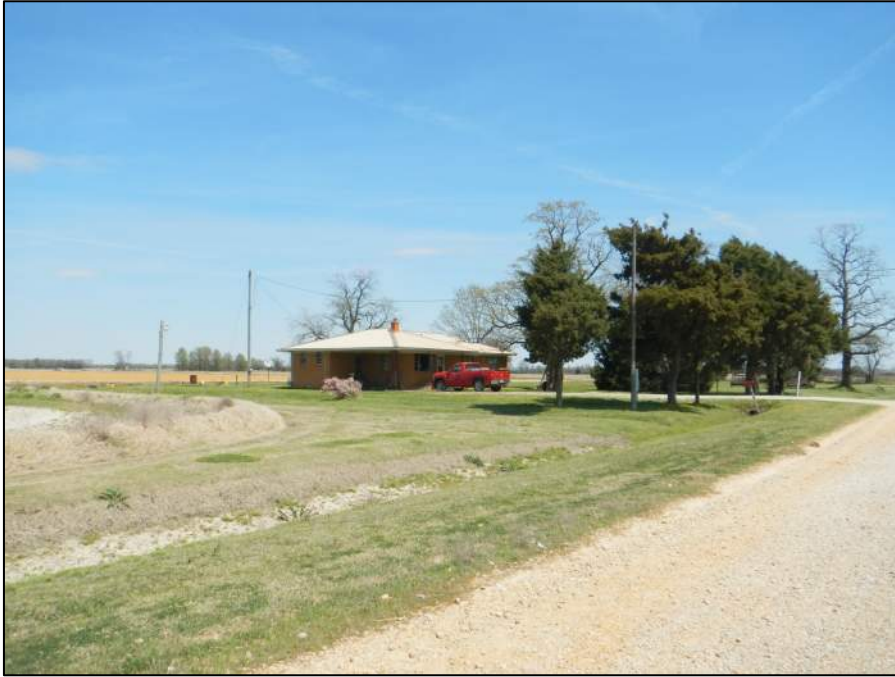
Figure 2-29. Property 4, view northeast (DSCN1605).

Property 4, located at 833 Greene 225 Road (ID 005-30430-001), is an early 1960s Ranch style one-story masonry residence (Figures 2-01 and 2-29–2-31). A small sheet metal yard barn or equipment shed is east of the main house. The structure is immediately north of the McKnelly/Getson Farm (Property 1) and northeast of a planned interchange along the “orange” corridor.

In the opinion of Panamerican, Property 4 is not eligible for listing in the NRHP because it does not meet any of the established criteria. The buildings are not known to be associated with any significant persons or event, thus Criteria A (association) and B (prominent individuals) do not apply. The buildings do not represent the distinctive characteristics of a type, the work of a master, nor do they possess any high artistic value (Criterion C Design/Construction). While Criterion D (Information Potential) can be applied to buildings, Property 4 appears to offer little future research potential, thus Criterion D is not applicable.

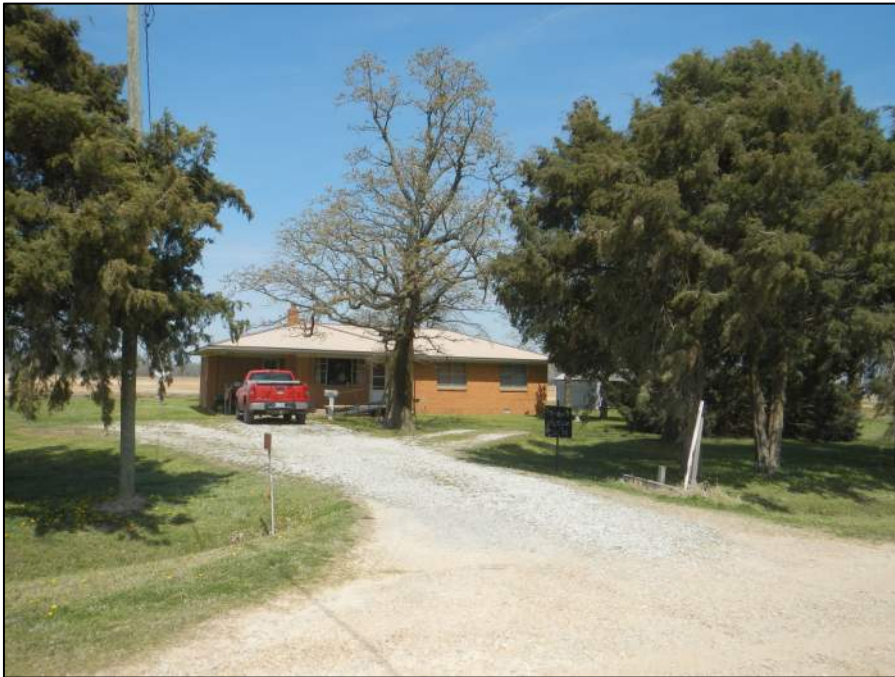
Figure 2-30. Property 4, front façade, view north (DSCN1606).

The house has an asphalt shingle-covered hipped roof and a rectangular floor plan. A small open carport is on the southwest corner of the house. The windows are 2-over-2 aluminum. The exterior façade is brick

and a single chimney is present on the west end of the house. The interior of the structure was not examined. The house is currently occupied. The barn or equipment shed is a simple frame structure with a corrugated sheet metal façade and roof.

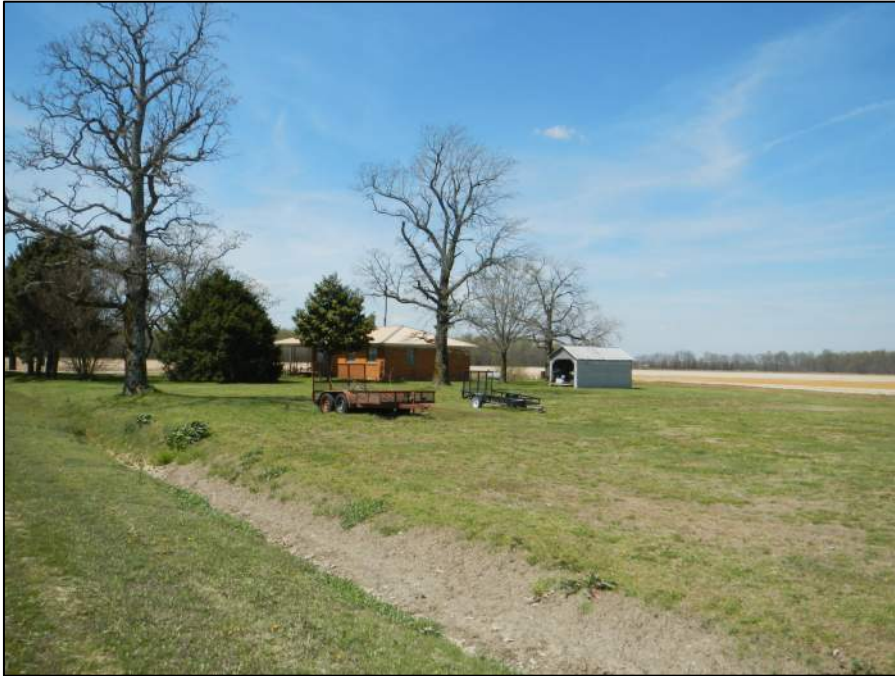
Figure 2-31. Property 4, main house and yard barn, view northwest (DSCN1607).

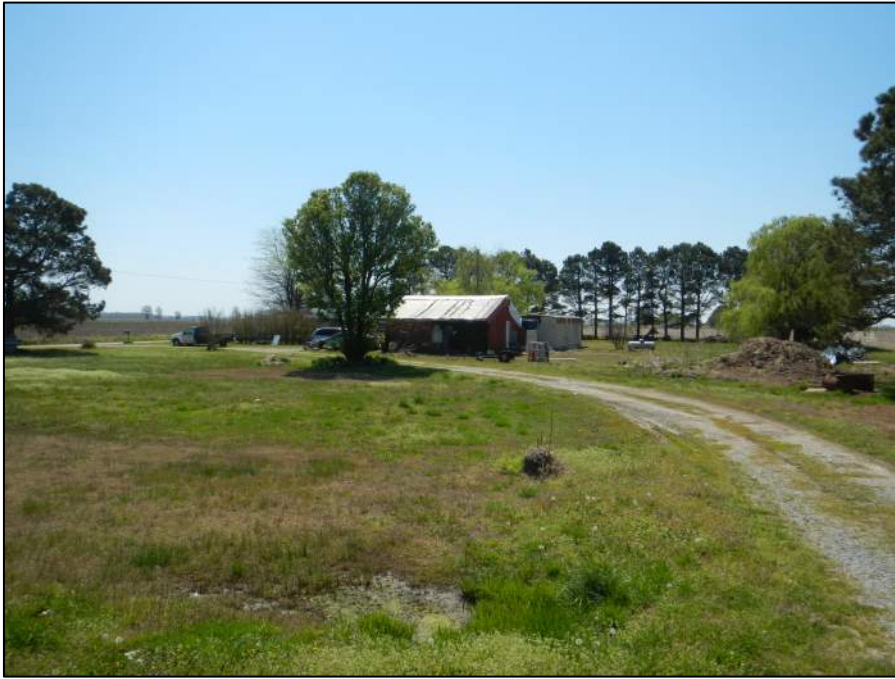
Figure 2-32. Property 5, view south-southeast (DSCN1575).

Property 5, located at 1049 Highway 231 in Giles Spur (ID 001-02237-000), is a post-1965 standard frame one-story masonry residence (Figures 2-02 and 2-32–2-34). An assemblage of small sheet metal outbuildings is distributed around the perimeter of the main house and yard. The structure is adjacent to White Oak Slough immediately north of the proposed “orange” corridor.

In the opinion of Panamerican, Property 5 is not eligible for listing in the NRHP because it does not meet any of the established criteria. The buildings are not known to be associated with any significant persons or event, thus Criteria A (association) and B (prominent individuals) do not apply. The buildings do not represent the distinctive characteristics of a type, the work of a master, nor do they possess any high artistic value (Criterion C Design/Construction). While Criterion D (Information Potential) can be applied to buildings, Property 5 appears to offer little future research potential, thus Criterion D is not applicable.

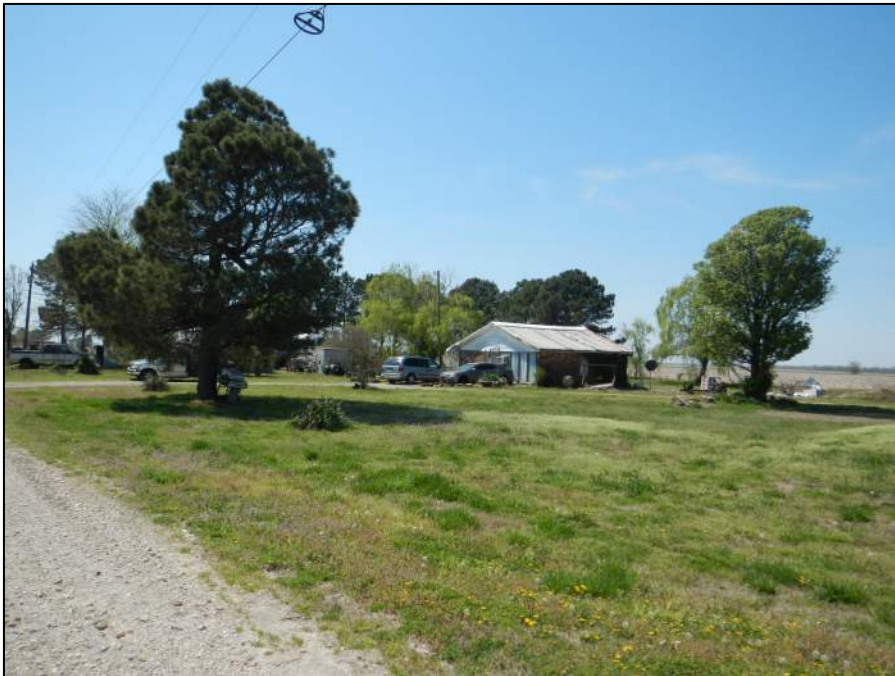
Figure 2-33. Property 5, view southwest (DSCN1576).

The house has an asphalt shingle-covered box gable roof and a rectangular floor plan covering about 750 ft². Part of the roof is covered with a large plastic tarp, suggesting previous storm damage. The exterior façade is brick. The interior of the structure was

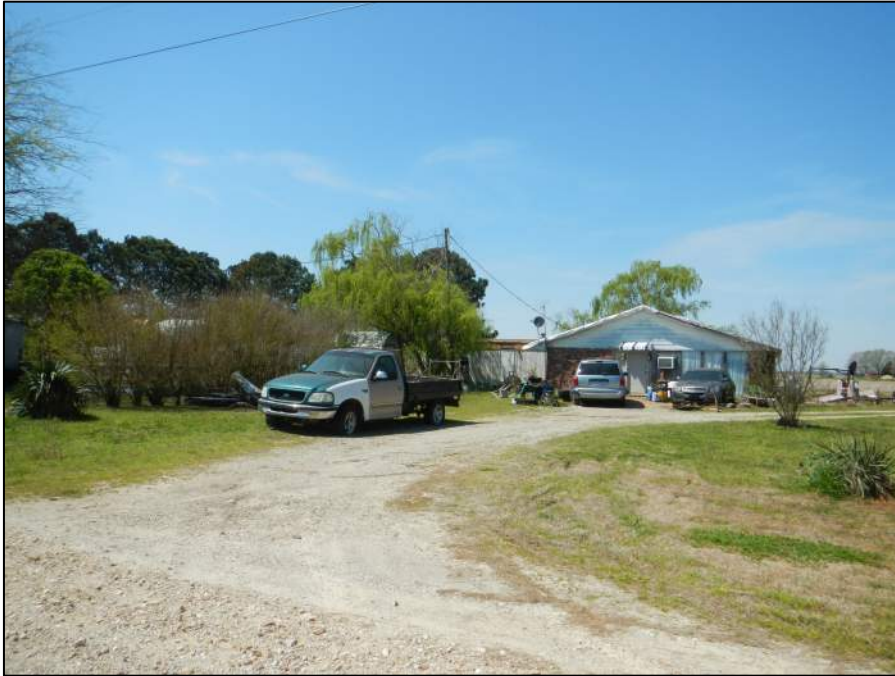
Figure 2-34. Property 5, view west (DSCN1577).

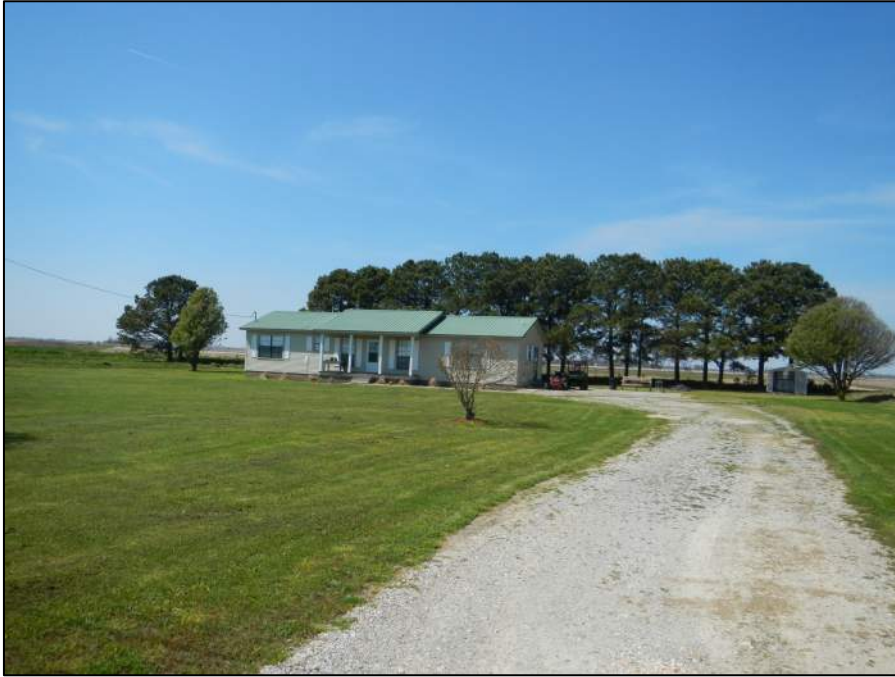
Figure 2-35. Property 6, view southwest (DSCN1578).

Property 6, located at 497 Lawrence Road 611 in Giles Spur (ID 001-02241-001), is a post-1991 Ranch style one-story residence (Figures 2-02 and 2-35–2-37). A small sheet metal yard barn and a covered swing are in the yard of the main house. A tree line/windbreak is planted on the western side of the property. The structure is on White Oak Slough immediately south of the proposed “orange” corridor.

In the opinion of Panamerican, Property 6 is not eligible for listing in the NRHP because it does not meet any of the established criteria. Buildings less than 50 years of age can be eligible for listing in the NRHP, but must be “exceptionally important” (NPS 1997; website). The buildings are not known to be associated with any significant persons or event, thus Criteria A (association) and B (prominent individuals) do not apply. The buildings do not represent the distinctive characteristics of a type, the work of a master, nor do they possess any high artistic value (Criterion C Design/Construction). While Criterion D (Information Potential) can be applied to buildings, Property 6 appears to offer little future research potential, thus Criterion D is not applicable.

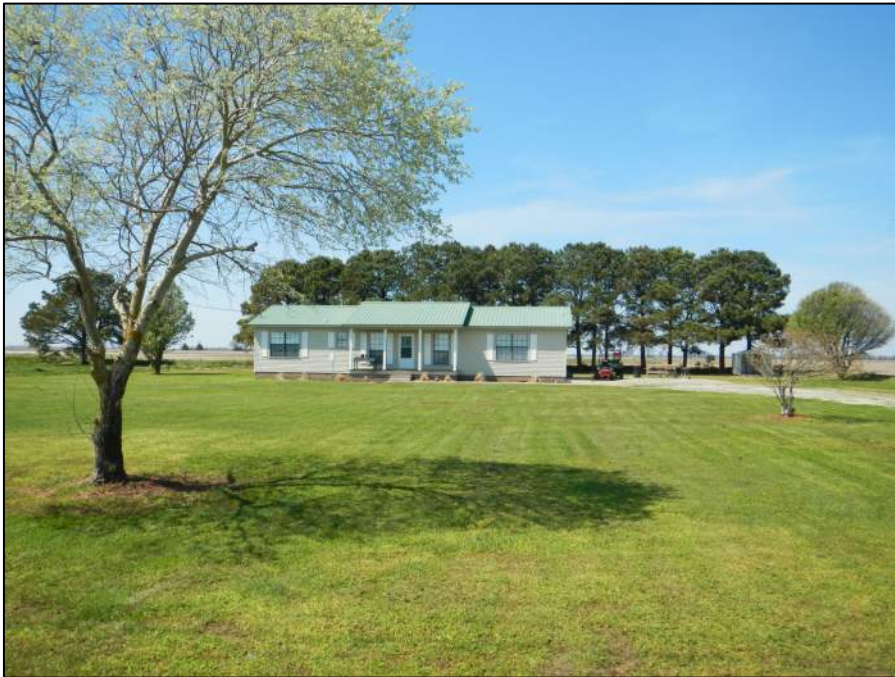
Figure 2-36. Property 6, view west (DSCN1579).

The house has a corrugated sheet metal open gable roof and a rectangular floor plan covering about 1440 ft². The exterior façade is vinyl siding. The interior of the structure was not examined. The house is currently occupied. The yard barn and covered swing are simple pre-fabricated structures available at big-box hardware and home improvement stores.

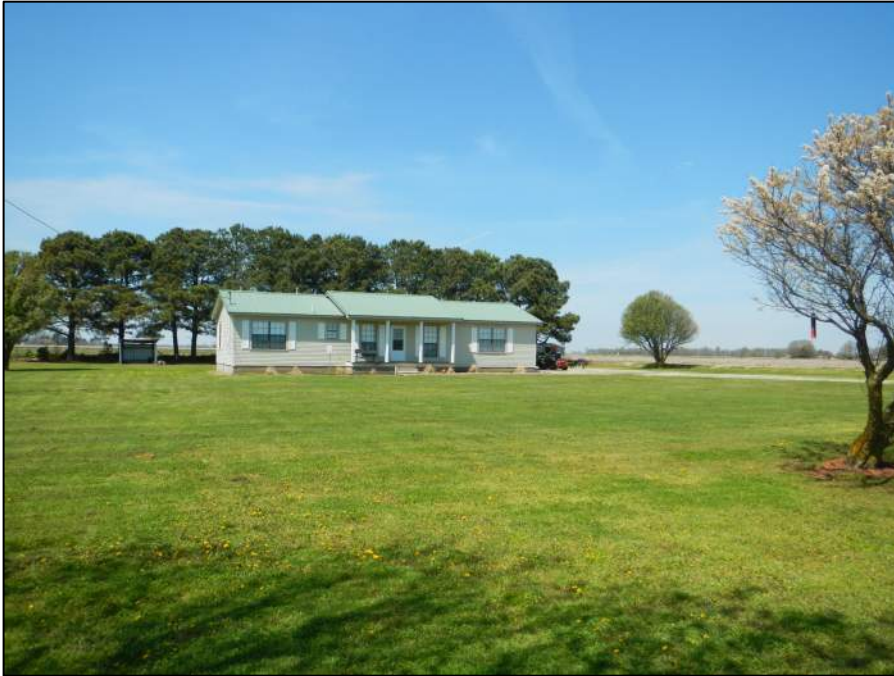
Figure 2-37. Property 6, view northwest (DSCN1580).

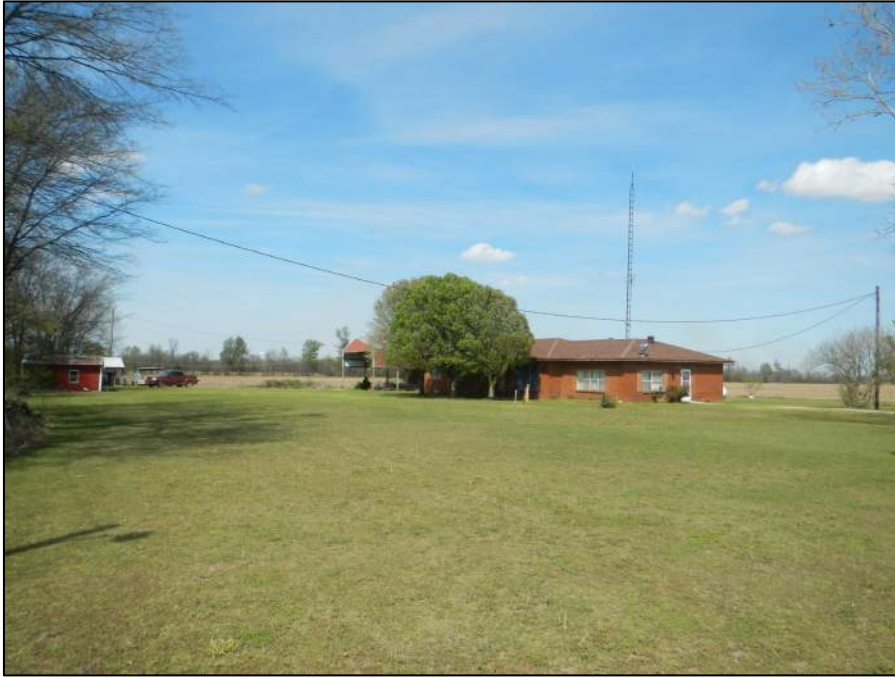
Figure 2-38. Property 7, view northeast (DSCN1616).

Property 7, located at 1902 Clay County Road 216 near Knobel (ID 022-01666-000), is a post-1964 Ranch style one-story residence (Figures 2-03 and 2-38–2-40). A sheet metal yard barn, an open carport cover/awning and a large equipment shed are in the yard of the main house. A tree line/windbreak is planted on the western side of the property. The structure is on a short intermittent tributary of the Black River immediately south of the proposed “orange” corridor.

In the opinion of Panamerican, Property 7 is not eligible for listing in the NRHP because it does not meet any of the established criteria. The buildings are not known to be associated with any significant persons or event, thus Criteria A (association) and B (prominent individuals) do not apply. The buildings do not represent the distinctive characteristics of a type, the work of a master, nor do they possess any high artistic value (Criterion C Design/Construction). While Criterion D (Information Potential) can be applied to buildings, Property 7 appears to offer little future research potential, thus Criterion D is not applicable.

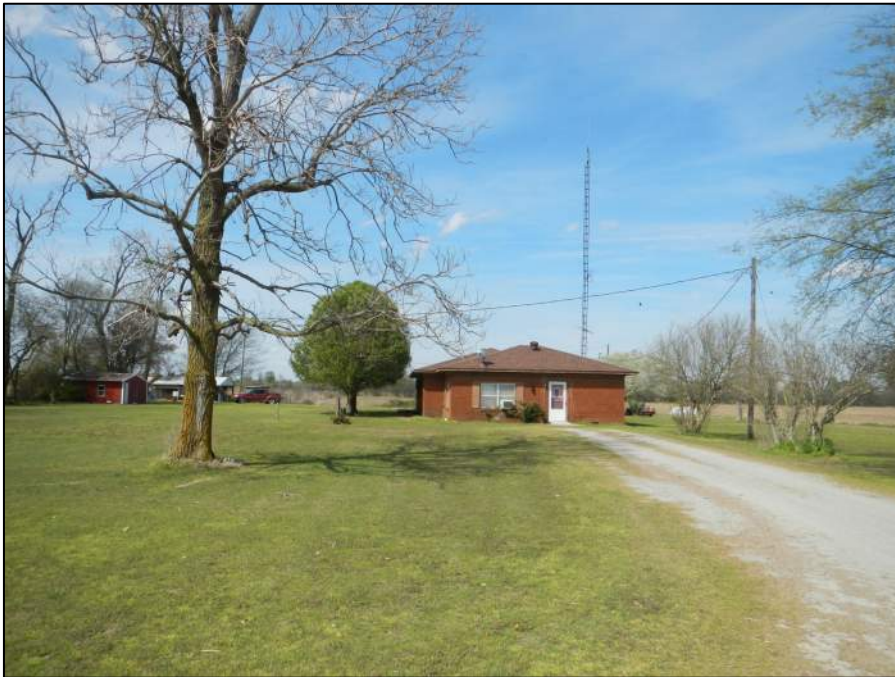
Figure 2-39. Property 7, view north (DSCN1617).

The yard barn and carport cover are simple pre-fabricated structures available at big-box hardware and home improvement stores. The larger equipment shed is corrugated sheet metal. This residential area probably replaced the earlier house shown on the 1941 15-minute quadrangle.

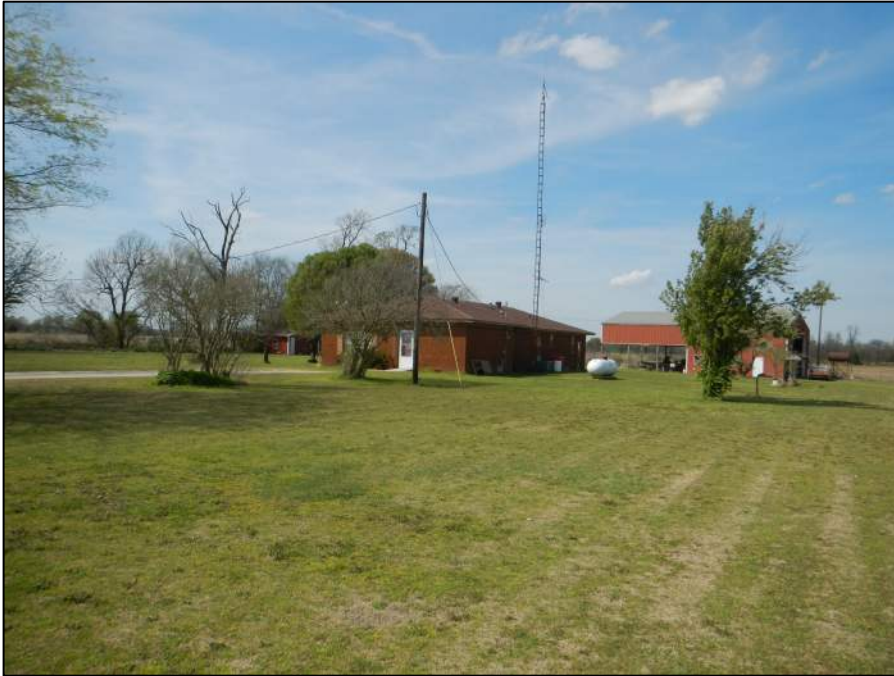
The house has an asphalt-shingled intersecting hipped roof and a rectangular floor plan. The exterior façade is brick. The windows are 1-over-1 aluminum with faux shutters. The interior of the structure was not examined. The house is currently occupied.

Figure 2-40. Property 7, view northwest (DSCN1618).

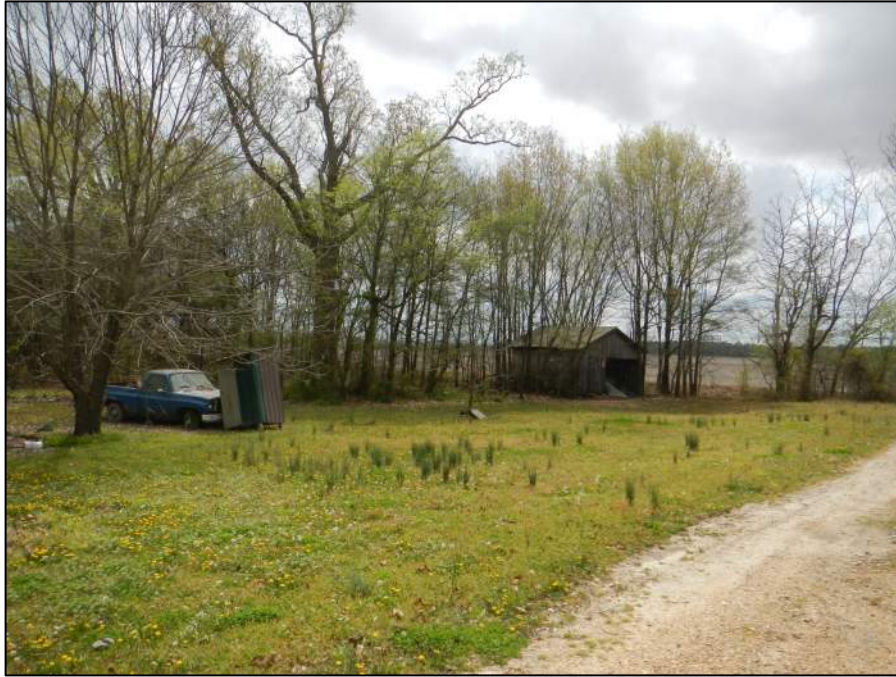
Figure 2-41. Property 8, south barn and outhouse, view southeast (DSCN1633).

Property 8, located at 304 Clay County Road 227 near Knobel (ID 022-01815-000), is a post-1941 farm complex (Figures 2-03 and 2-41–2-46). In addition to the main residential structure (now partially collapsed) are four barns, an outhouse, a house trailer, a swing set. The farm complex is at the head of a short intermittent tributary of the Black River immediately east of the proposed “orange” corridor.

In the opinion of Panamerican, Property 8 is not eligible for listing in the NRHP because it does not meet any of the established criteria. The buildings are not known to be associated with any significant persons or event, thus Criteria A (association) and B (prominent individuals) do not apply. The buildings do not represent the distinctive characteristics of a type, the work of a master, nor do they possess any high artistic value (Criterion C Design/Construction). While Criterion D (Information Potential) can be applied to buildings, Property 8 appears to offer little future research potential, thus Criterion D is not applicable.

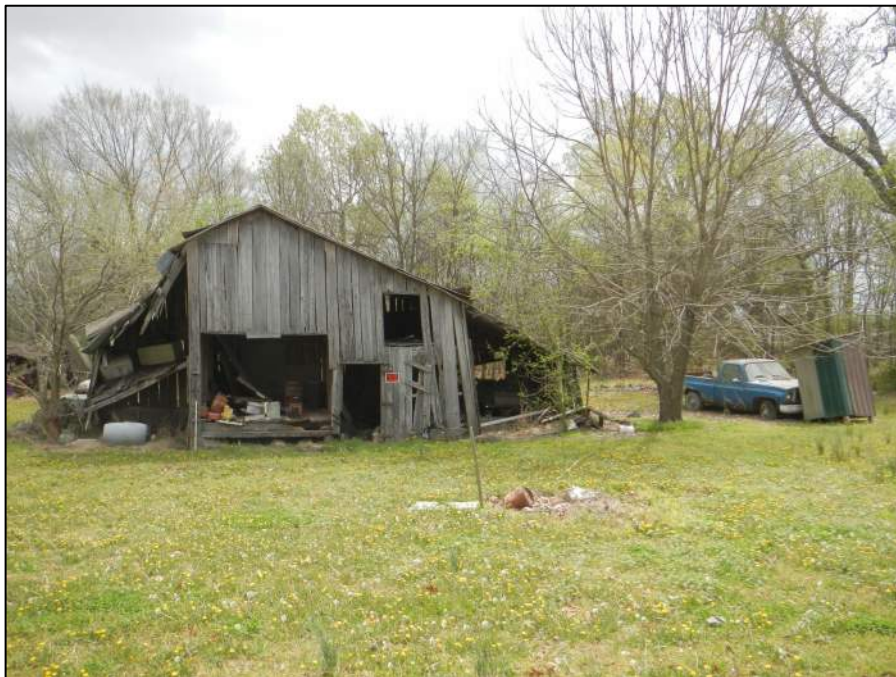
Figure 2-42. Property 8, central barn and outhouse, view east (DSCN1634).

The main house has an asphalt-shingled roof (form indeterminate) and a rectangular floor plan. The exterior façade appears to have been siding and asphalt. The interior of the structure was not examined. The farm complex appears to be unoccupied. The various barns have vertical board sides and corrugated sheet metal roofs. A smaller barn near the main house has a sheet asphalt façade and a conventional shingle roof.

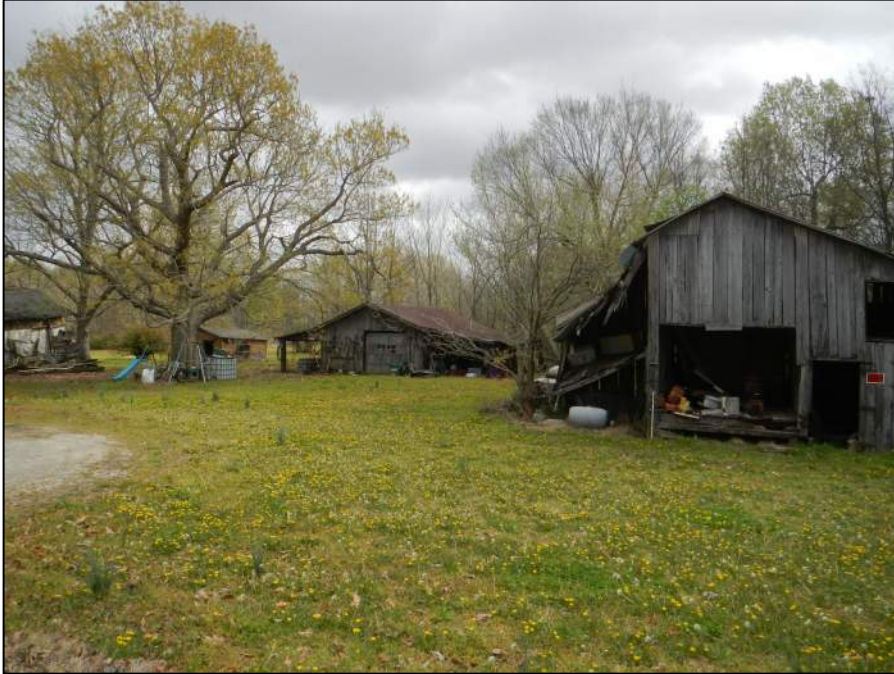
Figure 2-43. Property 8, central barns and main house, view northeast (DSCN1635).

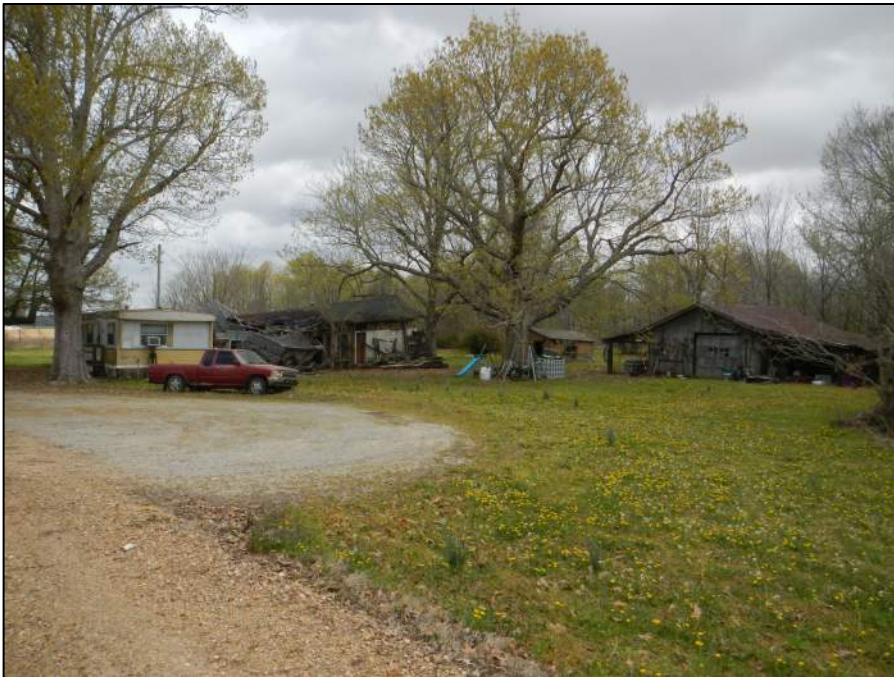
Figure 2-44. Property 8, main house, barns and trailer, view northeast (DSCN1636).

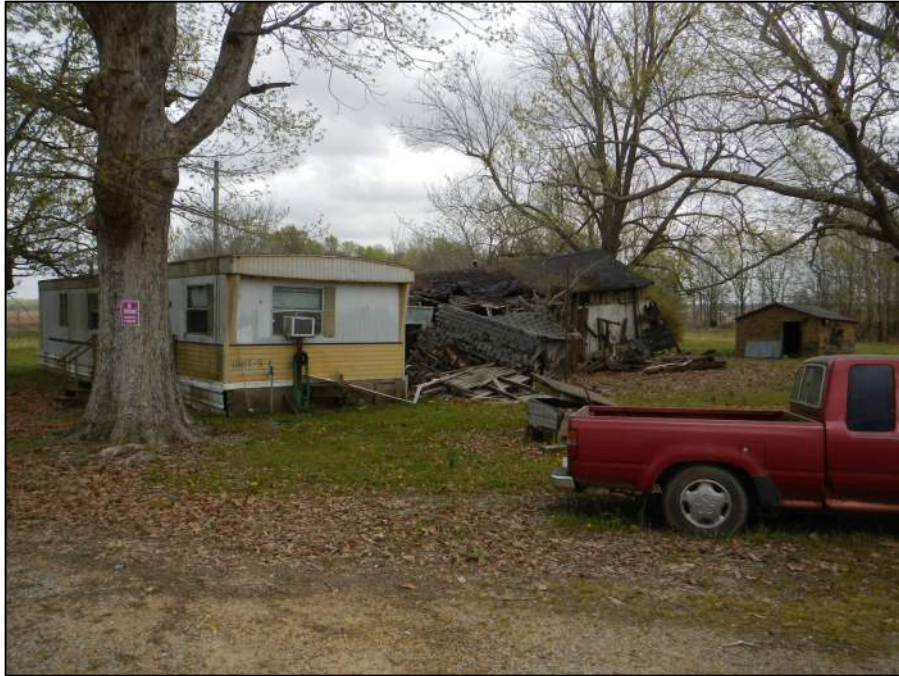
Figure 2-45. Property 8, main house and trailer, view northeast (DSCN1637).

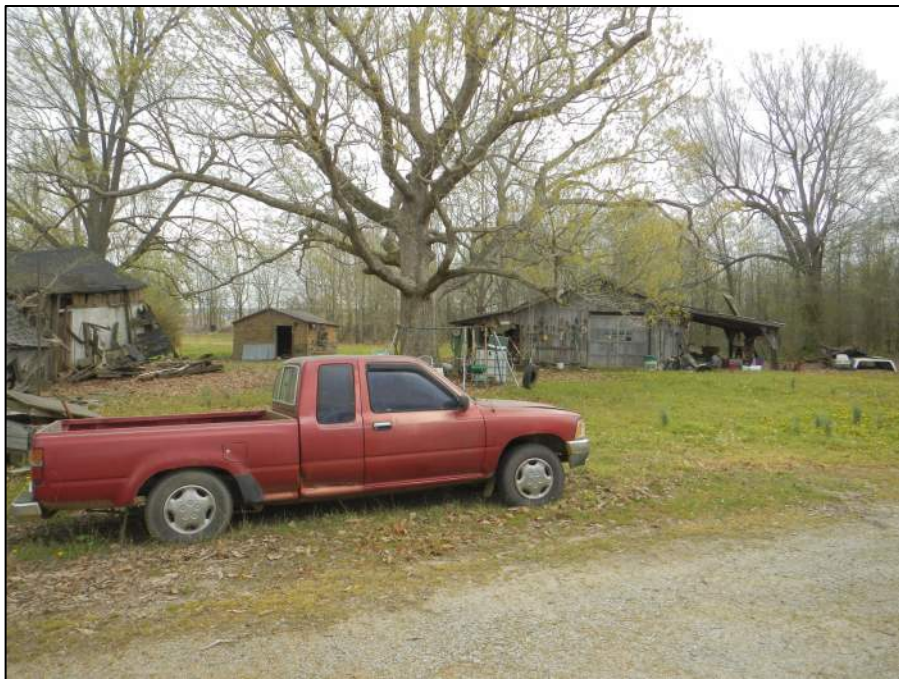
Figure 2-46. Property 8, main house and barns, view east (DSCN1638).

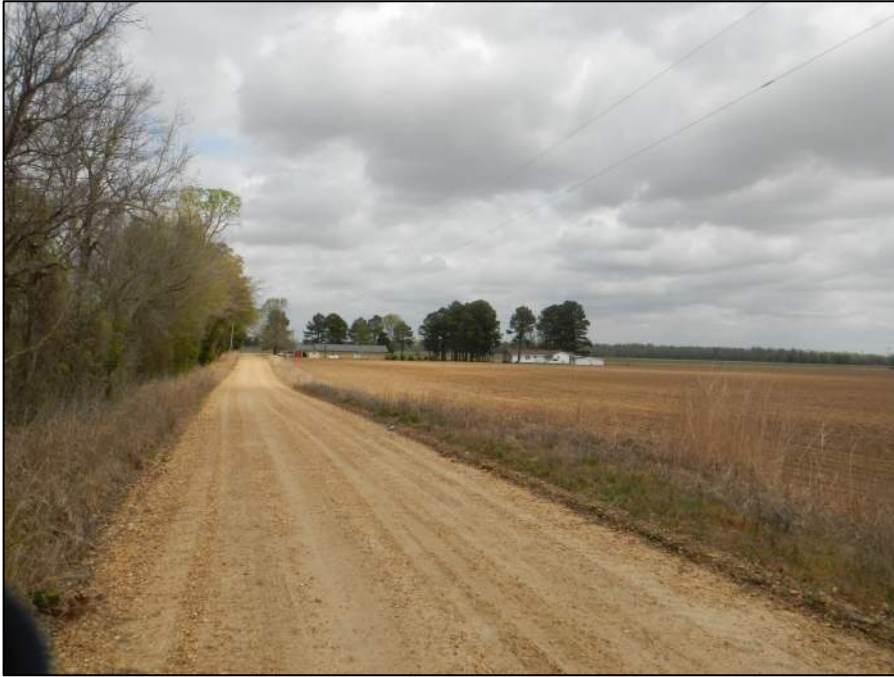
Figure 2-47. Properties 9 (left) and 10 (right), view north (DSCN1639).

Property 9, located at 434 Clay County Road 227 (ID 022-01813-000) and Property 10, located at 2688 Highway 90 (ID 022-01812-000) are on adjacent lots near Knobel (Figures 2-03 and 2-47-2-50). Property 9 is a 1960s Ranch style one-story residence with a combination brick and wood siding facade. Property 10 is a 1970s Ranch style one-story residence with a wood siding facade. The structures are adjacent to a short intermittent tributary of the Black River within an interchange of the proposed “orange” corridor. Both residences also have prefabricated “yard barns” and above-ground propane tanks in the back yards.

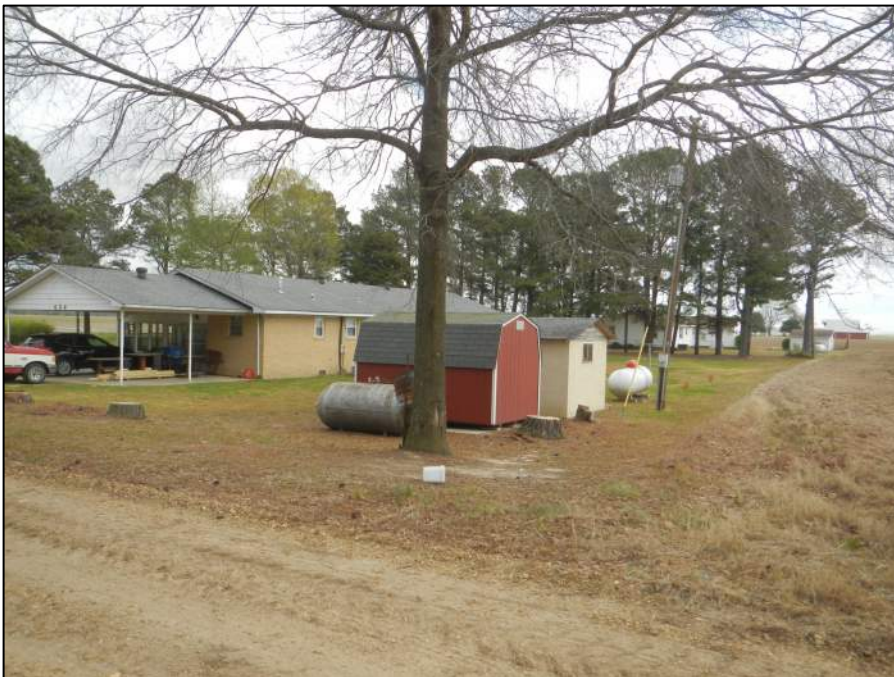
Figure 2-48. Properties 9 (left) and 10 (right back), view northeast (DSCN1640).

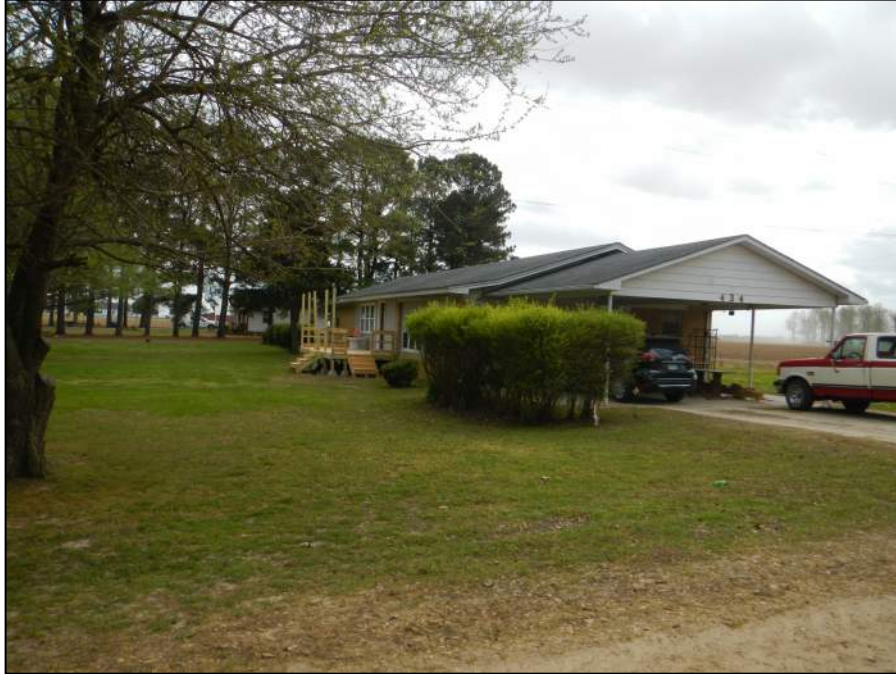
Figure 2-49. Properties 9 (right) and 10 (left back), view east (DSCN1641).

Property 9 has an asphalt-shingled open gable roof and a rectangular floor plan. The exterior façade is brick and wood siding. An open two-car carport is on the west end of the house. The windows are 1-over-1 aluminum. The interior of the structure was not examined. The house is currently occupied and a new front porch/deck was under construction during the time of fieldwork. The yard barns are simple pre-fabricated structures available at big-box hardware and home improvement stores.

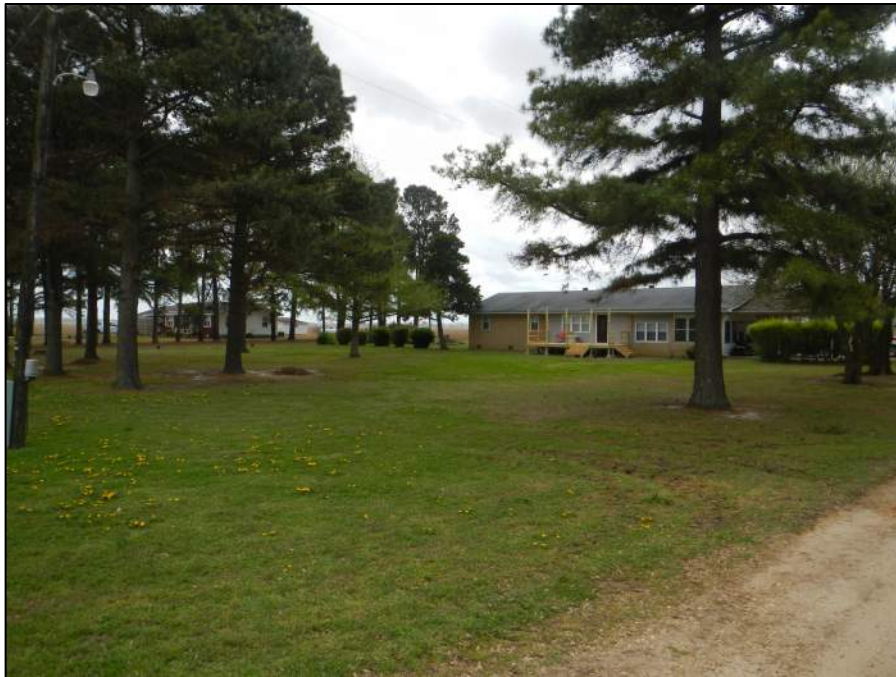
Figure 2-50. Properties 9 (right) and 10 (left back), view east (DSCN1642).

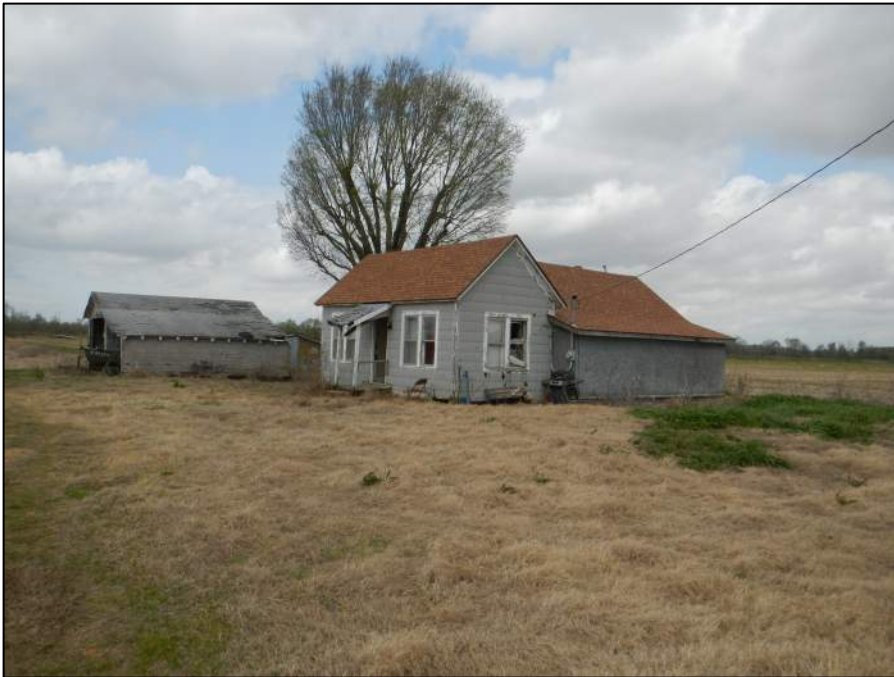
Figure 2-51. Property 11, view northwest (DSCN1643).

Property 11, located at 17 Clay County Road 250 (ID 022-01535-000) is on an isolated parcel near Knobel (Figures 2-03 and 2-51-2-56). Property 11 is a 1930s standard frame one-story residence with a plywood and asbestos siding façade. A detached garage/boat shed and a small outbuilding are adjacent to the main house. The structures are just southwest of the Bond Cemetery within an interchange of the proposed “orange” corridor.

Property 11 has a relatively new asphalt-shingled open gable roof and a rectangular floor plan. The rear portion of the house is clearly an addition. The exterior façade is plywood and asbestos shingles. A small shed roof covers the front stoop. The windows are 1-over-1 wood frame. The interior of the structure was not examined. The house is currently unoccupied. The detached garage is frame construction with an open gable roof and a shed roof addition to the east side. The exterior is covered in tar paper and sheet metal. The small outbuilding is of similar construction.

In the opinion of Panamerican, Property 11 is not eligible for listing in the NRHP because it does not meet any of the established criteria. The buildings are not known to be associated with any significant persons or event, thus Criteria A (association) and B (prominent individuals) do not apply. The buildings do not represent the distinctive characteristics of a type, the work of a master, nor do they possess any high artistic value (Criterion C Design/Construction). While Criterion D (Information Potential) can be applied to buildings, Property 11 appears to offer little future research potential, thus Criterion D is not applicable.

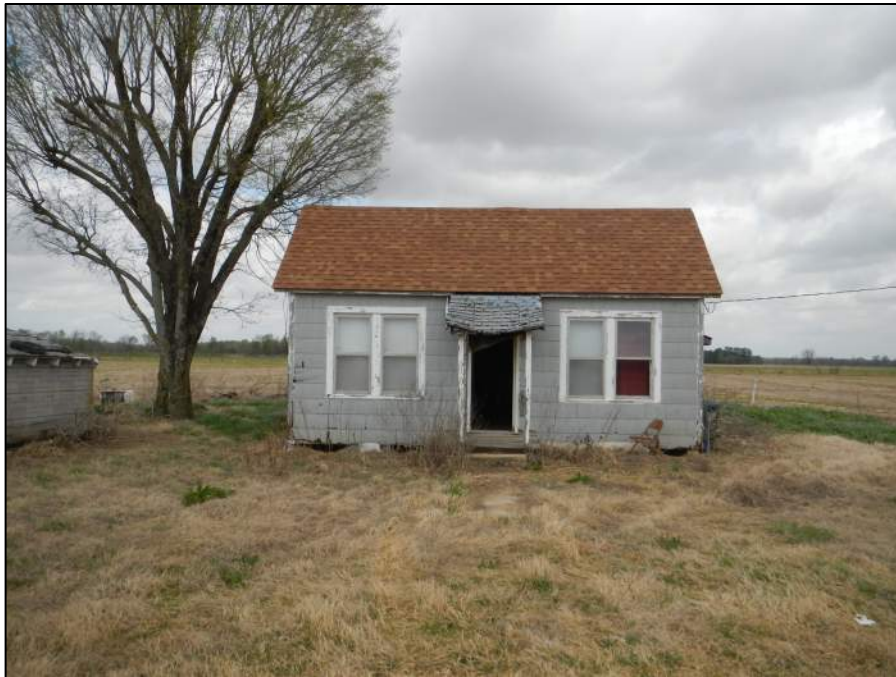
Figure 2-53. Property 11, front façade, view north (DSCN1645).

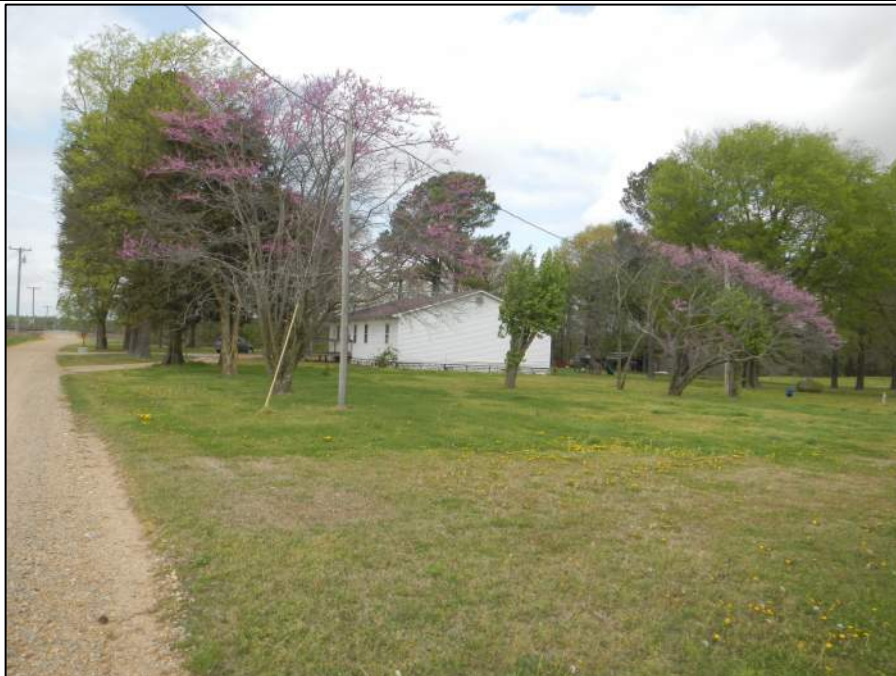
Figure 2-57. Property 12, view west-northwest (DSCN1652).

Property 12, located at 163 Clay County Road 226 (ID 022-01522-001) is near the Missouri Pacific railway line northeast of Knobel (Figures 2-03 and 2-57-2-61). Property 12 is an early 1970s Ranch style one-story residence with a vinyl siding façade. A detached guest house/studio apartment is adjacent to the main house. The structures are just northwest of the Bond Cemetery immediately west of the proposed “orange” corridor.

Property 12 has a sheet metal-covered, open gable roof and a plain, rectangular floor plan. An uncovered landing/deck is outside the front door. The exterior façade is vinyl lap siding. The windows are 6-over-6 aluminum. The interior of the structure was not examined. The house is currently occupied. The detached guest house/studio apartment is of similar construction.

In the opinion of Panamerican, Property 12 is not eligible for listing in the NRHP because it does not meet any of the established criteria. The buildings are not known to be associated with any significant persons or event, thus Criteria A (association) and B (prominent individuals) do not apply. The buildings do not represent the distinctive characteristics of a type, the work of a master, nor do they possess any high artistic value (Criterion C Design/Construction). While Criterion D (Information Potential) can be applied to buildings, Property 12 appears to offer little future research potential, thus Criterion D is not applicable.

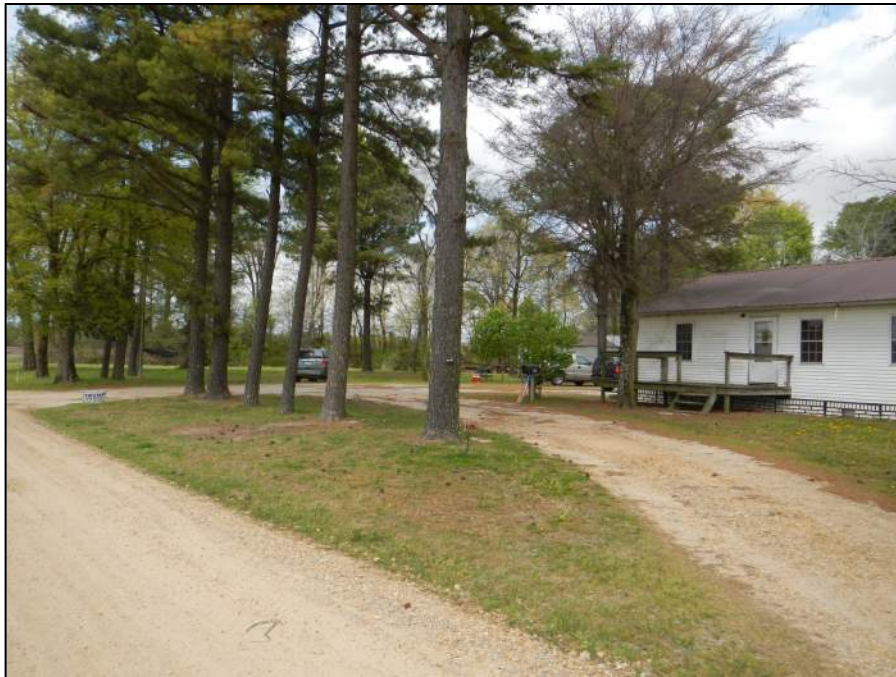
Figure 2-59. Property 12, front façade and drive, view northwest (DSCN1654).
