Appendix J – Cultural Resources Information

Job No. 100512, Walnut Ridge – Missouri State Line (Future I-57) P.E.

**ARCHITECTURAL RESOURCES SURVEY FOR
FUTURE INTERSTATE 57 (JOB 100512),
LAWRENCE, RANDOLPH, GREENE, AND CLAY COUNTIES,
ARKANSAS**

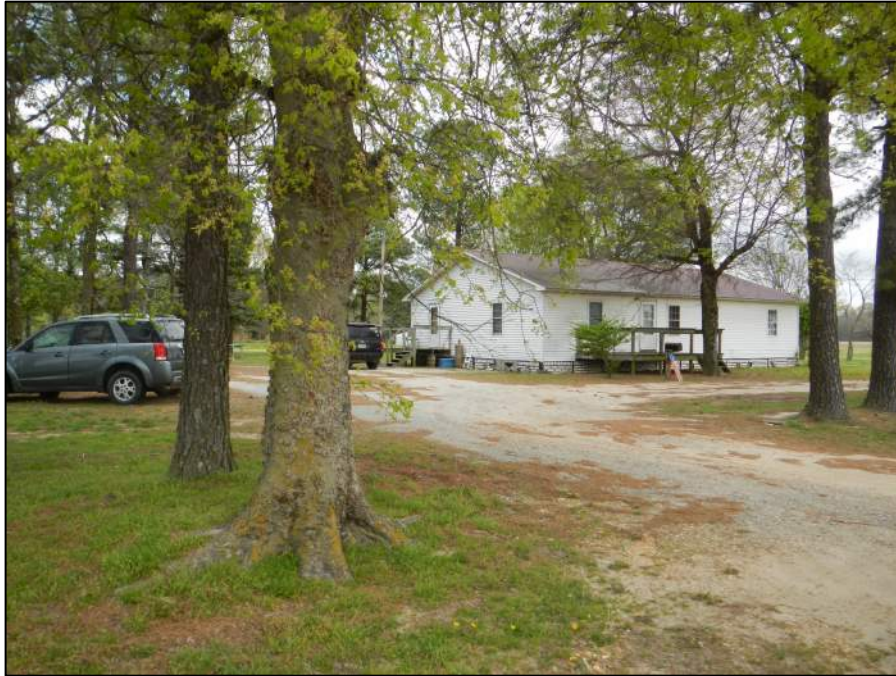
Figure 2-60. Property 12, oblique view northeast (DSCN1655).

Property 12 has a sheet metal-covered, open gable roof and a plain, rectangular floor plan. An uncovered landing/deck is outside the front door. The exterior façade is vinyl lap siding. The windows are 6-over-6 aluminum. The interior of the structure was not examined. The house is currently occupied. The detached guest house/studio apartment is of similar construction.

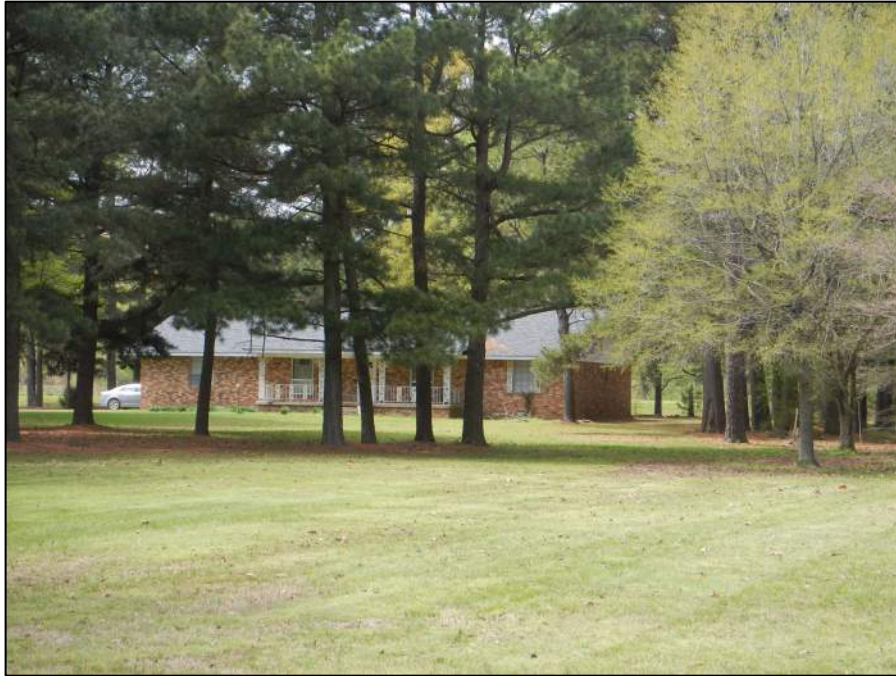
Property 13 has an asphalt shingle-covered, open gable roof and a plain, rectangular floor plan. A front porch with decorative “wrought-iron” railings and columns is outside the front door. The exterior façade is brick.

Figure 2-64. Property 13, view west, close-up 1 (DSCN1659).

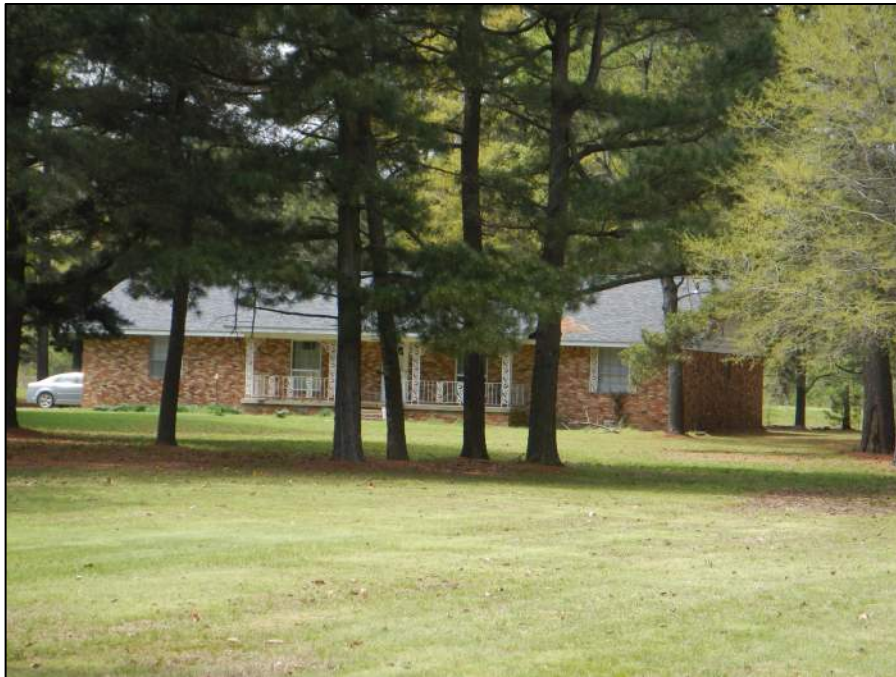
Figure 2-65. Property 13, view west, close-up 2 (DSCN1660).

Property 13, located at 333 (363?) Clay County Road 250 (ID 022-01522-003) is near the Missouri Pacific railway line northeast of Knobel (Figures 2-03 and 2-62-2-65). Property 13 is an early 1970s Ranch style one-story residence with a brick façade. An open carport is located on the southwest corner of the house. The structure is just northwest of the Bond Cemetery in the center of the proposed “orange” corridor.

The windows are 6-over-6 aluminum with faux shutters. The interior of the structure was not examined. The house is currently occupied.

In the opinion of Panamerican, Property 13 is not eligible for listing in the NRHP because it does not meet any of the established criteria. The building is not known to be associated with any significant persons or event, thus Criteria A (association) and B (prominent individuals) do not apply. The building does not represent the distinctive characteristics of a type, the work of a master, nor does it possess any high artistic value (Criterion C Design/Construction). While Criterion D (Information Potential) can be applied to buildings, Property 13 appears to offer little future research potential, thus Criterion D is not applicable.

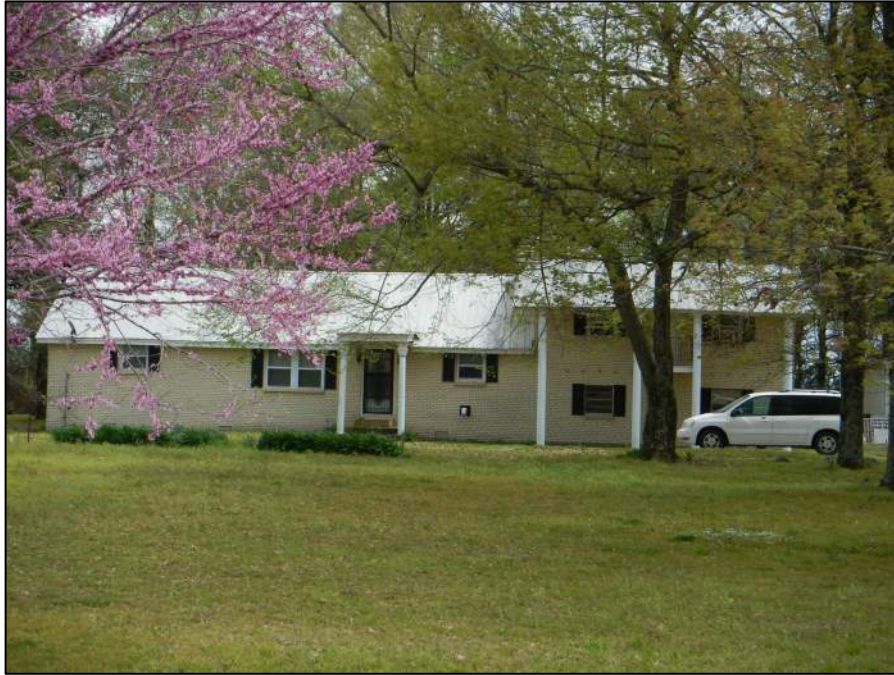
Figure 2-66. Property 14, view east (DCNS1661).

Property 14, located at 474 Clay County Road 250 (ID 022-02347-000) is near the Missouri Pacific railway line northeast of Knobel (Figures 2-03 and 2-66–2-67). Property 14 is a late 1970s-early 1980s standard frame Split-Level style residence with a brick façade. An unattached sheet metal building is at the end of the driveway southeast of the house. The structures are north of the Bond Cemetery immediately east of the proposed “orange” corridor.

In the opinion of Panamerican, Property 14 is not eligible for listing in the NRHP because it meets none of the established criteria. It is not known to be associated with any significant persons or event, thus Criteria A (association) and B (prominent individuals) do not apply. The buildings do not represent the distinctive characteristics of a type, the work of a master, nor do they possess any high artistic value (Criterion C Design/Construction). While Criterion D (Information Potential) can be applied to buildings, Property 14 appears to offer little future research potential, thus Criterion D is not applicable.

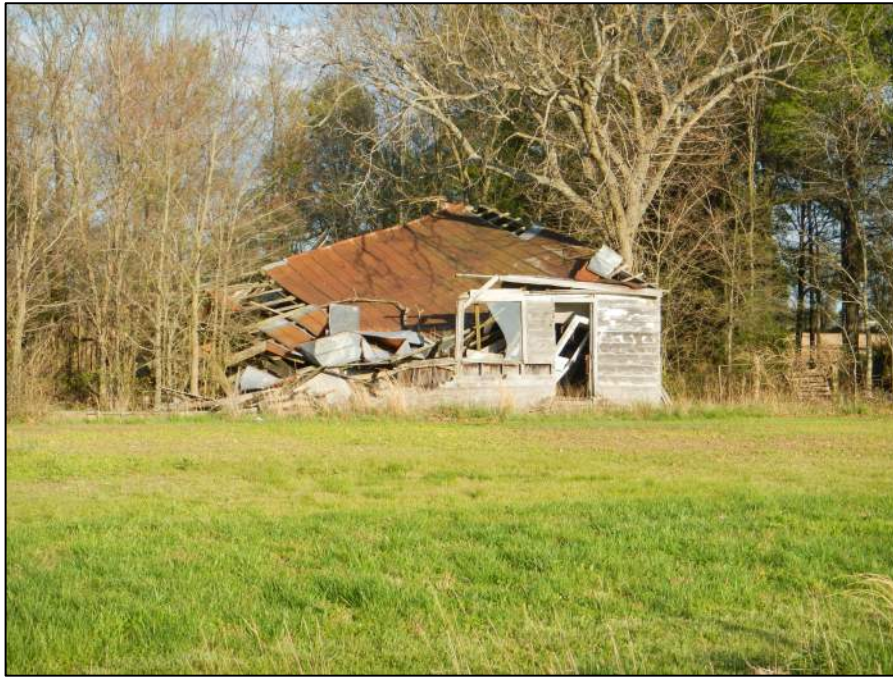
Figure 2-68. Property 15, collapsed south structure, view east (DCNS1805).

A collection of houses and barns is shown along this side of the highway on both the 1941 15-minute USGS Knobel and the 1964 Corning 7.5-minute quadrangles. With the exception of the two older houses shown in Figures 2-68 and 2-69, all of these structures have been razed. Aerial photographs taken in 1975 by the Soil Conservation Service seem to show the currently occupied brick standing structure (Fielder et al. 1978), but the tree cover makes it difficult to ascertain with certainty. The available map, photographic, and satellite imagery indicate that Property 15 was probably built sometime between 1964 and 1975. No historic association under Criterion

In the opinion of Panamerican, Property 15 is not eligible for listing in the NRHP because it meets none of the established criteria. It is not known to be associated with any significant persons or event, thus Criteria A (association) and B (prominent individuals) do not apply. The buildings do not represent the distinctive characteristics of a type, the work of a master, nor do they possess any high artistic value (Criterion C Design/Construction). While Criterion D (Information Potential) can be applied to buildings, Property 15 appears to offer little future research potential, thus Criterion D is not applicable.

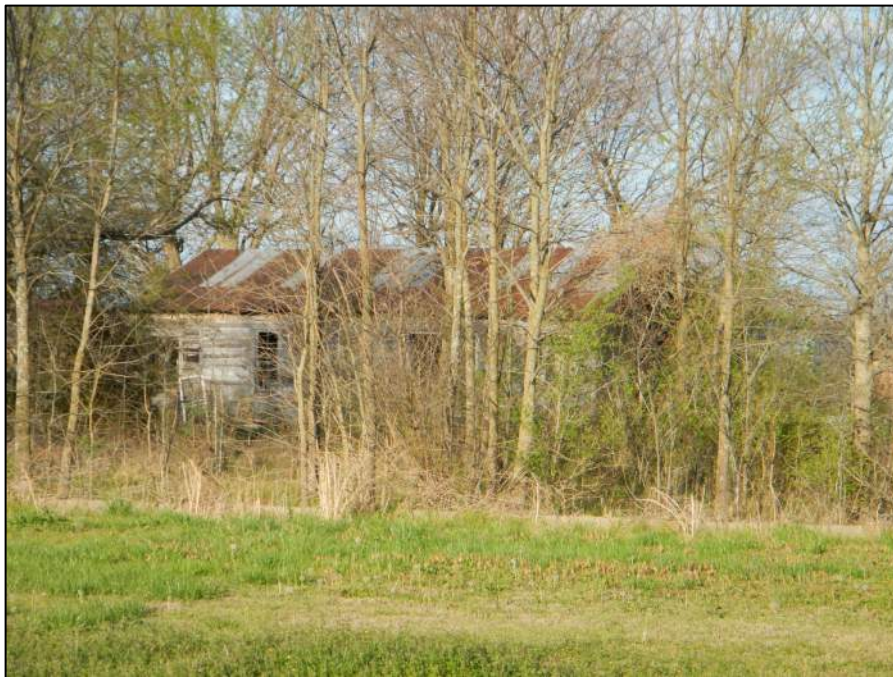
Figure 2-69. Property 15, central 1930s structure, view northeast (DCNS1806).

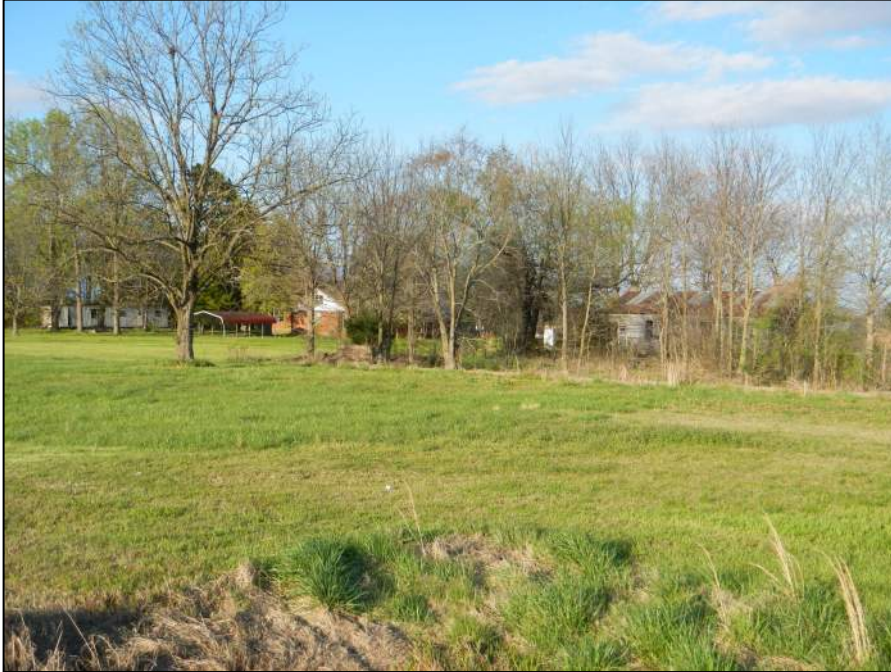
Figure 2-70. Property 15, view northeast (DCNS1807).

Property 15, located at 5468 Highway 67 (ID 022-02697-000) is north of Corning near the intersection of Clay County Road 328 (Figures 2-04 and 2-68–2-71). Property 15 is a ca. 1970s standard frame one-story residence with a brick façade. An unattached sheet metal car cover/gazebo is at the end of the driveway west of the house. Also on the property are a cargo container and two older abandoned houses that appear to date to the 1930s. The structures are near the head of Middle Creek within an interchange of the proposed combined “blue” and “orange” corridors.

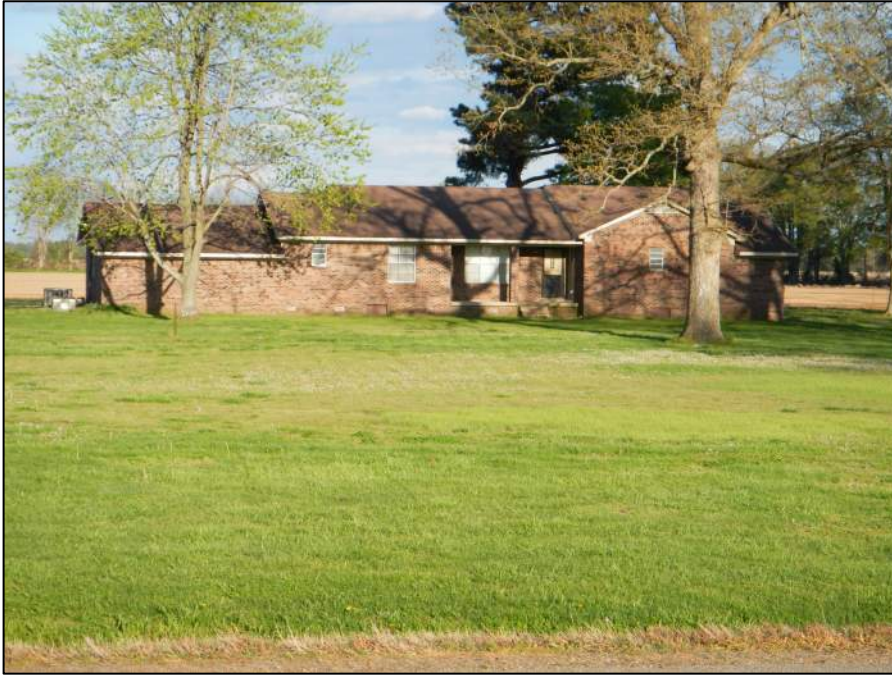
Figure 2-72. Property 16, view east (DCNS1808).

Property 16, located at 5424 Highway 67 (ID 022-02698-000) is north of Corning near the intersection of Clay County Road 328 (Figures 2-04 and 2-72-2-73). Property 16 is a 1972 Ranch style one-story residence with a brick façade. The house is located between the mapped location of an older house and barn (demolished). The structure is near the head of Middle Creek within an interchange of the proposed combined “blue” and “orange” corridors.

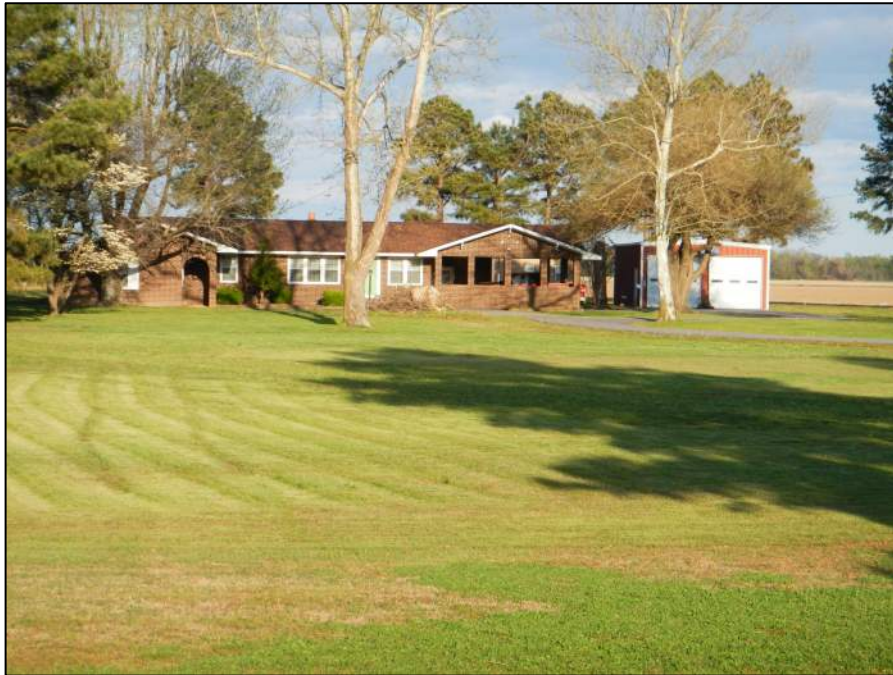
Figure 2-74. Property 17, view east (DCNS1809).

Property 17, located at 5306 Highway 67 (ID 022-02700-000) is north of Corning near the intersection of Clay County Road 328 (Figures 2-04 and 2-74–2-75). Property 17 is a ca. 1972 Ranch style one-story residence with a brick façade. The house is located in the mapped location of an older barn (demolished). The Clay County Assessors office photograph (Figure 2-75) appears to show the wrong house on this lot. In addition to the main house is a large, unattached pre-fabricated sheet metal two-car garage. The structures are near the head of Middle Creek within an interchange of the proposed combined “blue” and “orange” corridors.

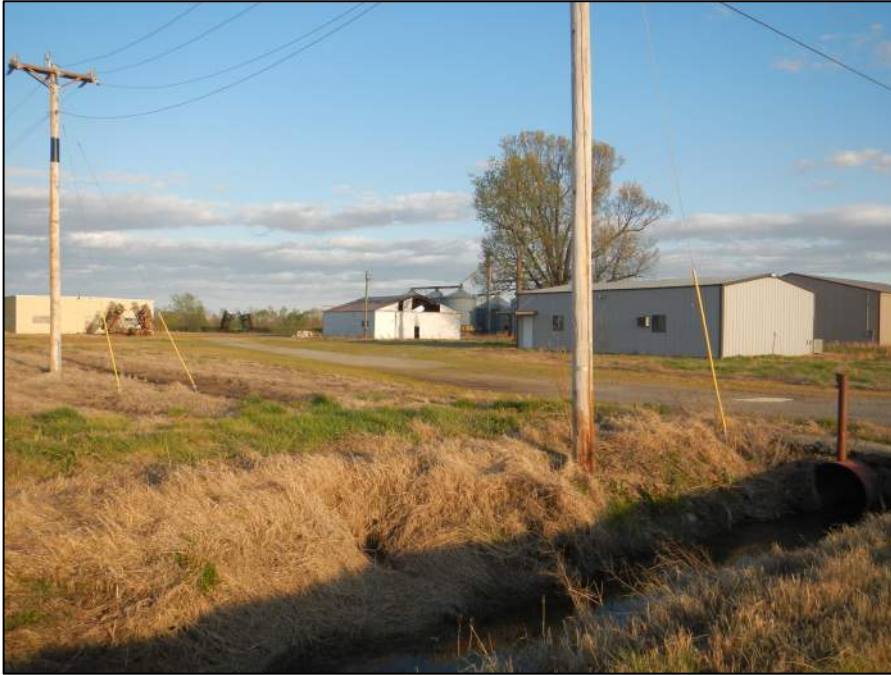
Figure 2-76. Property 18, view southeast (DCNS1820).

Property 18, located on Clay County Road 155 (ID 022-02546-000) is a ca. 1970s farm complex (Ahrent Farms, LLC) north of Corning near Williams Cemetery (Figures 2-05 and 2-76-2-80). The structures, including several grain silos and general utility buildings, are in the mapped location of an older house and barn (now demolished). The structures are just west of Moark Ridge within the northern split of the proposed combined “blue” and “orange” corridors.

In the opinion of Panamerican, Property 18 is not eligible for listing in the NRHP because it meets none of the established criteria. It is not known to be associated with any significant persons or event, thus Criteria A (association) and B (prominent individuals) do not apply. The buildings do not represent the distinctive characteristics of a type, the work of a master, nor do they possess any high artistic value (Criterion C Design/Construction). While Criterion D (Information Potential) can be applied to buildings, Property 18 appears to offer little future research potential, thus Criterion D is not applicable.

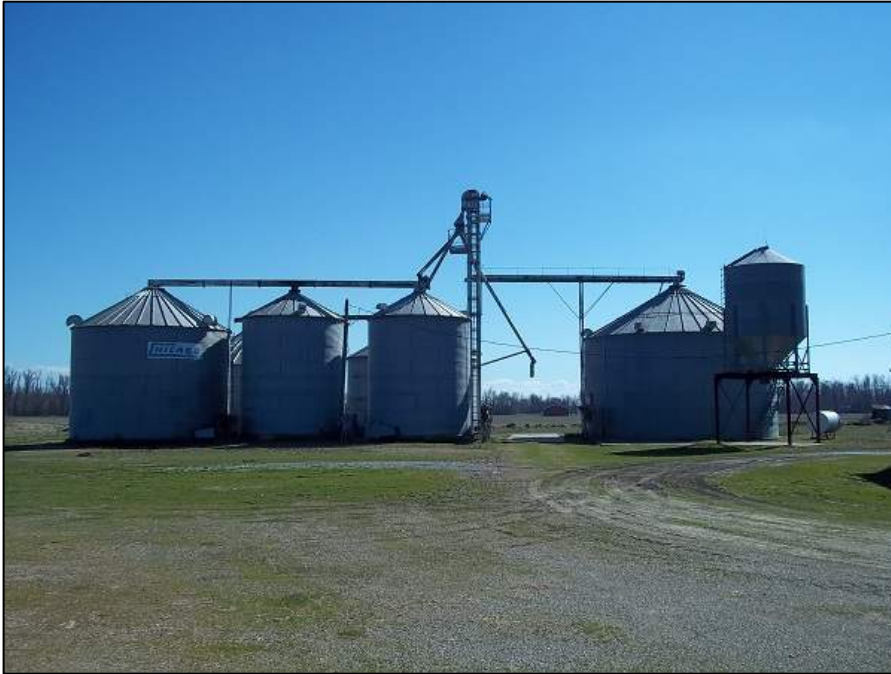
Figure 2-80. Property 18, grain silos, view south (assessors office photo).

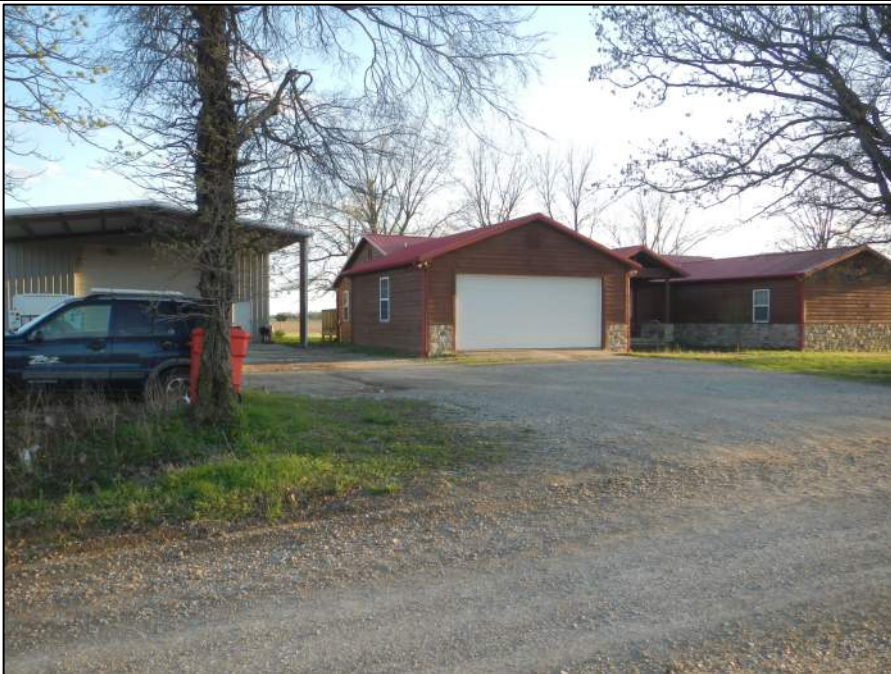
Figure 2-81. Property 19, view south-southwest (DCNS1823).

Property 19, located at 932 Clay County Road 154 (ID 022-02544-000) is a fairly recent (post-1994) residential space north of Corning near Williams Cemetery (Figures 2-05 and 2-81-2-84). The complex consists of the main U-shaped residence, a large workshop, carport, and an outdoor swimming pool. The structures are just west of Moark Ridge adjacent to the northern split of the proposed combined “blue” and “orange” corridors.

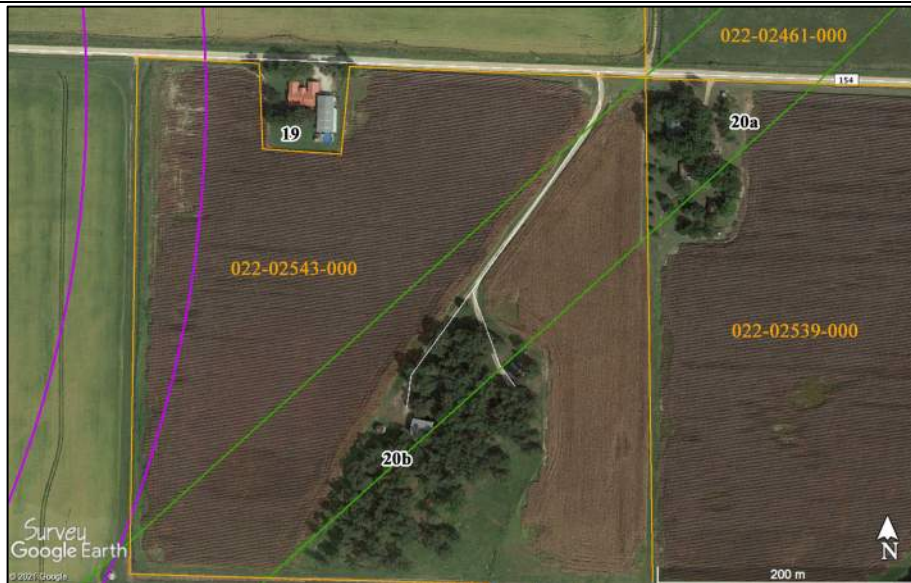
Property 20a, located at 1006 Clay County Road 154 (ID 022-02539-000) is a rural residential and farm complex north of Corning near Williams Cemetery (Figures 2-05 and 2-84–2-86). The complex consists of a main residence, a well, and at least nine other buildings (barns, utility sheds, etc.). The structures are just west of Moark Ridge adjacent to the northern split of the proposed combined “blue” and “orange” corridors in the center of the “green” line (Figure 2-84).

Figure 2-84. Properties 19 and 20 in relation to the northern I-57 alternatives.

Property 20b, located at 986 Clay County Road 154 (ID 022-02543-000) is a rural residential complex north of Corning near Williams Cemetery (Figures 2-05, 2-84 and 2-87-2-88). The complex consists of a main residence and a large spatially segregated garage and workshop building with a separate drive (Figure 2-84). The structures are just west of Moark Ridge adjacent to the northern split of the proposed combined “blue” and “orange” corridors in the center of the “green” line (Figure 2-84).

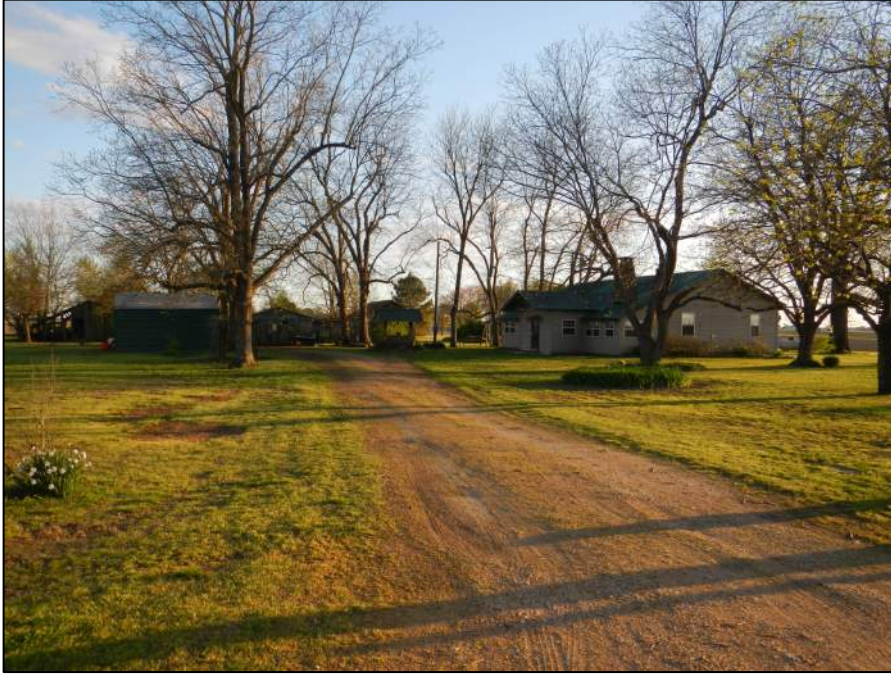
Figure 2-85. Property 20a, view south-southwest (DCNS1824).

The structures at Property 20a are in the northwestern corner of a 40-acre parcel (NE 1/4 of Section 9, T21N, R5E). Residential and farm activity is reflected on this parcel for quite some time, with two houses shown here on the 1941 15-minute USGS Knobel quadrangle. A house and two barns are shown on the parcel on the 1964 Corning 7.5-minute quadrangle, and aerial photographs taken in 1975 by the Soil Conservation Service appear to show the standing structures on this lot in something close to their contemporary configuration (Fielder et al.

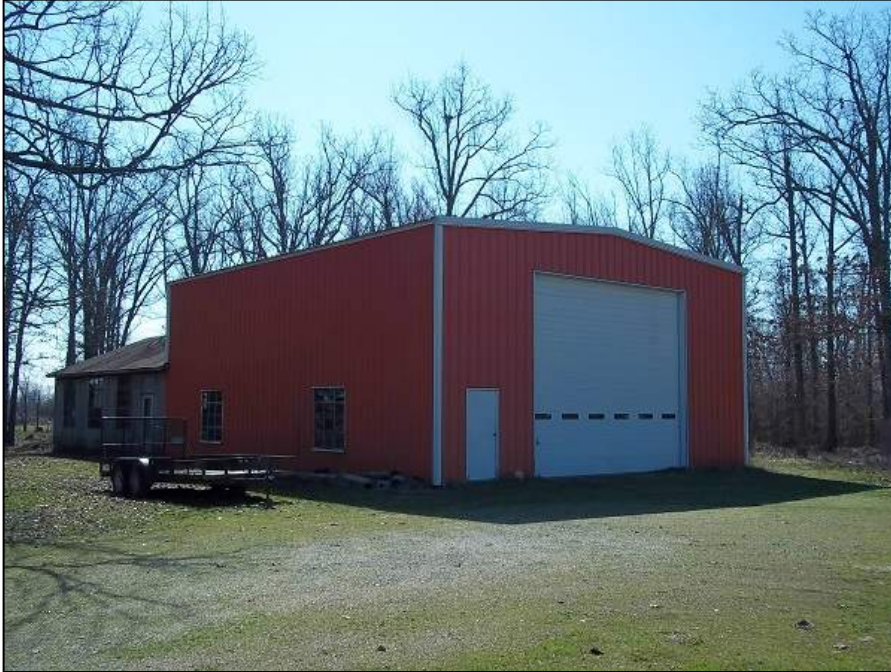
Figure 2-88. Property 20b, garage/shop, view southeast (assessors office photo).

The structures at Property 20b are semi-secluded in the east-central wooded portion of a 40-acre parcel (NW 1/4 of Section 9, T21N, R5E). The area is shown as wooded on the 1941 15-minute USGS Knobel quadrangle, the 1964 Corning 7.5-minute quadrangle, and on aerial photographs taken in 1975 by the Soil Conservation Service (Fielder et al. 1978). The earliest satellite

imagery shows structures on the lot as early as 1994. The available map, photographic, and satellite imagery thus suggest the construction of the buildings between 1975 and 1994. No historic association under Criterion A or B was found for the property.

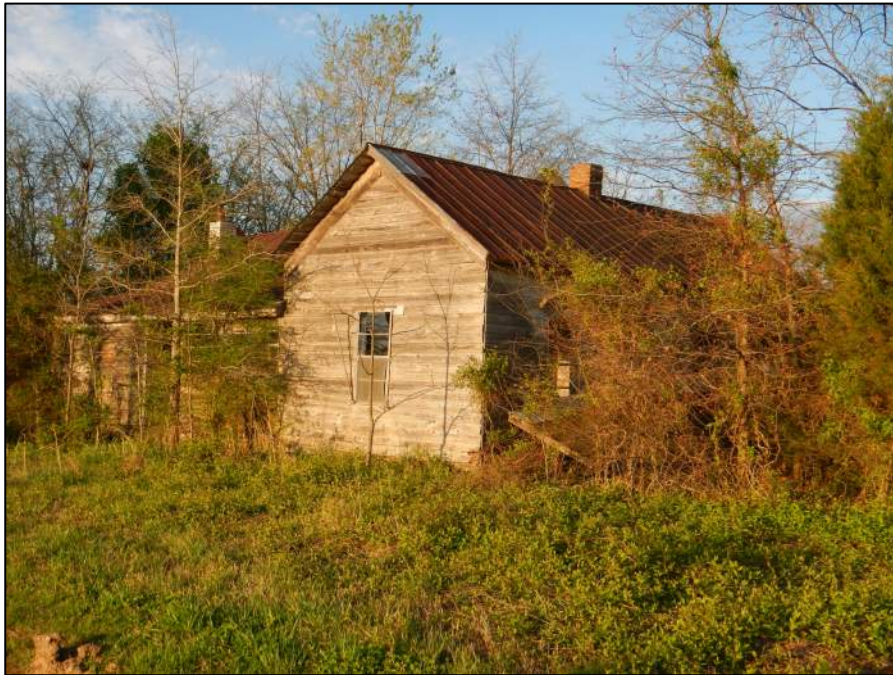
Figure 2-89. Property 21, NRHP-eligible 1940s house, view northeast (DSCN1825).

Property 21, located at 1075 Clay County Road 154 (ID 022-02461-000) is a rural residential and farm complex at Moark (Figures 2-05 and 2-89–2-92). The complex consists of an older house (1941-1964) close to the main road, two utility structures (1964-1993), and a contemporary main residence (2003) and several outbuildings or auxiliary structures (Figure 2-92). The complex is just west of Moark Ridge adjacent to the northern split of the proposed combined “blue” and “orange” corridors in the center of the “green” line (Figure 2-92).

The 1964 Corning 7.5-minute quadrangle shows two different houses and a barn near the road; the only remaining structure from this map is the house shown in Figure 2-89. On aerial photographs taken in 1975 by the Soil Conservation Service (Fielder et al. 1978) one structure is shown at the end of the longer entrance drive. The Clay County Assessor's office records provide a build date of 2003 for the main house in the center of the proposed right-of-way. No historic association under Criterion A or B was found for the property.

The unoccupied older house is a standard wood frame construction with wood lap siding, skip decking, two chimneys, and an open gable combination sheet metal roof. The occupied main residence is a fairly recent standard frame construction built on a concrete slab, with vinyl siding, 6-over-6 windows, and an asphalt shingle/fiberglass combination open gable roof. A one-car garage is located on the east end of the house.

Property 21 is an abandoned ca. 1940s residence located at 1075 Clay County Road 154 (see Panamerican 2021:Figure 2-89). As instructed, additional photos of this structure were taken on March 31, 2022 (Figures 4-15).

Since the *Architectural Resources Survey for the Future Interstate 57 (Job 100512), Lawrence, Randolph, and Clay Counties, Arkansas* was prepared (Panamerican 2021), the exterior portion of the southwest façade has fallen off exposing the wooden framing and interior wall boards (compare Panamerican 2021:Figure 2-89 to Figure 4, which are the same view). Property 21 is a plain traditional one-story frame structure with an interior brick chimney and corrugated metal roof that rests on concrete blocks and/or piers. It appears to have originally been a T-shaped plan facing County Road 154 (with the T projecting to the north). Later former porches on the northwest and

3) Property 21. Comments regarding this building complex on the same real estate parcel indicated that ArDOT thinks the property might be eligible for listing in the NRHP. As described in the report, most of the buildings in this complex are located in the center of a quarter-section parcel at the end of a private drive; no close inspection of the structures was accomplished. Map and database research clearly indicated a significant span of construction, ranging from the 1940s to 2003. The comment that the property appears relatively intact and a good example of regional rural architecture may therefore only be referring to the single older house near the main road shown in PCI 2021:Figure 2-89. If that is the case, we certainly concur that this is the most well-preserved example of a typical 1940s-era rural residence extant in the entire project area.

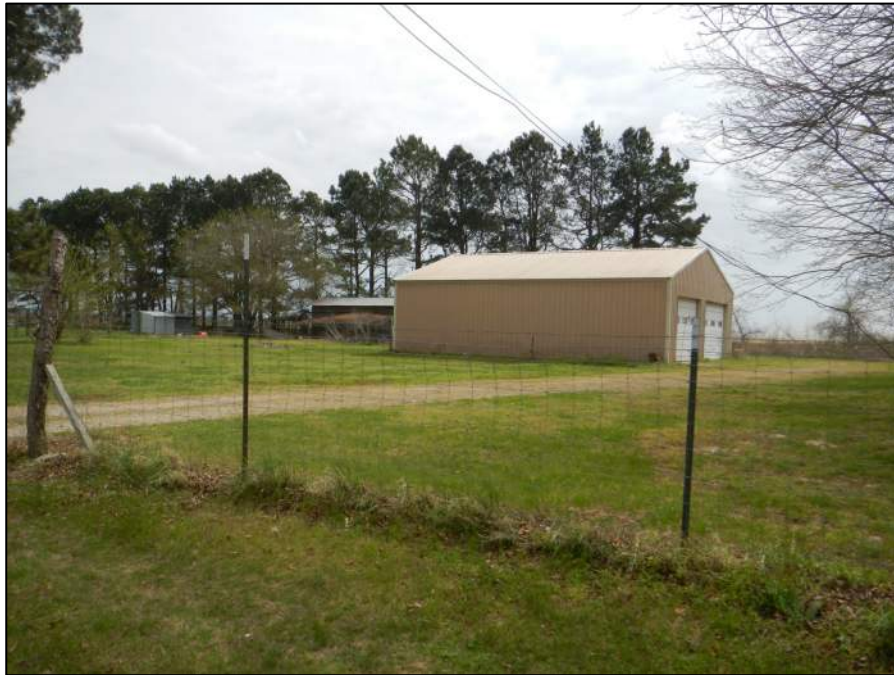
Figure 2-93. Property 22, view southeast (DSCN1664).

Property 22, located at 1094 Stateline Road (ID 022-02950-000) consists of a prefabricated sheet metal two-car garage and three adjacent outbuildings northwest of Moark (Figures 2-05 and 2-93–2-94; 2-97). To the east across the head of Moark Ditch is a separate real estate parcel (ID 022-02951-000) with a trailer and three outbuildings (Figures 2-95–2-97). The buildings on Property 22 post-date 1994. The property is just northwest of Moark in the center of the terminus of the “green” line (Figure 2-97).

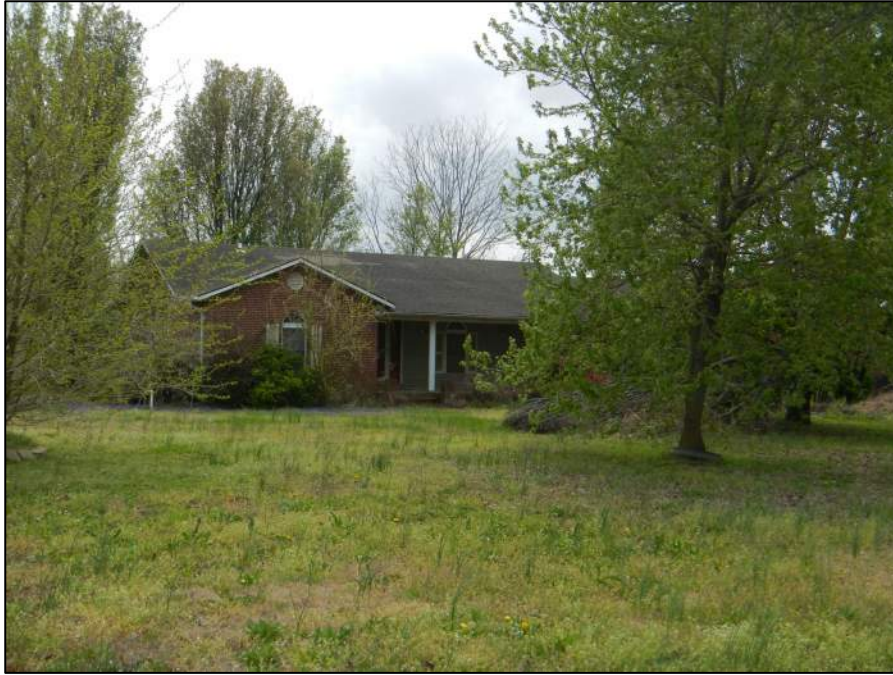
Figure 2-98. Property 23, view south (DSCN1670).

Property 23, located at 1024 Stateline Road (ID 022-02949-000) is an unoccupied 1997 residence northwest of Moark (Figures 2-05 and 2-98–2-100). A small prefabricated “yard barn” is at the rear of the driveway. The property is between the northern terminus of the “green” and “purple” lines.

The currently unoccupied main residence is a standard frame construction built on a concrete slab, with a brick facade, 6-over-6 windows with faux shutters, and an asphalt shingle/fiberglass combination open gable roof. A two-car garage is located on the west end of the house.

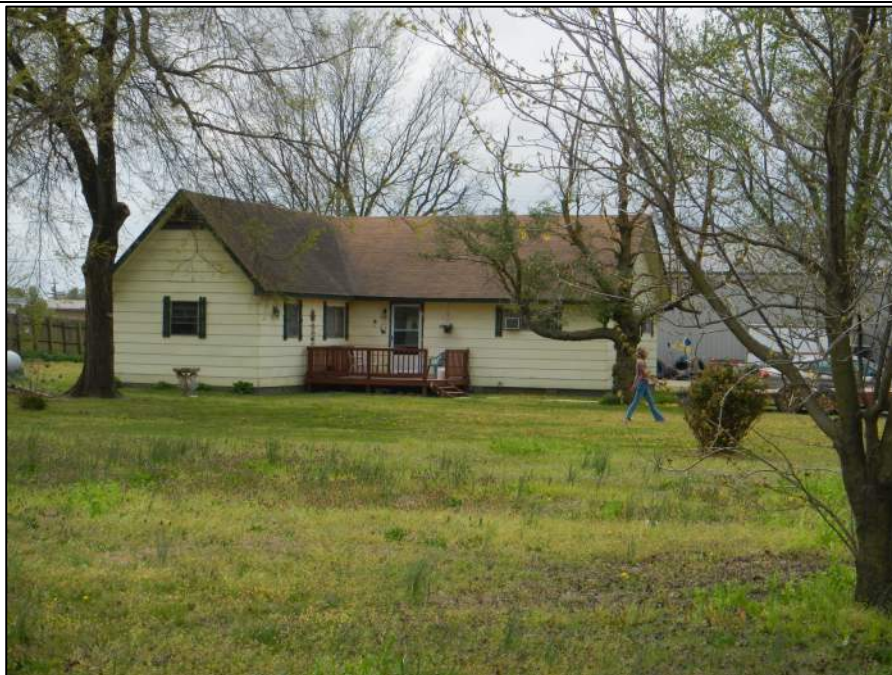
Figure 2-101. Property 24, view west (DSCN1672).

Property 24, located at 1008 Stateline Road (ID 022-02948-000) is an occupied 1983 residence (ArDOT research indicates that the structure is shown as early as 1949 on aerial imagery) northwest of Moark (Figures 2-05 and 2-101-2-104). The property is between the northern terminus of the “green” and “purple” lines at the intersection of Highway 67.

The residence is a standard frame construction built on piers, with an aluminum siding facade, combination sash and sliding aluminum frame windows with faux shutters, and an asphalt shingle/fiberglass combination open gable roof.

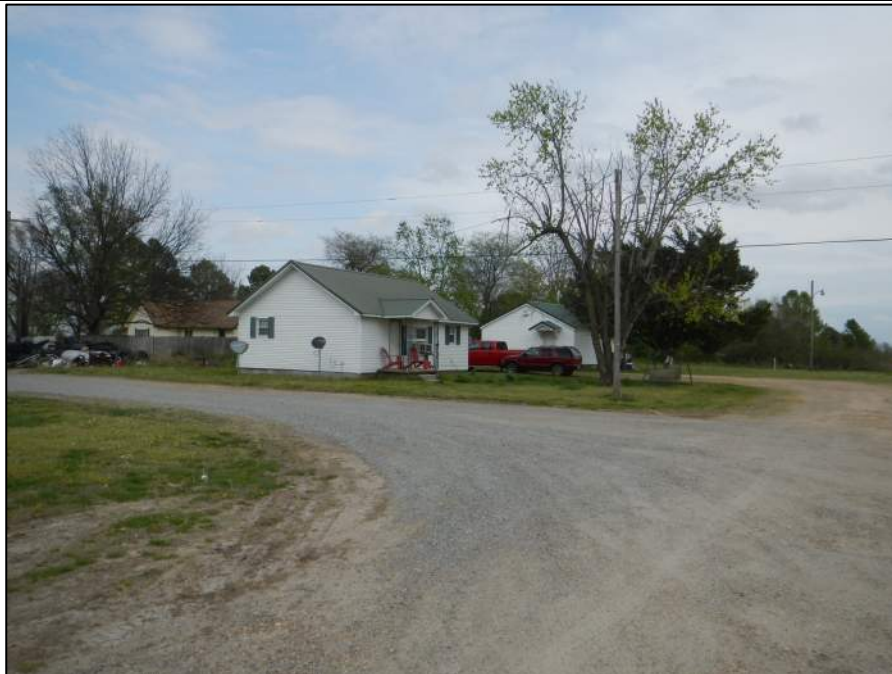
Figure 2-105. Property 25, view east (DSCN1675).

Property 25, located at 11 Clay County Road 156-1 (ID 022-02431-000) is a pair of small 1991 residential rental properties northwest of Moark (Figures 2-05 and 2-105–2-106). To the immediate south on the eastern side of Highway 67 are several commercial buildings on a separate real estate parcel (ID 022-02432-000C) (Figures 2-107–2-109). The buildings are between the northern terminus of the “green” and “purple” lines at the intersection of Highway 67 and Stateline Road.

The residences are standard frame constructions built on piers, with vinyl siding facades, combination sash and sliding aluminum frame windows with faux shutters, and an asphalt shingle/fiberglass combination open gable roofs.

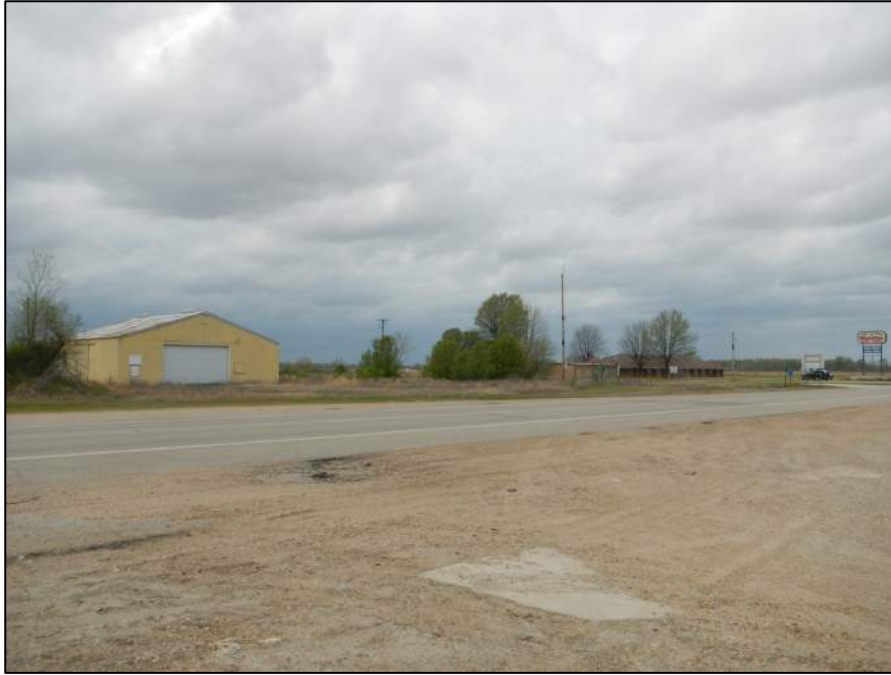
Figure 2-110. Property 26, view northwest (DSCN1679).

Property 26, located at 7167 Highway 67 (ID 022-02441-000C and 022-02438-000C) is a linear assemblage of concrete and sheet metal commercial buildings along the western side of Highway 67 south of the intersection of Stateline road (Figures 2-05 and 2-110–2-115). The buildings are at the northern terminus of the “purple” line at the intersection of Highway 67 and Stateline Road.

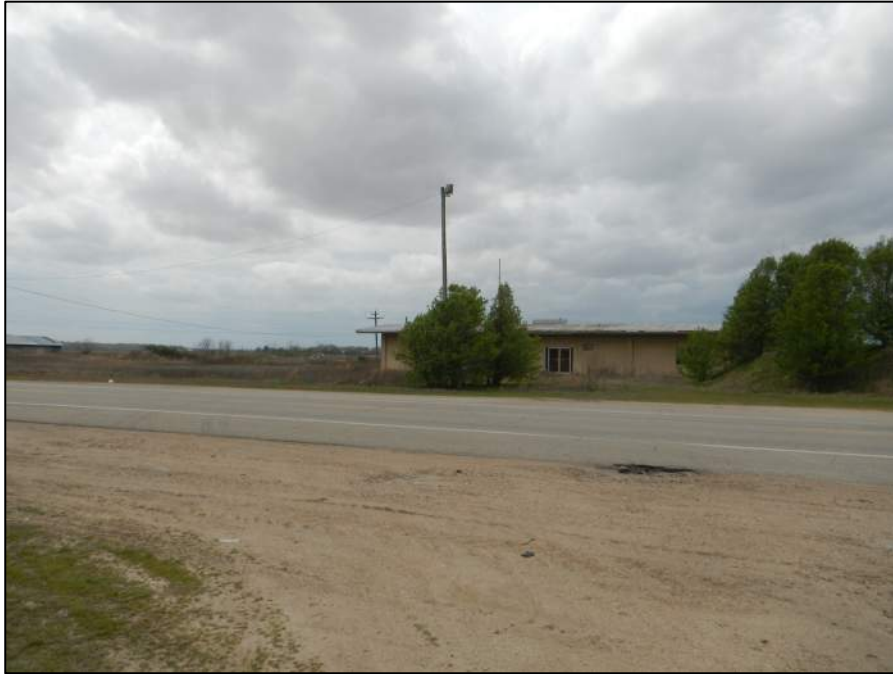
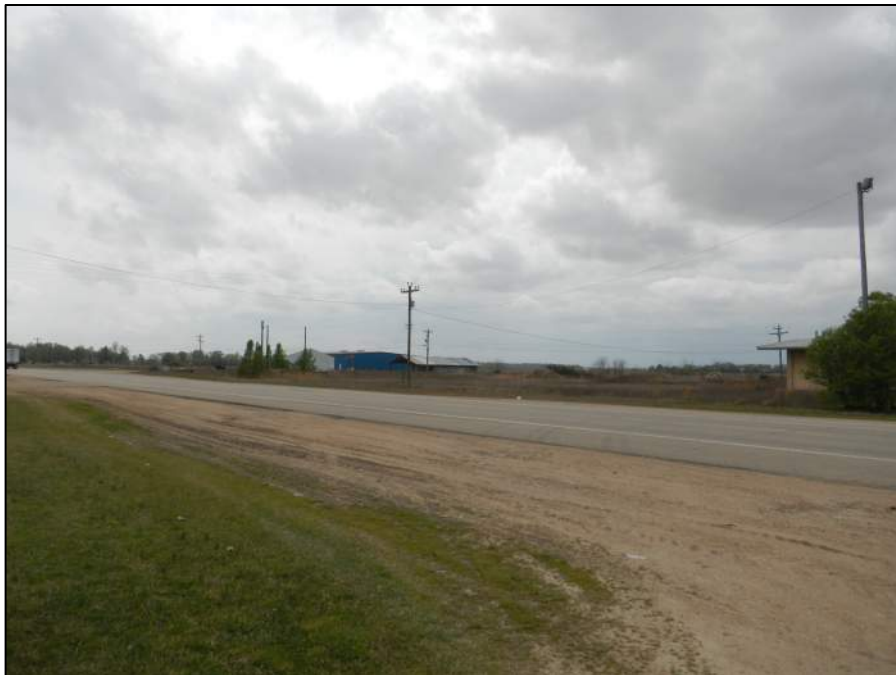
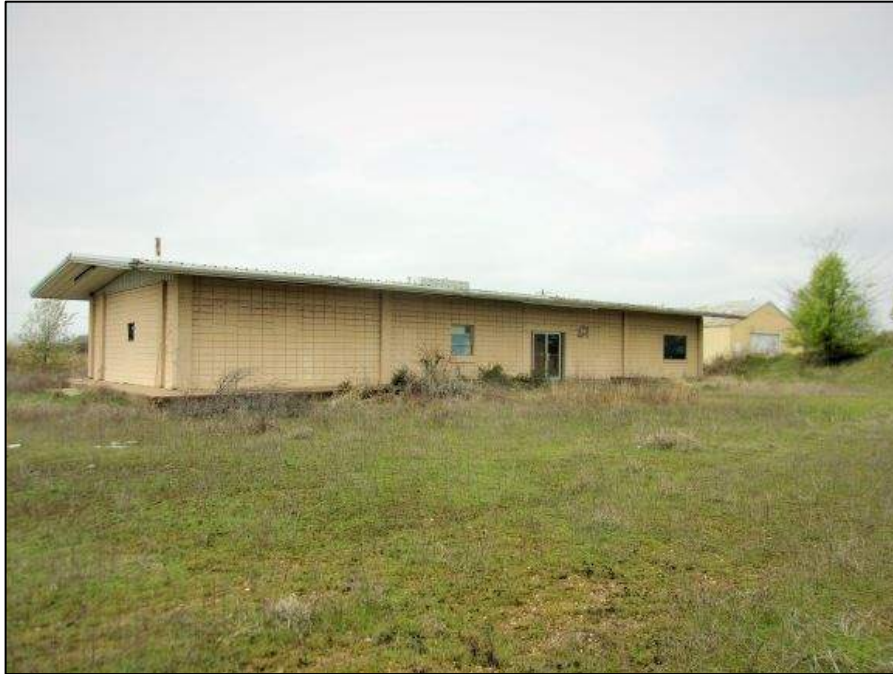
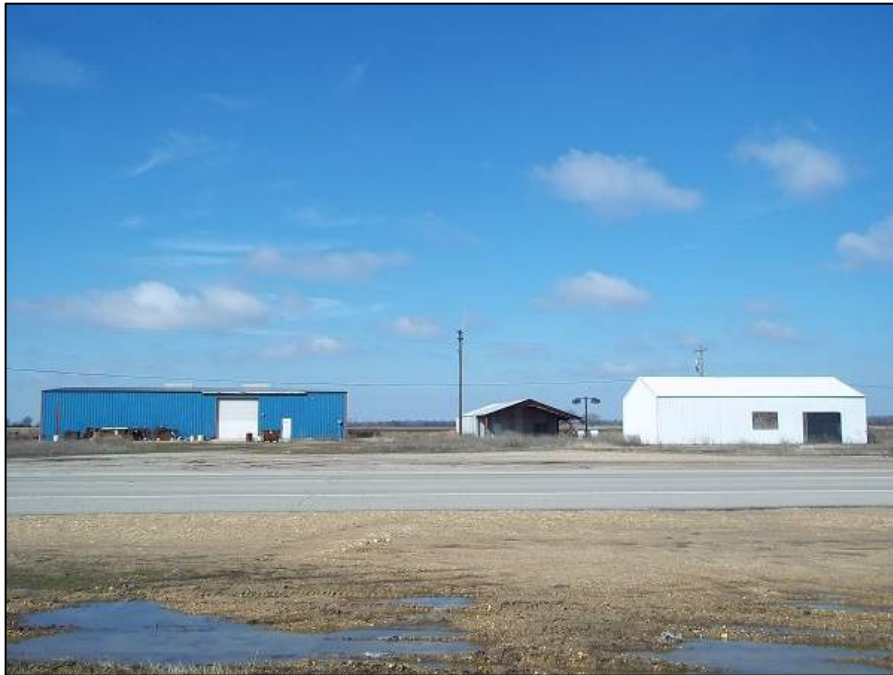
Figure 2-112. Property 26, view southwest (DSCN1681).

Figure 2-113. Property 26, view south-southwest (DSCN1682).

The commercial buildings at Property 26 are for the most part relatively non-descript corrugated sheet metal storage structures. The northern-most building is concrete block and was the location of the Stateline Service Center.

Figure 2-114. Property 26, view southeast of northern building (assessors office photo).

Figure 2-115. Property 26, view west of southern buildings (assessors office photo).

In the opinion of Panamerican, Property 26 is not eligible for listing in the NRHP because it meets none of the established criteria. It is not known to be associated with any significant persons or event, thus Criteria A (association) and B (prominent individuals) do not apply. The buildings do not represent the distinctive characteristics of a type, the work of a master, nor do they possess any high artistic value (Criterion C Design/Construction). While Criterion D (Information Potential) can be applied to buildings, Property 26 appears to offer little future research potential, thus Criterion D is not applicable.
