Appendix J – Cultural Resources Information

Job No. 100512, Walnut Ridge – Missouri State Line (Future I-57) P.E.

**ARCHITECTURAL RESOURCES SURVEY FOR
FUTURE INTERSTATE 57 (JOB 100512),
LAWRENCE, RANDOLPH, GREENE, AND CLAY COUNTIES,
ARKANSAS**

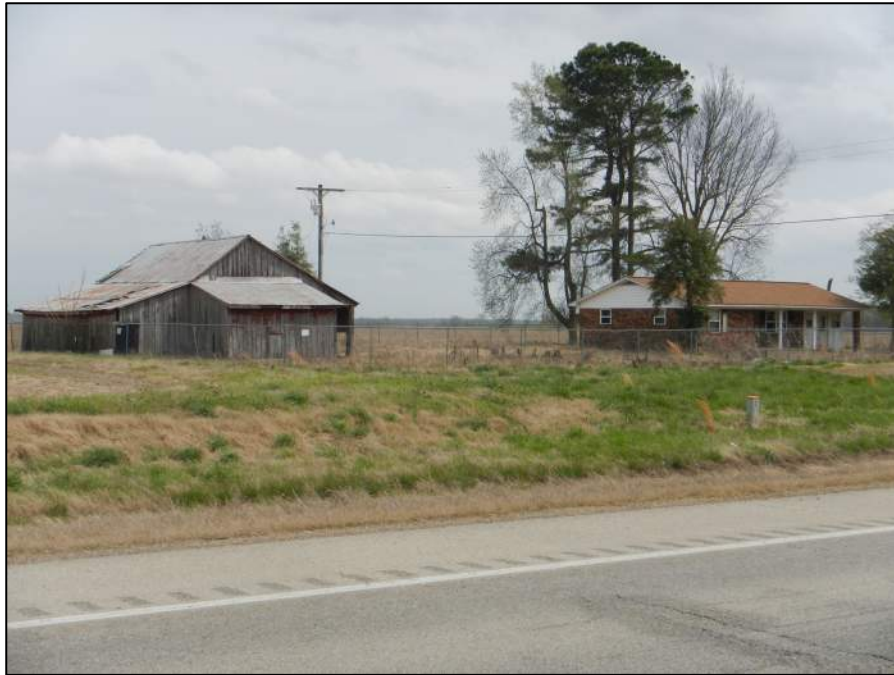
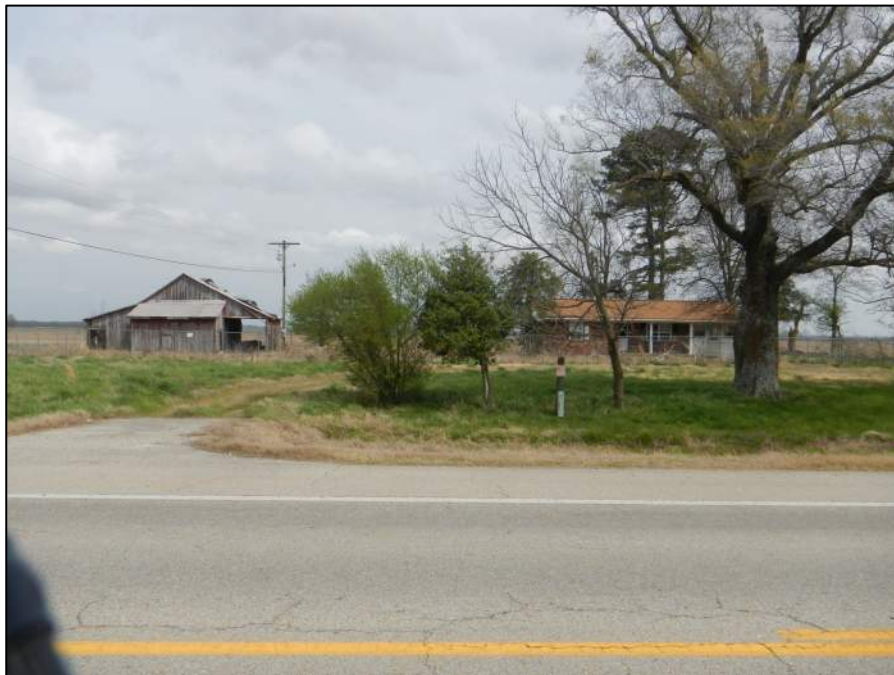
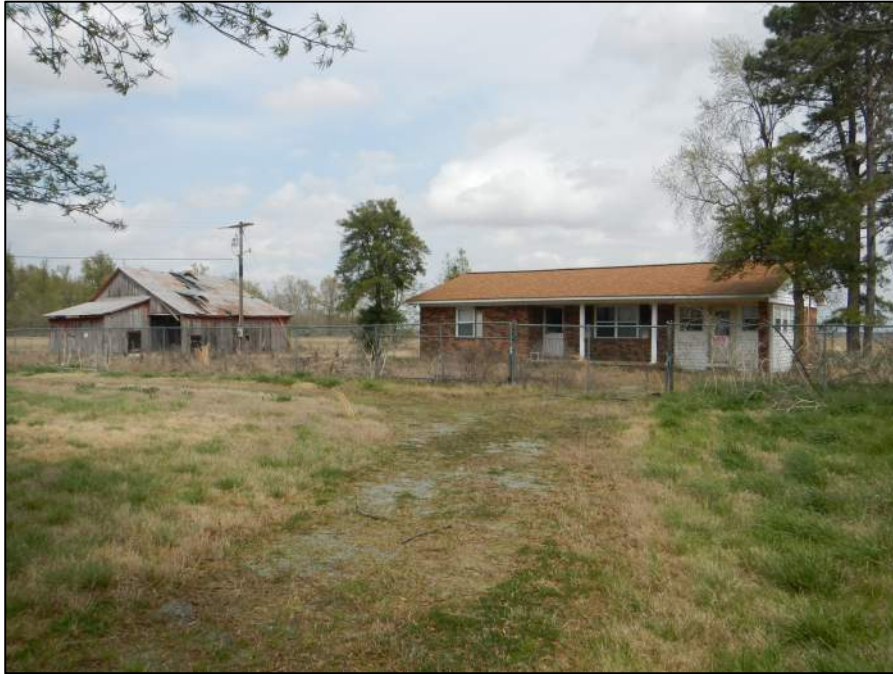
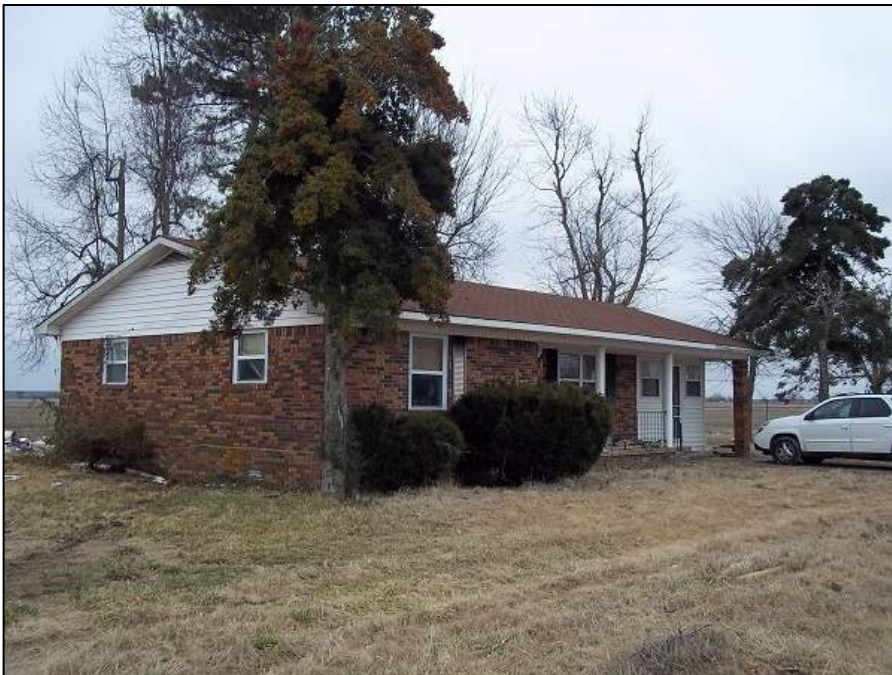
Figure 2-116. Property 27, view southeast (DSCN1685).

Figure 2-117. Property 27, view east (DSCN1686).

Figure 2-118. Property 27, view northeast (DSCN1687).

Figure 2-119. Property 27, view south-southwest (assessors office photo).

The older barn (ca. 1941-64) at Property 27 is a wooden board-and-batten structure with a combination open gable roof on the main structure and a shed roof on the front façade. Roofing material is sheet metal. The adjacent house (ca. 1994) is a rectangular masonry and lap siding Ranch style structure with 1-over-1 aluminum sash windows, faux shutters, and an asphalt/fiberglass shingle covered open gable roof. A carport has been enclosed with the siding. There are two front entrances on a shallow front porch supported by three columns. Both structures are behind a chain link fence.

In the opinion of Panamerican, Property 27 is not eligible for listing in the NRHP because it meets none of the established criteria. It is not known to be associated with any significant persons or event, thus Criteria A (association) and B (prominent individuals) do not apply. The buildings do not represent the distinctive characteristics of a type, the work of a master, nor do they possess any high artistic value (Criterion C Design/Construction). While Criterion D (Information Potential) can be applied to buildings, Property 27 appears to offer little future research potential, thus Criterion D is not applicable.

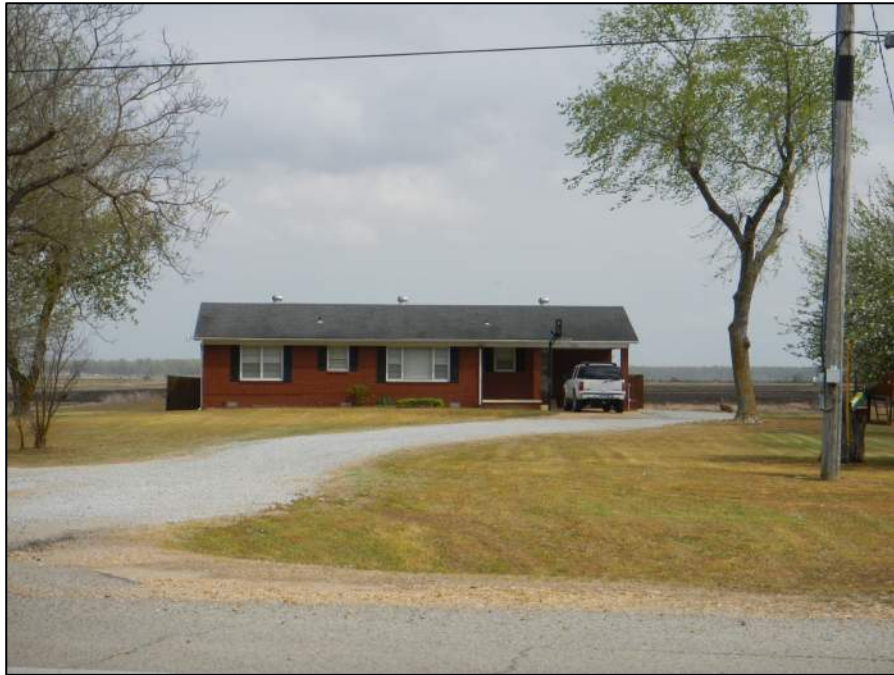
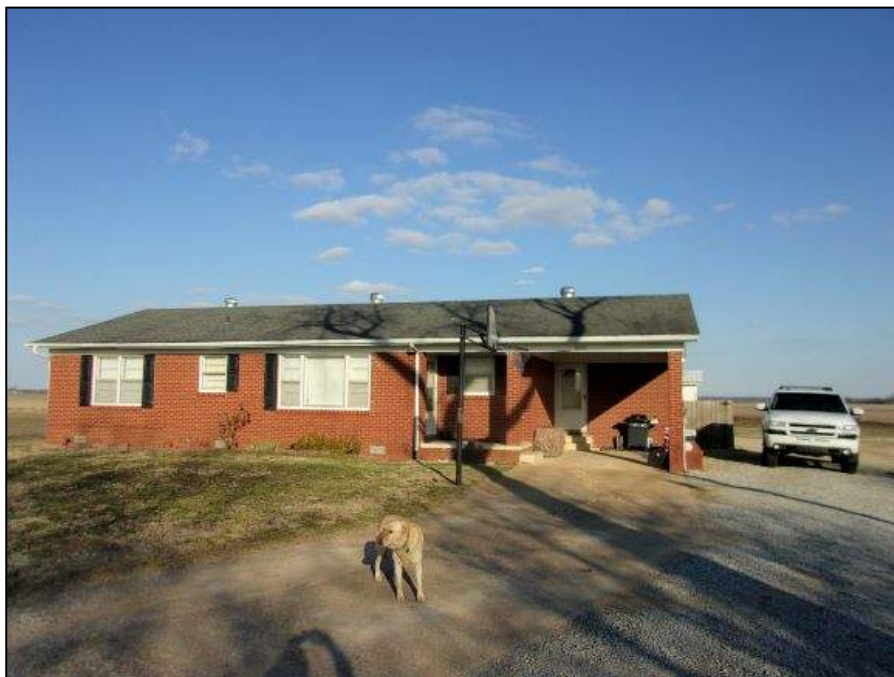
Figure 2-120. Property 28, view east (DSCN1688).

Figure 2-121. Property 28, view east (assessors office photo).

Property 28, located at 7036 Highway 67 (ID 022-02437-000) is a 1995 Ranch style house on a small (2-acre) parcel along the eastern side of Highway 67 (Figures 2-05 and 2-120–2-121). The main house has a fenced back yard, an outbuilding in yard, and an unattached garage to the rear of the fenced yard. Additions to the house and erection of the freestanding garage postdate 2010. The buildings are at a slight bend in the highway near the northern terminus of the “purple” line south of the intersection of Highway 67 and Stateline Road.

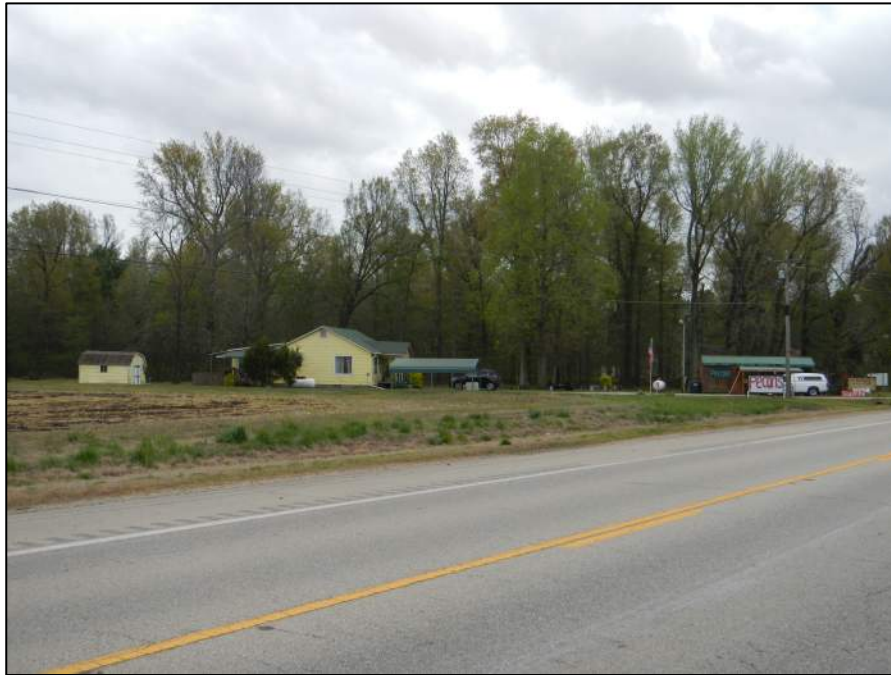
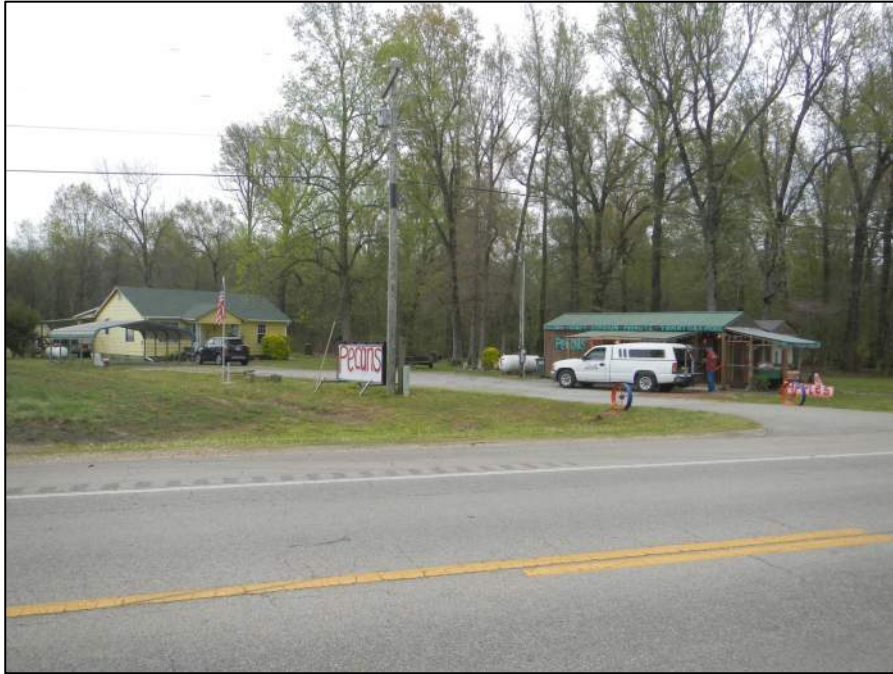
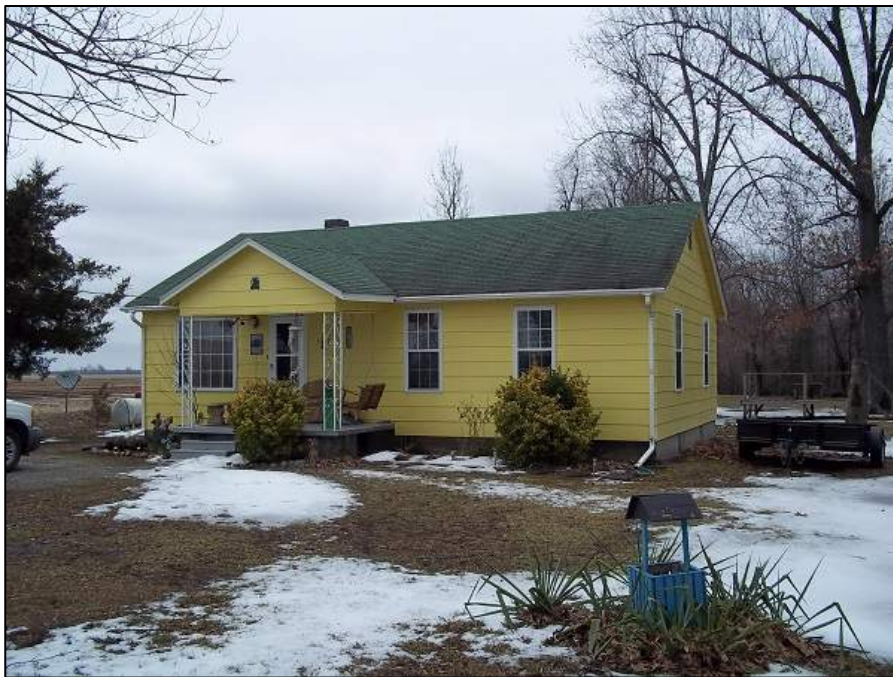
Figure 2-123. Property 29a-1, view southeast (DSCN1689).

Figure 2-124. Property 29a-1, view east (DSCN1692).

Figure 2-125. Property 29a-1, view east (assessors office photo).

Property 29a-1 (Figures 2-123–2-126) includes a primary residence, an automobile canopy, a yard barn, and a pecan stand. The main house (ca. 1993) is a rectangular standard frame structure with aluminum lap siding, 6-over-6 aluminum or vinyl sash windows, a large 24-light picture window, and an asphalt/fiberglass shingle covered open gable roof. The appearance of the house indicates the property is a 1950s-1960s Minimal Traditional Transitional Ranch style house, which contrasts the Assessor’s site stating it is of the 1990s. The front porch is defined by a small gable supported by two decorative steel columns. The yard barn and carport canopy are both prefabricated units.

In the opinion of Panamerican, none of the structures at Property location 29a are eligible for listing in the NRHP because they meet none of the established criteria. They are not known to be associated with any significant persons or event, thus Criteria A (association) and B (prominent individuals) do not apply. The buildings do not represent the distinctive characteristics of a type, the work of a master, nor do they possess any high artistic value (Criterion C Design/Construction). While Criterion D (Information Potential) can be applied to buildings, Property location 29a appears to offer little future research potential, thus Criterion D is not applicable.

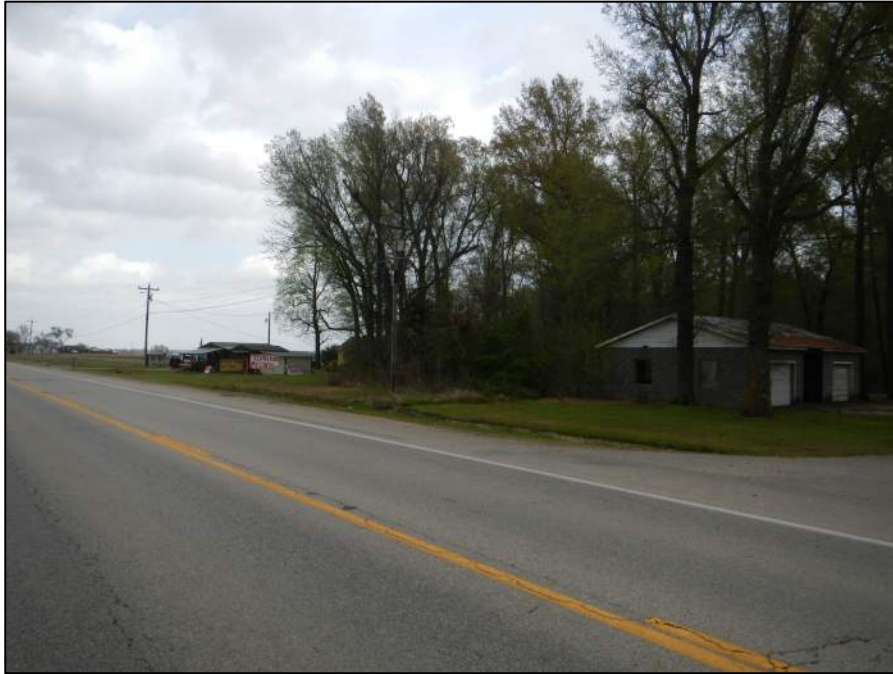
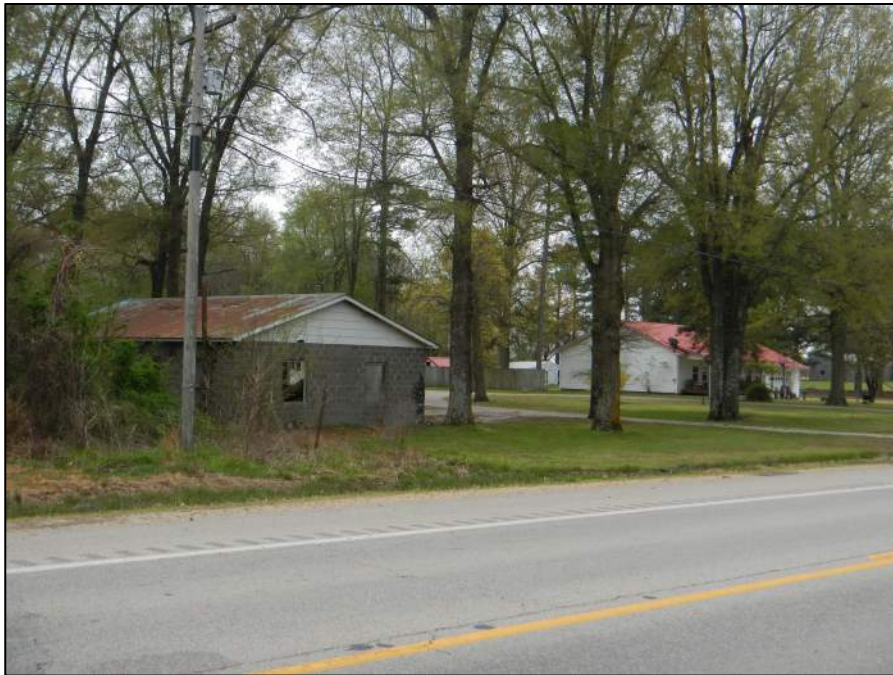
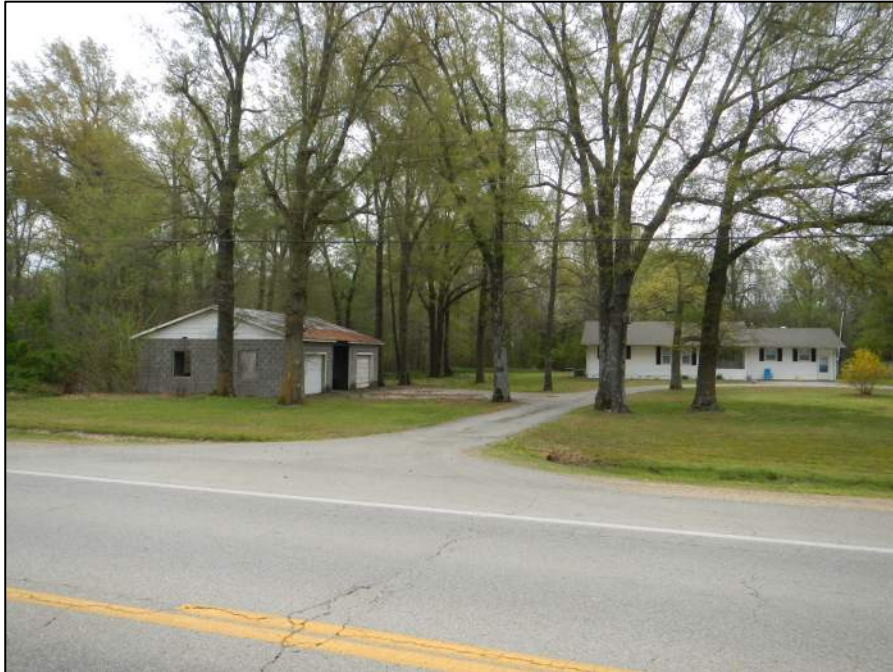
Figure 2-126. Properties 29a-1 and 2, view northeast (DSCN1697).

Figure 2-127. Properties 29a-2 and 4, view southeast (DSCN1694).

Property 29a-2 (Figures 2-126–2-128) is a concrete block two-car garage with a sheet metal roof and aluminum lap siding in the gables. The structure is incomplete (no windows set in the openings) and is currently unused. It is not shown as a property improvement on the Clay County Assessors office records and there is no build date. Like the other structures in this location, it probably dates to the early to mid-1990s.

Figure 2-128. Properties 29a-2 and 3, view east (DSCN1698).

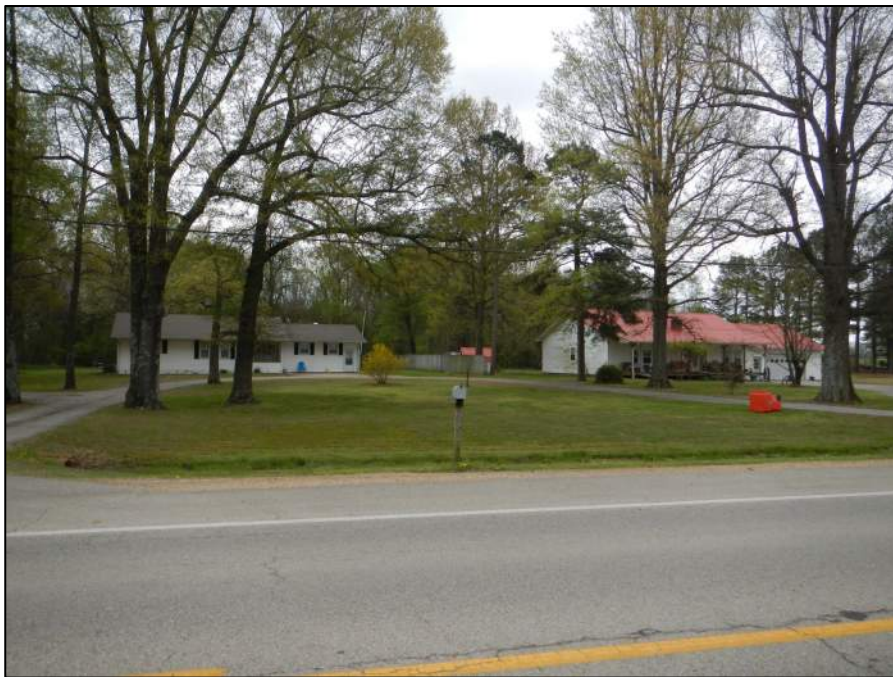
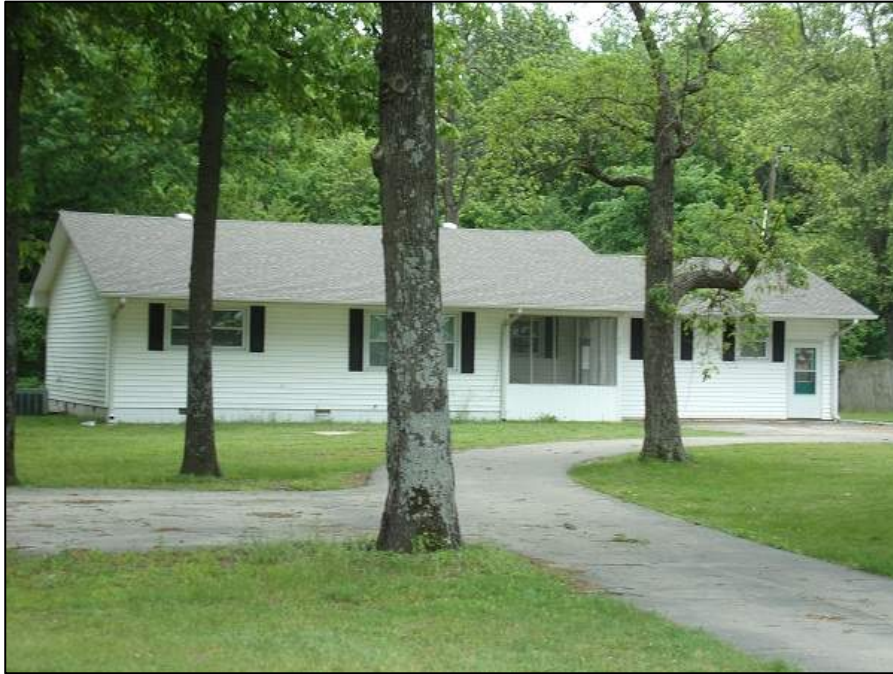
Property 29a-3 (Figures 2-128–2-130) is a ca. 1995 rectangular standard frame Ranch style residential structure with wooden lap siding, 1-over-1 aluminum sash windows, faux shutters, and an asphalt/fiberglass shingle covered open gable roof. The front porch has been enclosed and is inset on the south central part of the façade, and a separate entrance is located on south end of the house.

Figure 2-129. Properties 29a-3 and 4, view east (DSCN1699).

Figure 2-130. Property 29a-3, view east (assessors office photo).

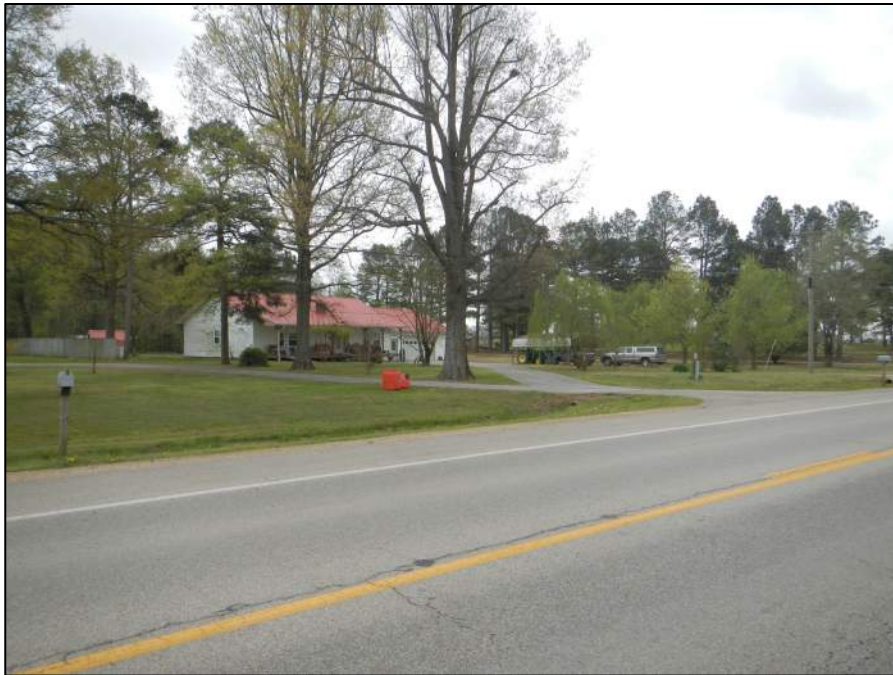
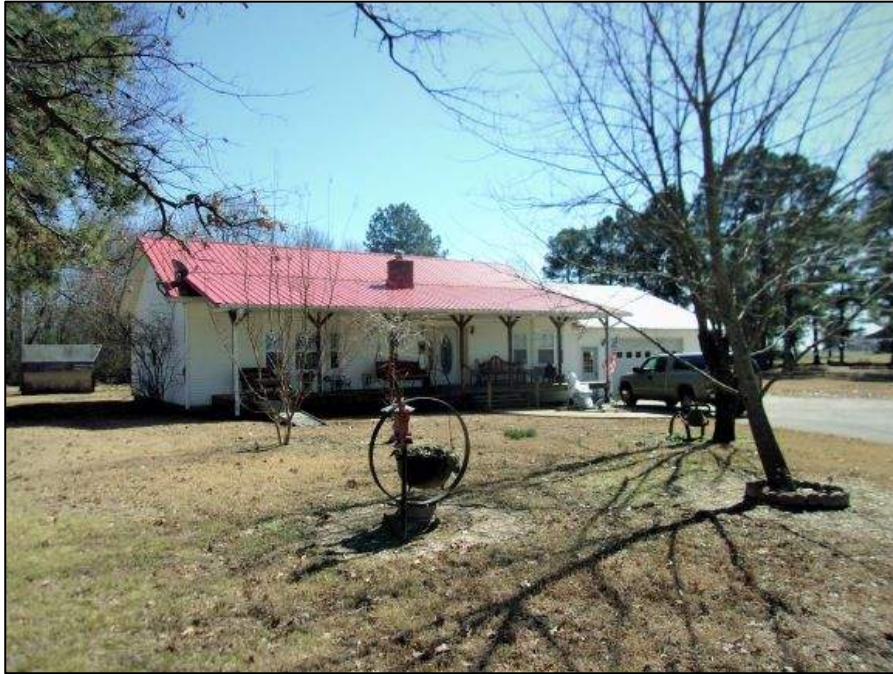
Property 29a-4 (Figures 2-127, 2-129, 2-131–2-132) is a ca. 1993 rectangular standard frame Ranch style residential structure with wooden lap siding, 1-over-1 aluminum sash windows, and a sheet metal or “galvalume” covered combination open gable roof. The open front porch runs the length of the front façade and is supported by seven plain columns with top braces. A second entrance is located on the attached garage on the south end of the house. There are also two outbuildings on the property.

Figure 2-131. Property 29a-4, view southeast (DSCN1700).

Figure 2-132. Property 29a-4, view east (assessors office photo).

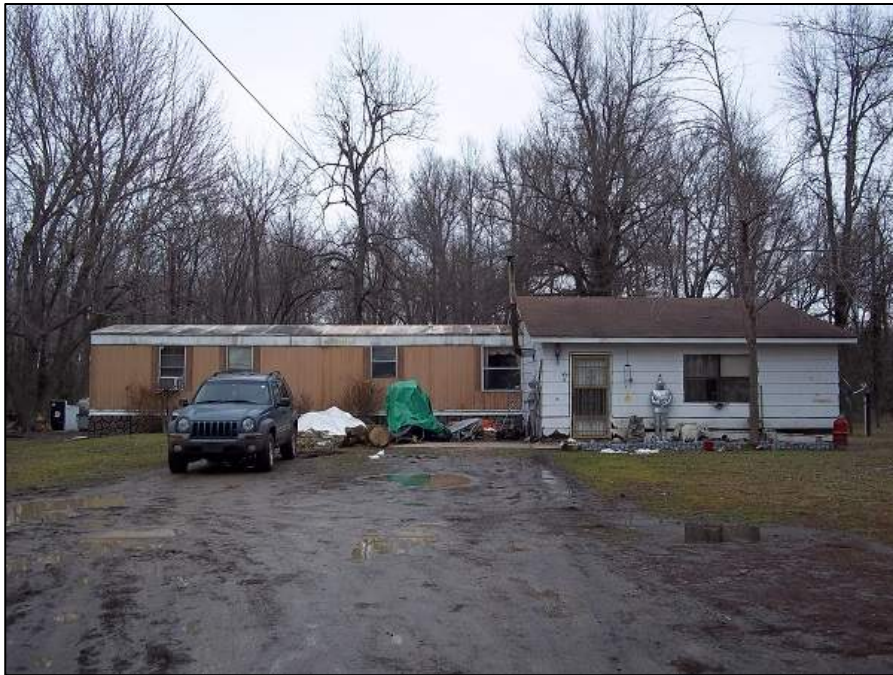
Property 29a-5 (Figure 2-133) is a ca. 1990 mobile home with a small frame addition. The frame addition serves as a small entrance room and has a flue for a wood-burning stove or perhaps a hot water tank (?). A small pond is located on the front section of the parcel.

Figure 2-133. Property 29a-5, view east (assessors office photo).

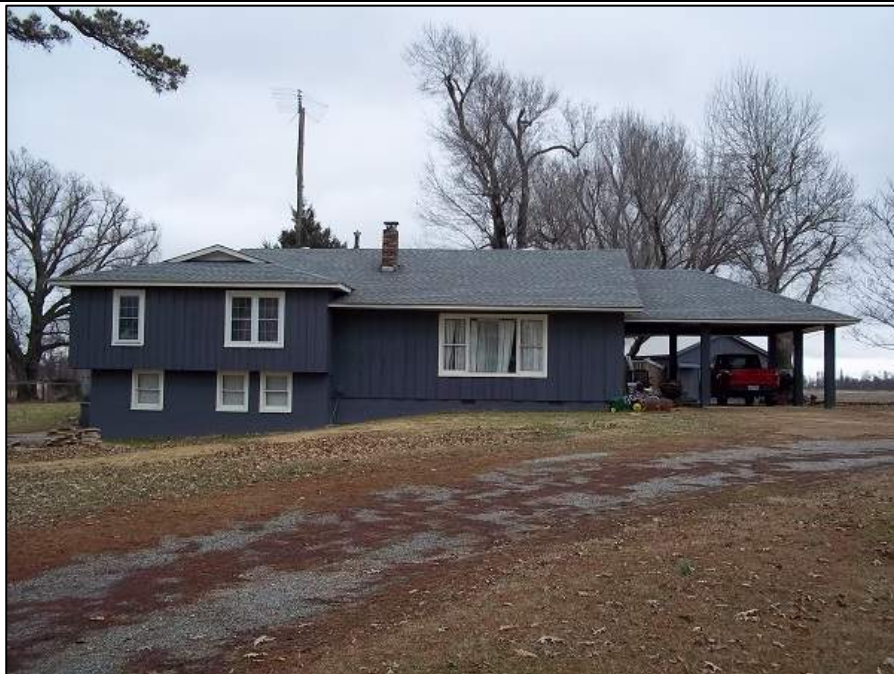
Property 29a-6 (Figure 2-134) is a ca. 1992 rectangular standard frame Split-Level style residential structure with wooden board-and-batten siding, 1-over-1, 6-over-6, and single pane aluminum sash and picture windows, a single chimney, and an asphalt/fiberglass shingle covered open gable roof. The primary entrance to the house appears to be on the south end under an open two-car carport supported by five columns. A large sheet barn or utility building is behind the main house and a small outbuilding is to the southwest on the side of the circular entrance drive.

Figure 2-134. Property 29a-6, view east (assessors office photo).

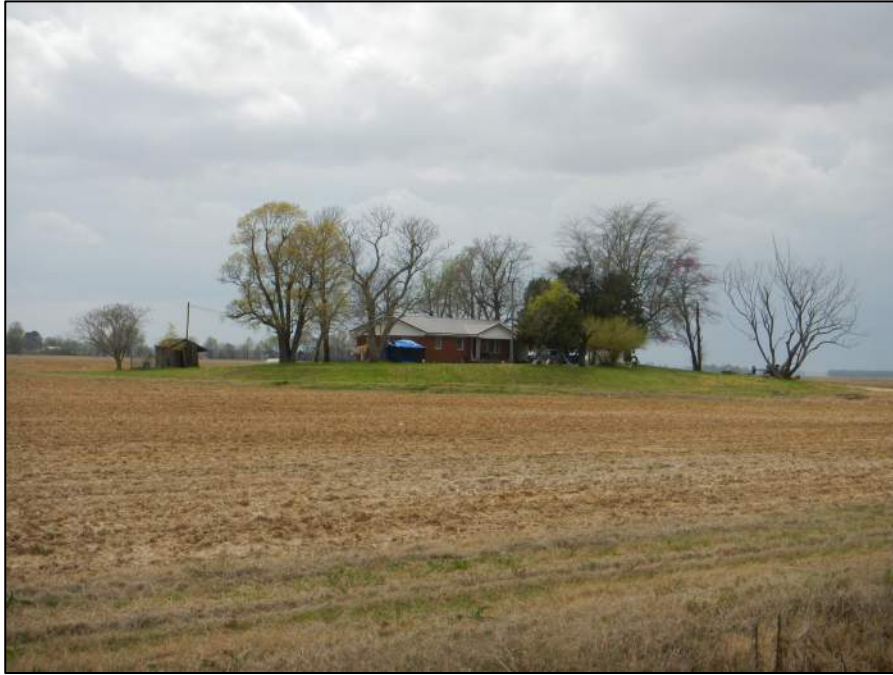
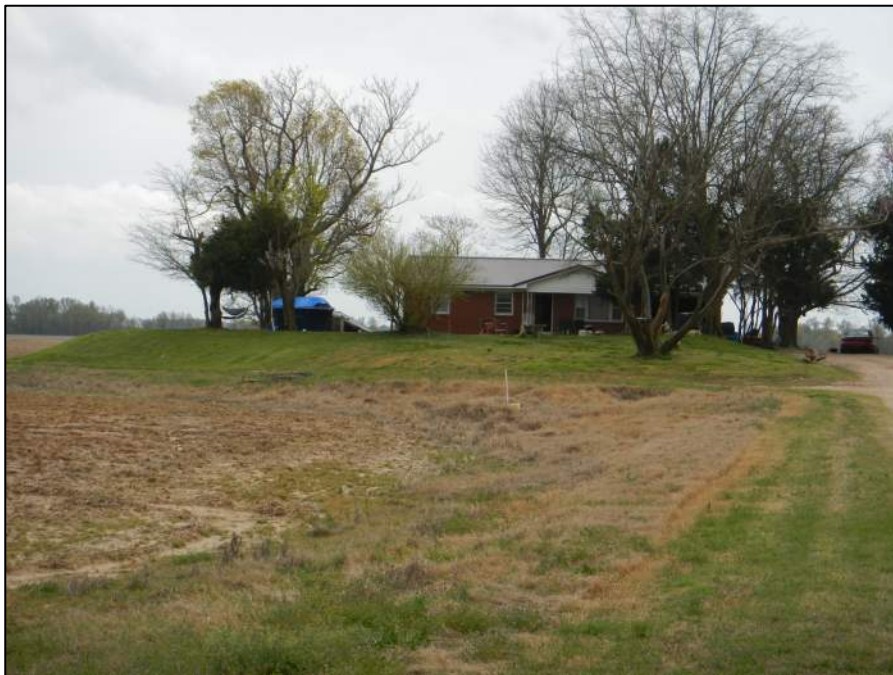
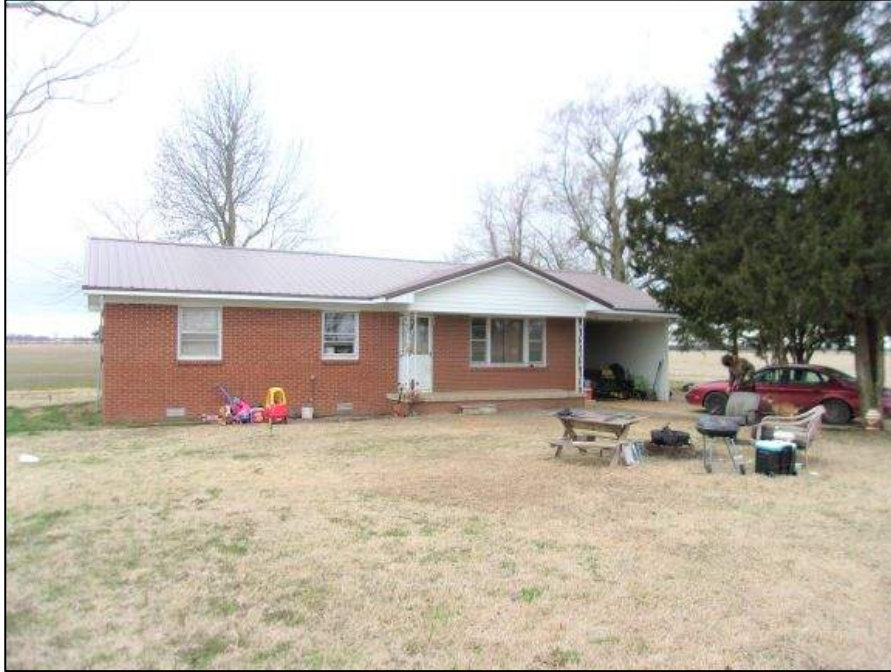
Figure 2-135. Property 29b, view southwest (DSCN1683).

Figure 2-136. Property 29b, view south (DSCN1684).

Property 29b, located at 798 Stateline Road (ID 022-02440-000) is a ca. 1991 house (again, the Assessor's site could be in error as the style, windows, and porch posts are consistent with structures of the 1960s) on a small knoll along the southern side of the road (Figures 2-05 and 2-120–2-121). In addition to the main house, there is a small outbuilding in back yard. The buildings are at the northern terminus of the "purple" line west of the intersection of Highway 67 and Stateline Road.

Figure 2-137. Property 29b, view southsouthwest (assessors office photo).

In the opinion of Panamerican, Property 29b is not eligible for listing in the NRHP because it meets none of the established criteria. It is not known to be associated with any significant persons or event, thus Criteria A (association) and B (prominent individuals) do not apply. The buildings do not represent the distinctive characteristics of a type, the work of a master, nor do they possess any high artistic value (Criterion C Design/Construction). While Criterion D (Information Potential) can be applied to buildings, Property 29b appears to offer little future research potential, thus Criterion D is not applicable.

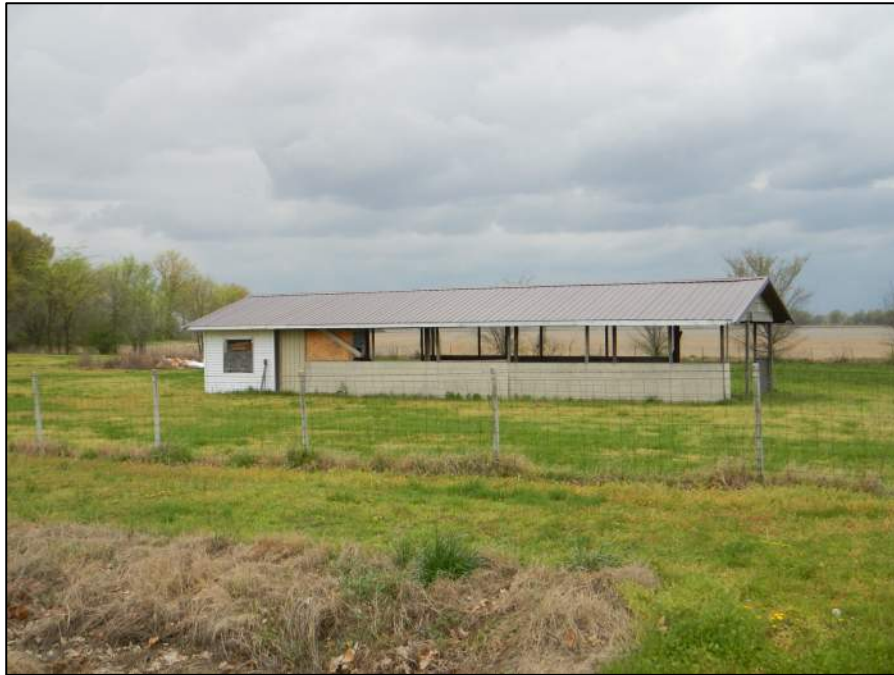
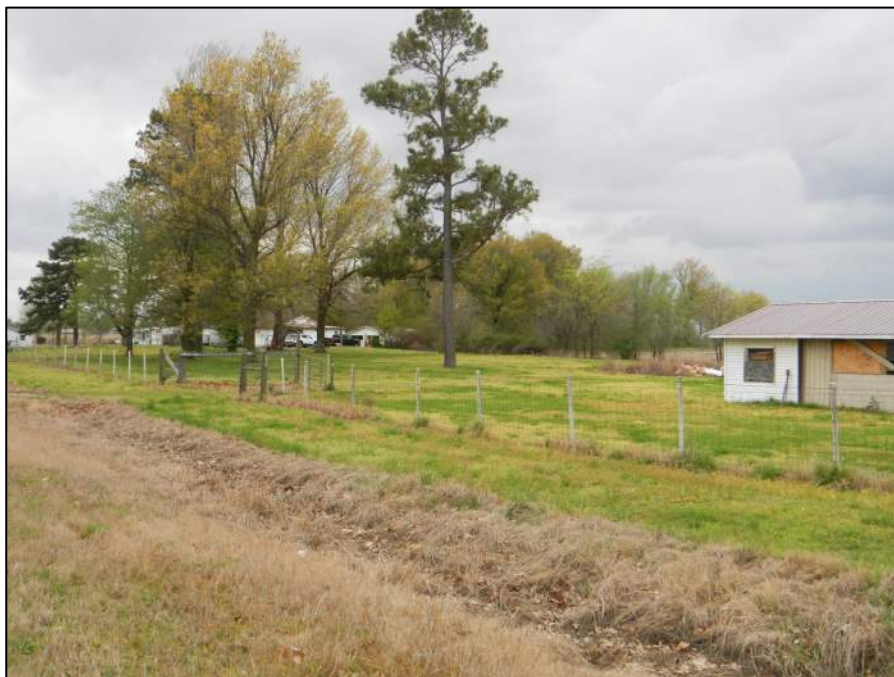
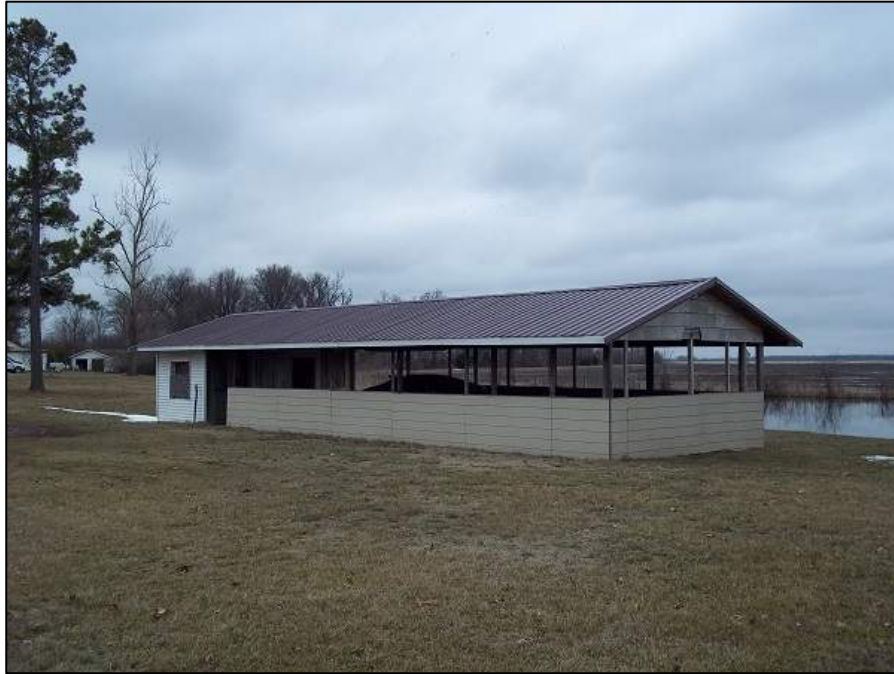
Figure 2-138. Property 30-1, view west (DSCN1690).

Figure 2-139. Properties 30-1 and 2 view southwest (DSCN1691).

Figure 2-140. Property 30-1, view southwest (assessors office photo).

Property 30-1 (Figures 2-138–2-140) is an open sided shed or utility building with an enclosed room on the south end of the building. It has an open gable roof with a corrugated sheet metal roof. The function is undetermined, but its location with a small fenced pasture suggest it may something to do with livestock. Three other buildings on the parcel were removed/demolished between 1994 and 2001.

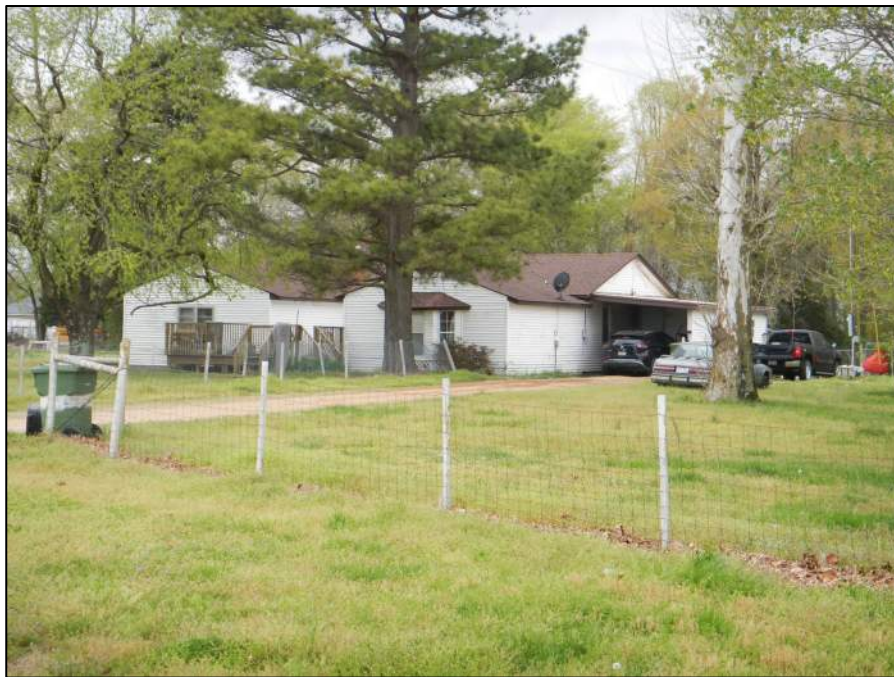
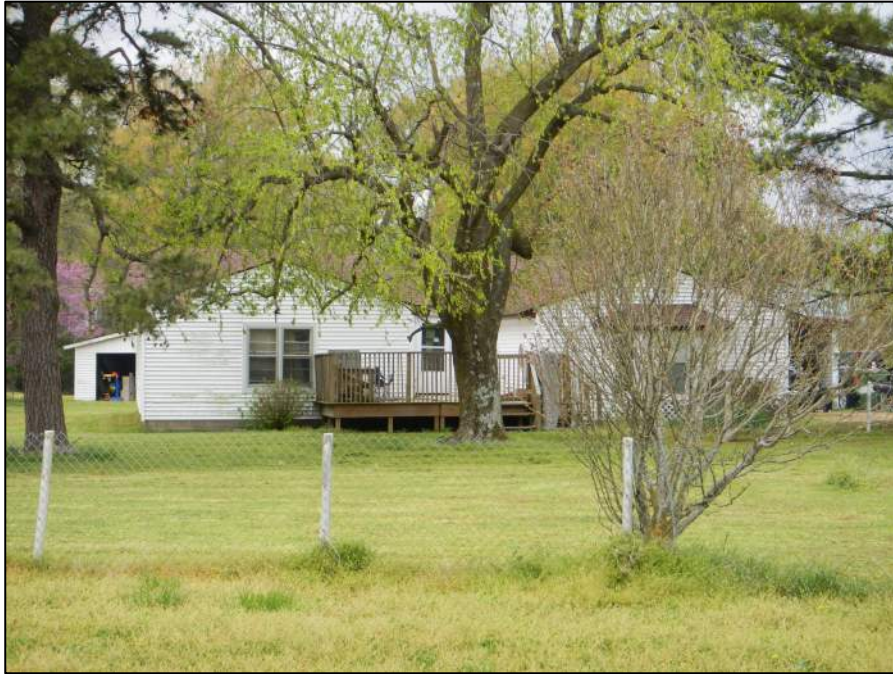
Figure 2-141. Property 30-2, view southwest (DSCN1693).

Figure 2-142. Property 30-2, view west (DSCN1696).

Property 30-2 (Figures 2-141–2-144) is a ca. 1993 standard frame residential structure with wooden lap siding, 2-over-1 aluminum sash windows, and an asphalt/fiberglass shingle covered open gable roof. There is a deck/landing between the two wings on the front façade. A carport with a secondary shed roof is on the north end. On the back end of the parcel is a large, unattached two-car garage built in a matching style.

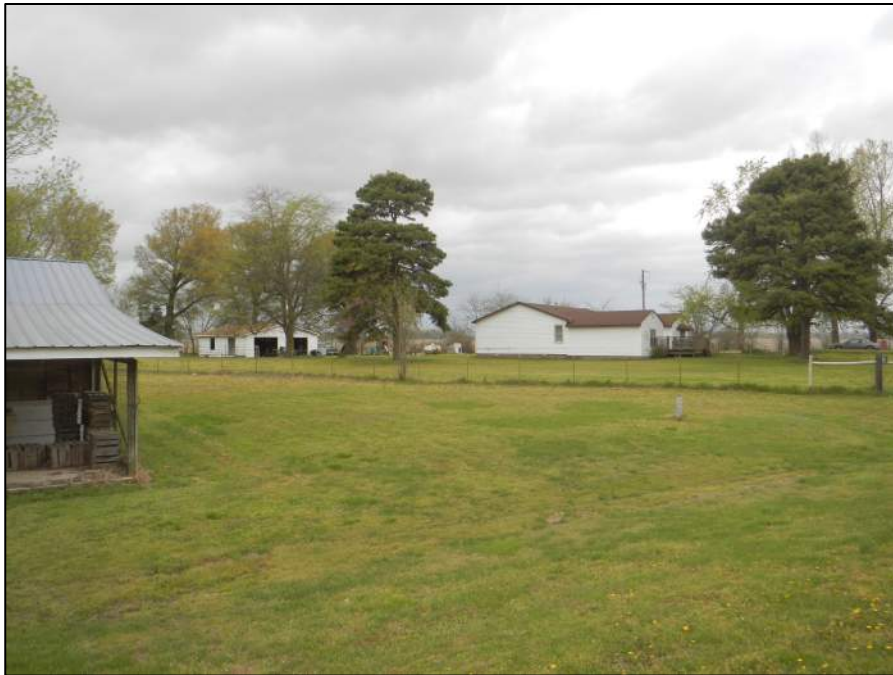
Figure 2-143. Properties 30-2 and 3, view northwest (DSCN1703).

Property 30-3 (Figures 2-143 and 2-145–2-149) is an assemblage of five buildings on a commercial parcel. Close to the road is an elongated rectangular commercial utility building with a sheet metal roof and an open front landing. There are three windows on one side of the building and a garage door on the opposite side. This looks like a roadside fruit and vegetable stand/storage facility. Behind the stand is a ca. 1997 singlewide mobile home, listed as the only residential improvement on the property. At the back end of the parcel are two matching utility buildings or barns and several smaller outbuildings.

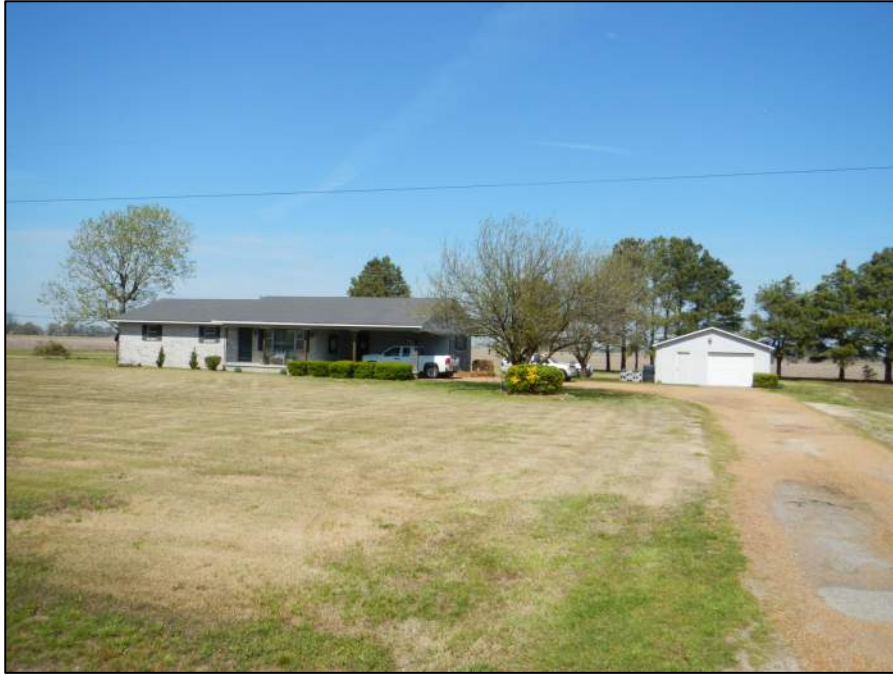
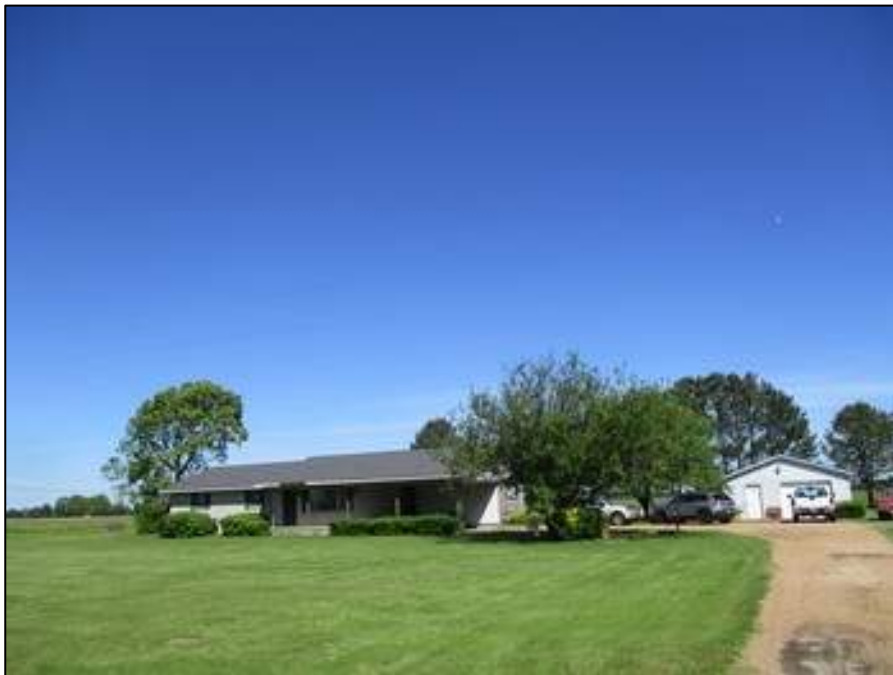
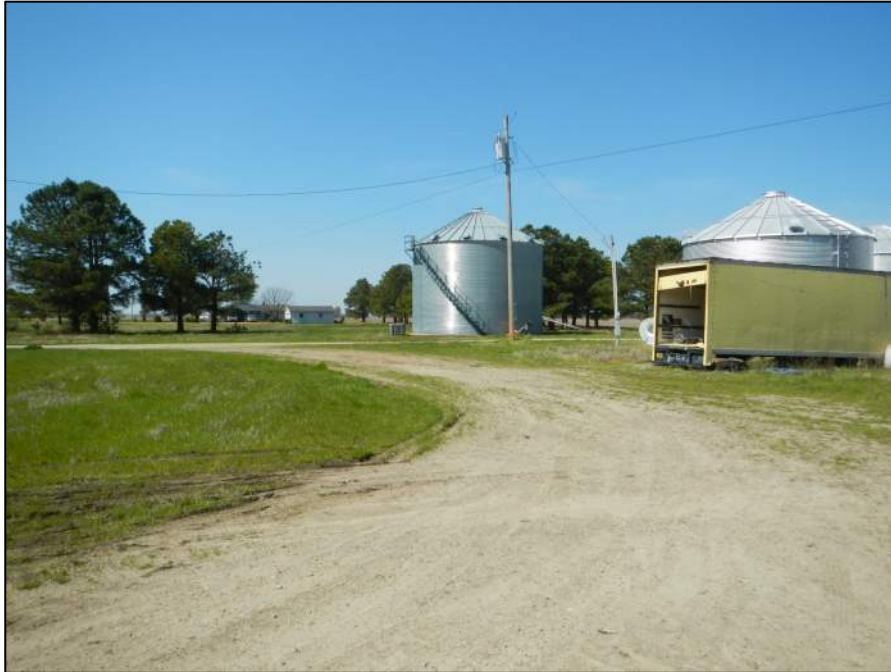
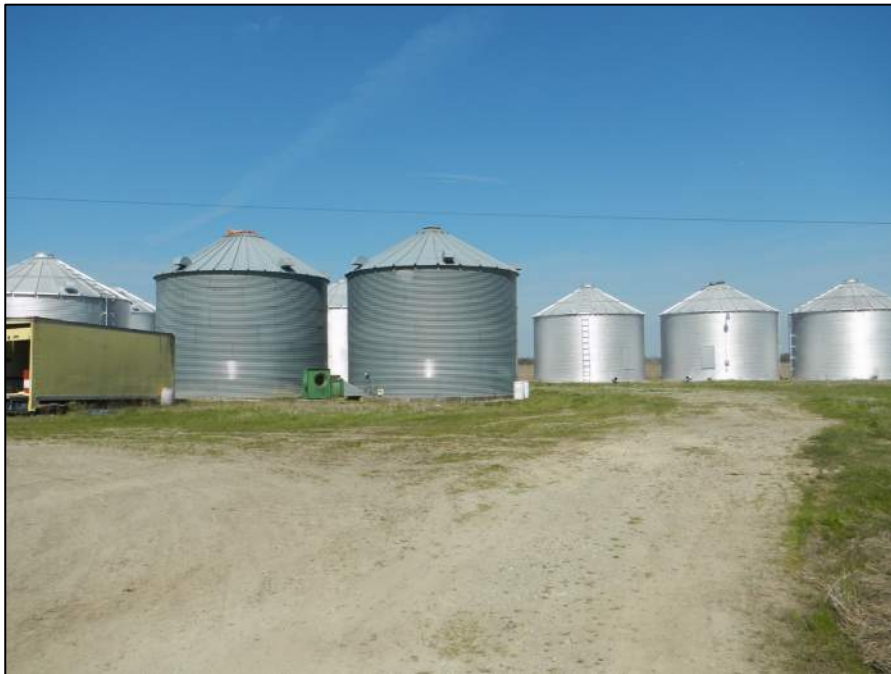
Property 31, located at 713 Highway 34 in Lawrence County (ID 001-02337-000) is a ca. 1991 house on a 2.74-acre parcel south of a grain silo complex (Figures 2-06 and 2-150–2-153). In addition to the main house there is an unattached garage at the end of the driveway. The buildings are just north of the split in the “blue” and “orange” alternatives.

Map research shows timber on this parcel on the 1935 Walnut Ridge 15-minute USGS quadrangle. The 1965 Walnut Ridge USGS 7.5-minute quadrangle shows a house in the same location, which is now gone. This earlier structure is visible on aerial photographs taken in 1974 by the Soil Conservation Service (Gore et al. 1978). Another structure is shown where the grain silos are now. Satellite imagery shows the newer house and some of the silos as early as 1994, in correspondence with the effective age of 22 years recorded on the Lawrence County real estate record. No historic association under Criterion A or B was found for the property.

In the opinion of Panamerican, Property 31 is not eligible for listing in the NRHP because it meets none of the established criteria. It is not known to be associated with any significant persons or event, thus Criteria A (association) and B (prominent individuals) do not apply. The buildings do not represent the distinctive characteristics of a type, the work of a master, nor do they possess any high artistic value (Criterion C Design/Construction). While Criterion D (Information Potential) can be applied to buildings, Property 31 appears to offer little future research potential, thus Criterion D is not applicable.
