Appendix J – Cultural Resources Information

Job No. 100512, Walnut Ridge – Missouri State Line (Future I-57) P.E.

**ARCHITECTURAL RESOURCES SURVEY FOR
FUTURE INTERSTATE 57 (JOB 100512),
LAWRENCE, RANDOLPH, GREENE, AND CLAY COUNTIES,
ARKANSAS**

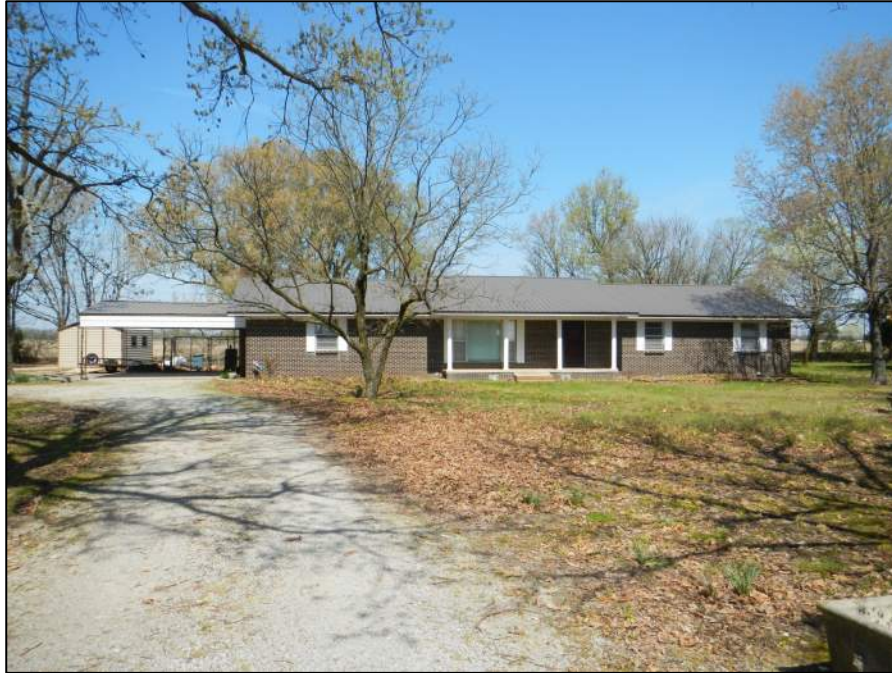
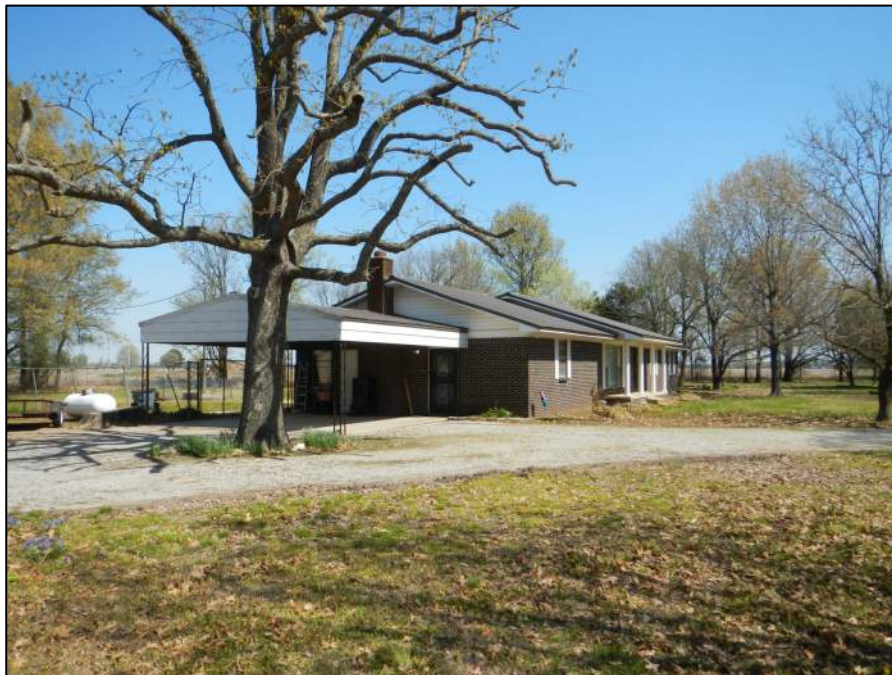
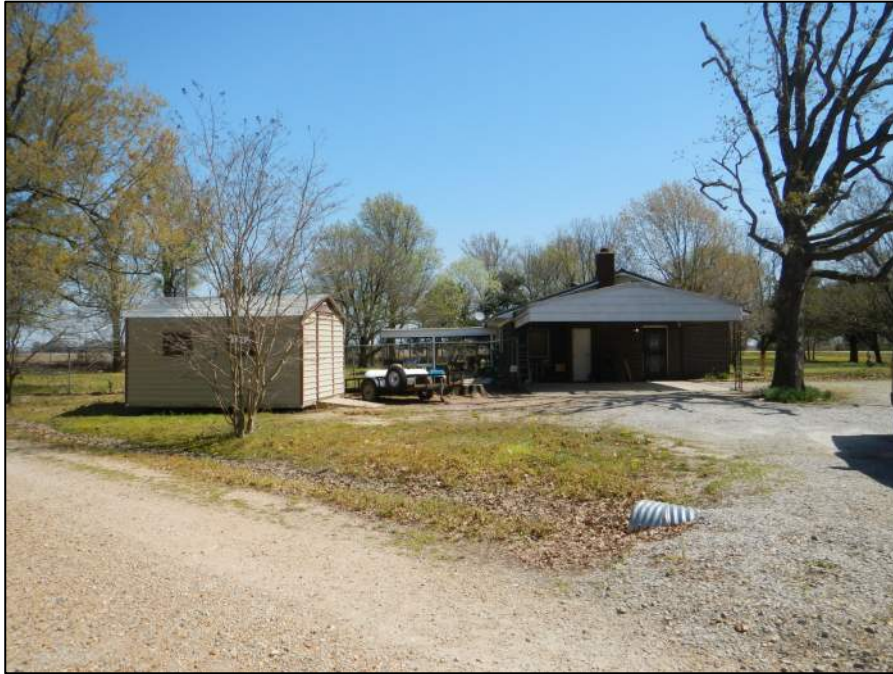
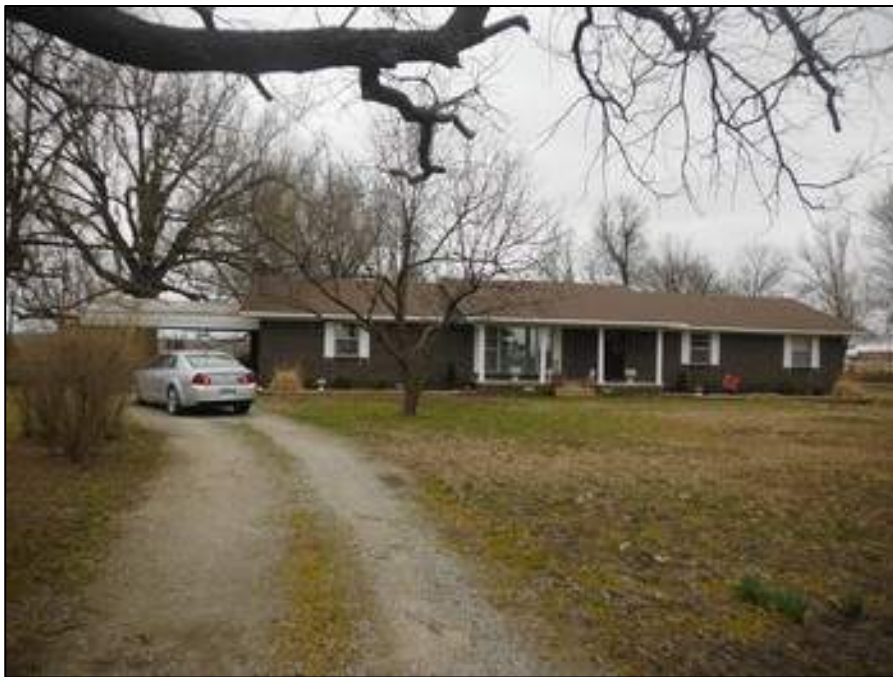
Property 32, located at 767 Highway 34 in Lawrence County (ID 001-02320-001) is a ca. 1988 house on a 1.63-acre triangular parcel at the intersection of Lawrence Road 409 (Figures 2-06 and 2-154–2-157). In addition to the main house there is a small prefabricated “yard barn” at the end of the driveway. The buildings are just north of the split in the “blue” and “orange” alternatives.

Map research shows timber on this parcel on the 1935 Walnut Ridge 15-minute USGS quadrangle. The 1965 Walnut Ridge USGS 7.5-minute quadrangle shows a house in the same location, which is now gone. This earlier structure is visible on aerial photographs taken in 1974 by the Soil Conservation Service (Gore et al. 1978). Satellite imagery shows the newer house as early as 1994, in correspondence with the effective age of 25 years recorded on the Lawrence County real estate record. No historic association under Criterion A or B was found for the property.

In the opinion of Panamerican, Property 32 is not eligible for listing in the NRHP because it meets none of the established criteria. It is not known to be associated with any significant persons or event, thus Criteria A (association) and B (prominent individuals) do not apply. The buildings do not represent the distinctive characteristics of a type, the work of a master, nor do they possess any high artistic value (Criterion C Design/Construction). While Criterion D (Information Potential) can be applied to buildings, Property 32 appears to offer little future research potential, thus Criterion D is not applicable.

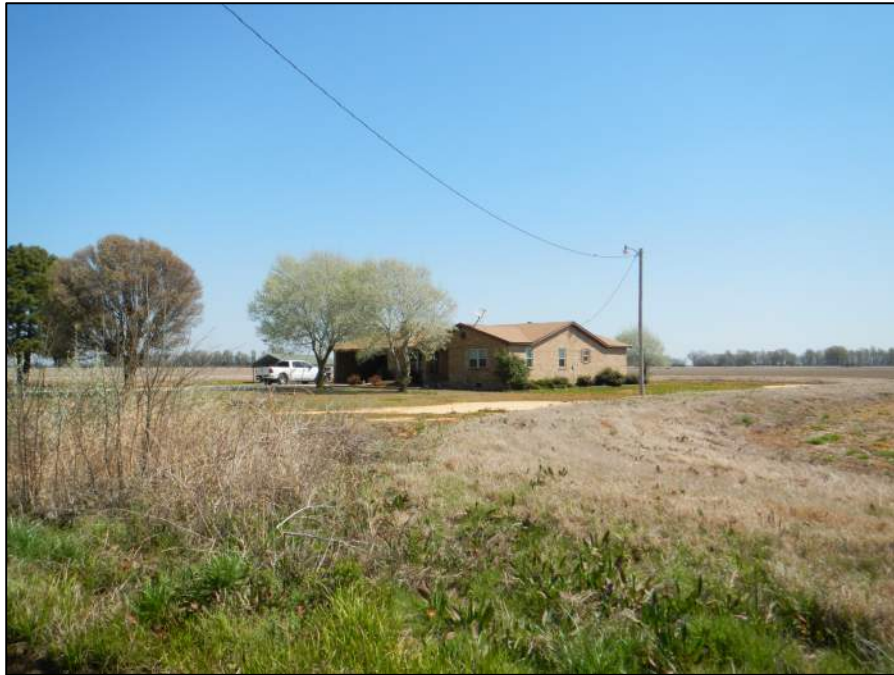
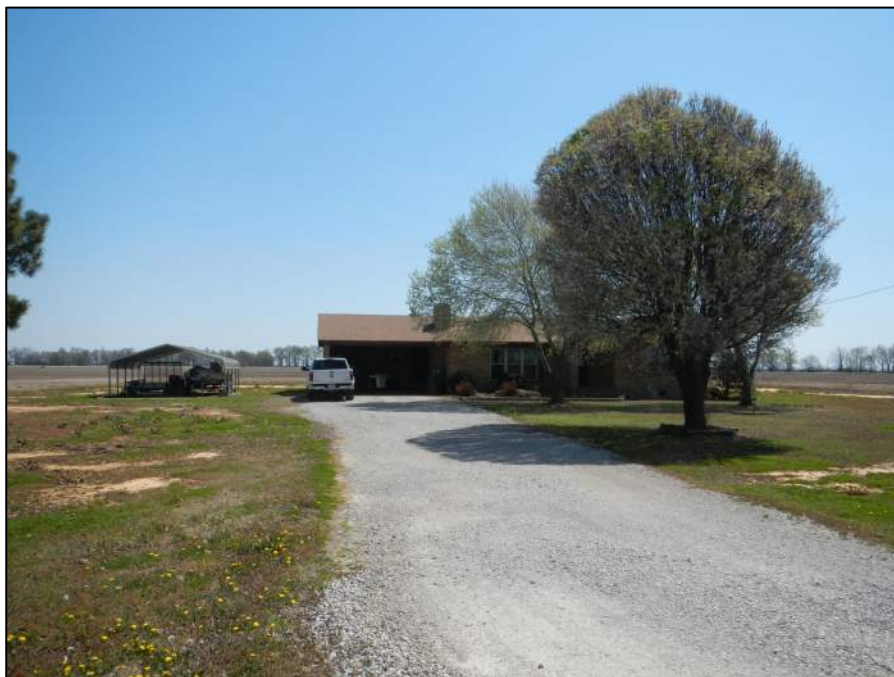
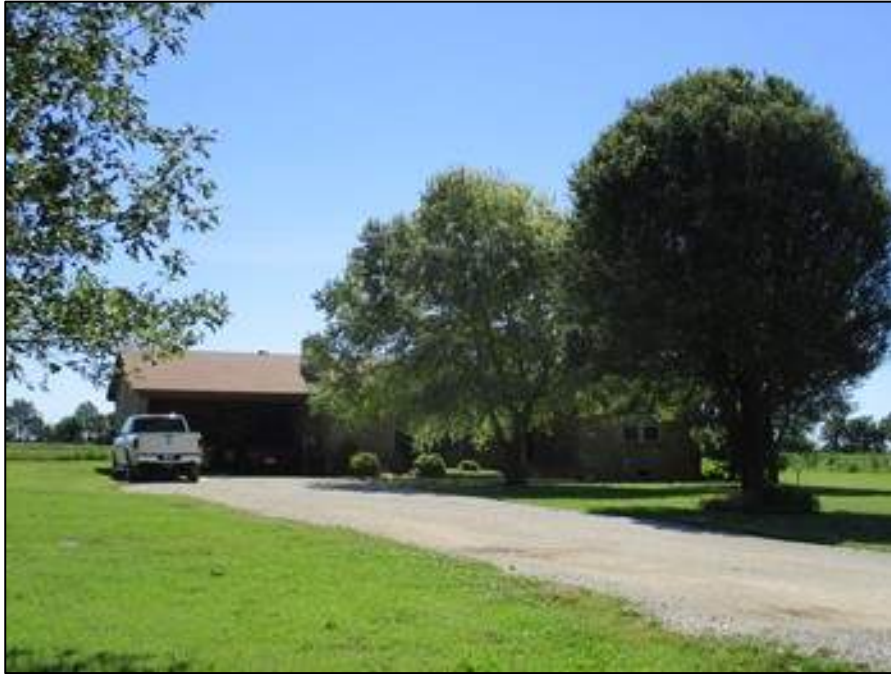
Property 33, located at 715 Highway 34 North in Lawrence County (ID 001-02307-000) is a ca. 1989 house on a 0.84-acre parcel just north of the intersection of Lawrence Road 409 (Figures 2-06 and 2-158–2-160). In addition to the main house there is a stand-alone prefabricated canopy cover at the end of the driveway. The buildings are just north of the split in the “blue” and “orange” alternatives.

Map research shows timber on this parcel on the 1935 Walnut Ridge 15-minute USGS quadrangle. The 1965 Walnut Ridge USGS 7.5-minute quadrangle shows a house in the same location, which is now gone. This earlier structure is not visible on aerial photographs taken in 1974 by the Soil Conservation Service (Gore et al. 1978). Satellite imagery shows the newer house as early as 1994, in correspondence with the effective age of 24 years recorded on the Lawrence County real estate record. No historic association under Criterion A or B was found for the property.

In the opinion of Panamerican, Property 33 is not eligible for listing in the NRHP because it meets none of the established criteria. It is not known to be associated with any significant persons or event, thus Criteria A (association) and B (prominent individuals) do not apply. The buildings do not represent the distinctive characteristics of a type, the work of a master, nor do they possess any high artistic value (Criterion C Design/Construction). While Criterion D (Information Potential) can be applied to buildings, Property 33 appears to offer little future research potential, thus Criterion D is not applicable.

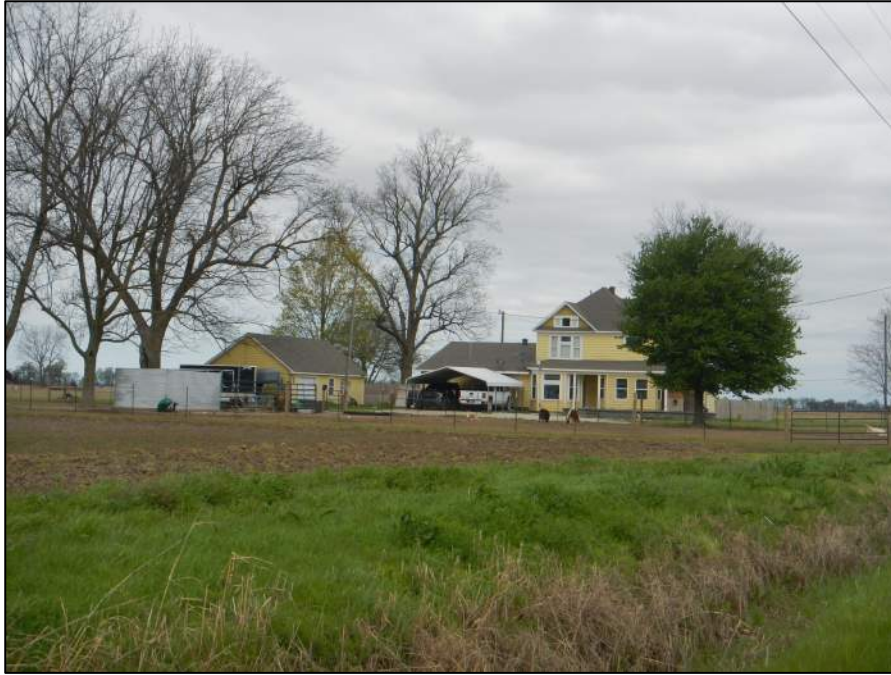
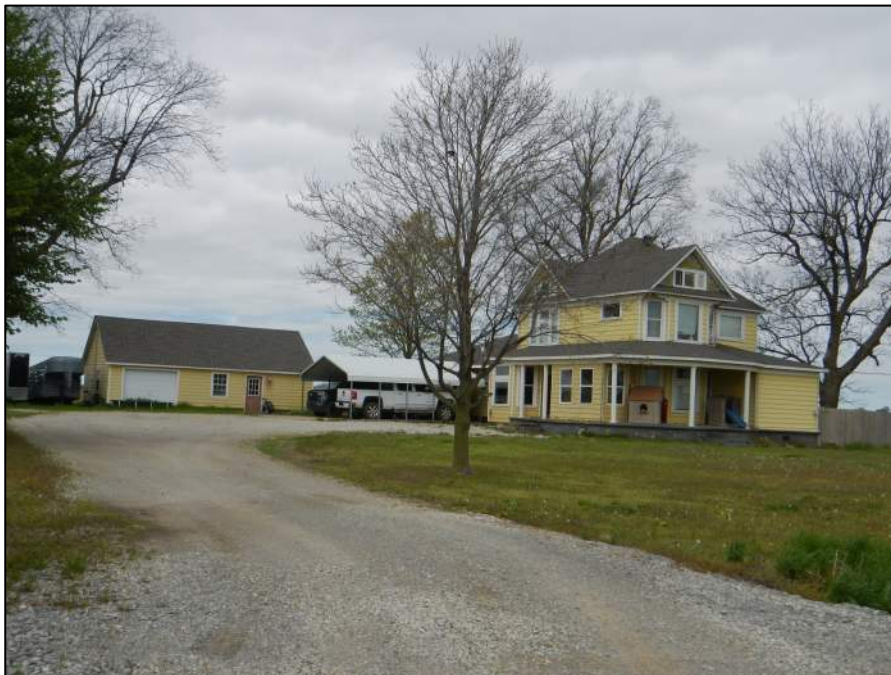
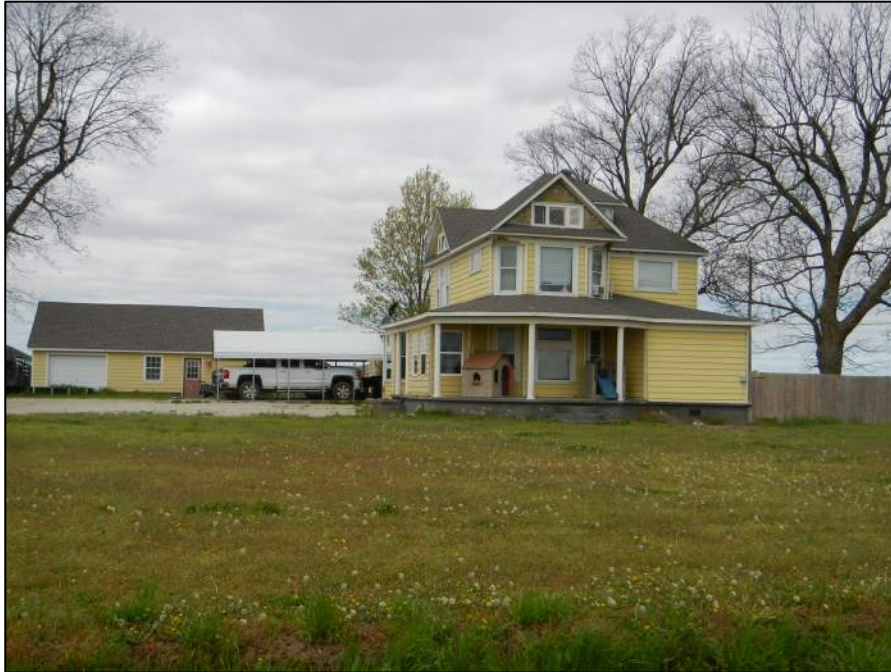
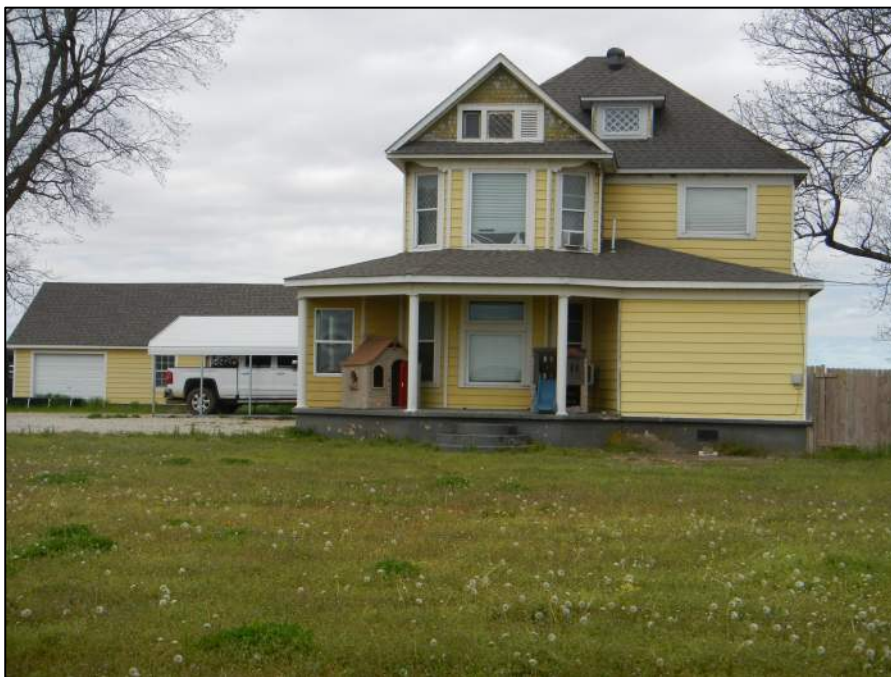
Property 34, located at 127 Lawrence County Road 409 (ID 001-02190-000) is an early twentieth century two-story Victorian house on a 1.37-acre parcel on the western side of Village Creek (Figures 2-07 and 2-161–2-165). In addition to the main house there is a large unattached garage/workshop and a stand-alone prefabricated canopy cover at the end of the driveway. The buildings are in the center of the “blue” alternative just south of the Randolph County line.

Map research shows a dwelling on this parcel since at least 1935. On the 1935 Walnut Ridge 15-minute USGS quadrangle a house is shown in association with five other dwellings to the south on the same side of the section line road (a 1910 deed indicates that these may have all been part of the Vivian Snow estate). The 1965 Walnut Ridge USGS 7.5-minute quadrangle shows a house in the same location, with two now demolished barns to the south. The house is visible on aerial photographs taken in 1974 by the Soil Conservation Service (Gore et al. 1978), but the barns appear to be gone by this time. Satellite imagery shows the house as early as 1994. No direct historic association under Criterion A or B was found for the property.

Although this is the only Victorian era house documented in the I-57 project area, it appears to have a compromised integrity of design, materials, and feeling. In the opinion of Panamerican, Property 34 is not eligible for listing in the NRHP because it meets none of the established criteria. It is not known to be associated with any significant persons or event, thus Criteria A (association) and B (prominent individuals, although additional research on the Snow family might reverse this recommendation) do not apply. The buildings do not represent the distinctive characteristics of a type, the work of a master, nor do they possess any high artistic value (Criterion C Design/Construction). While Criterion D (Information Potential) can be applied to buildings, Property 34 appears to offer little future research potential, thus Criterion D is not applicable.

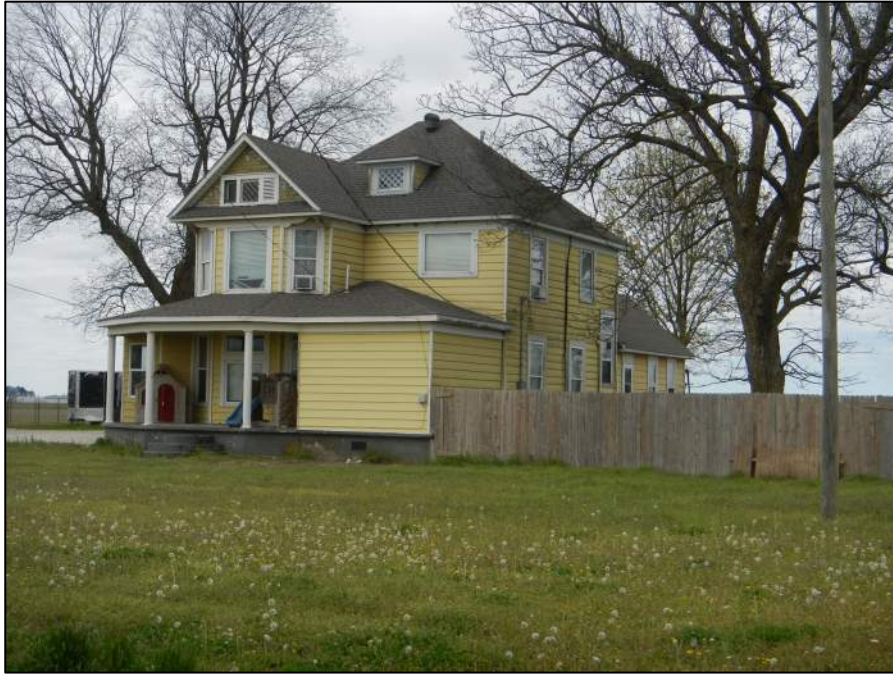
There are a number of original architectural details, such as the fish-scale cedar shakes in the upper dormers and cross hatched windows, that date the house to the early twentieth century. The original floor plan and layout seems greatly modified, however. What appears to have originally been a wrap-around porch has been enclosed on one end, and the exterior wall lacks a window opening. The exterior siding is aluminum. More research would be required, but the rear one-story wing may have been added later. The free-standing garage is recent (post-1996).

Figure 2-165. Property 34, view southwest (DSCN1710).

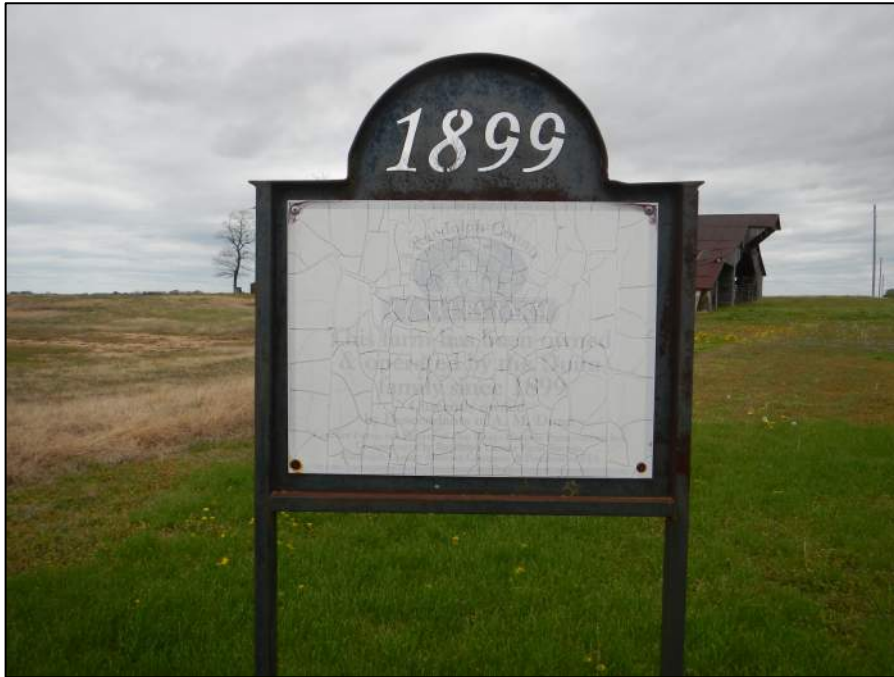
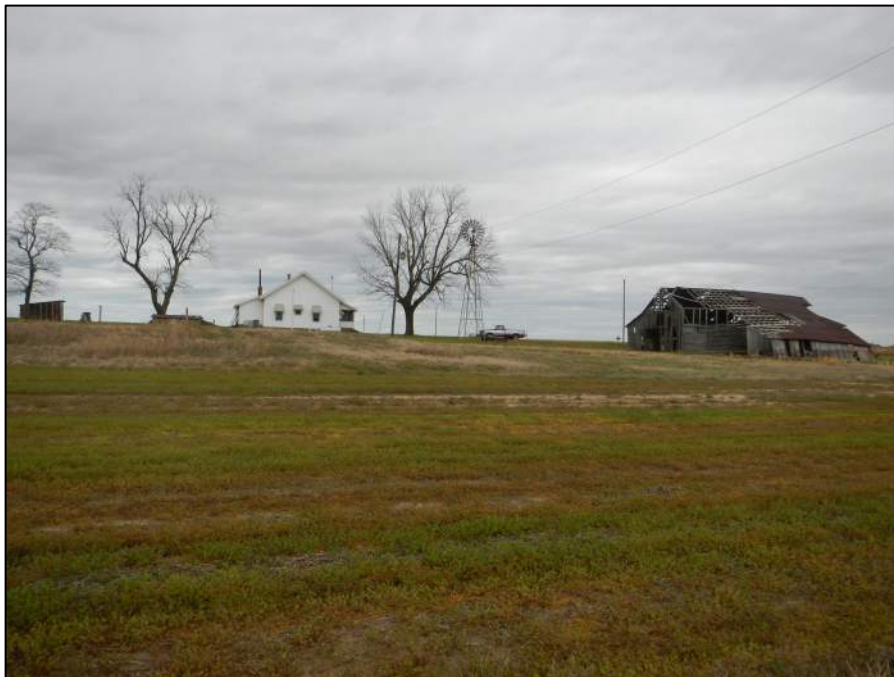
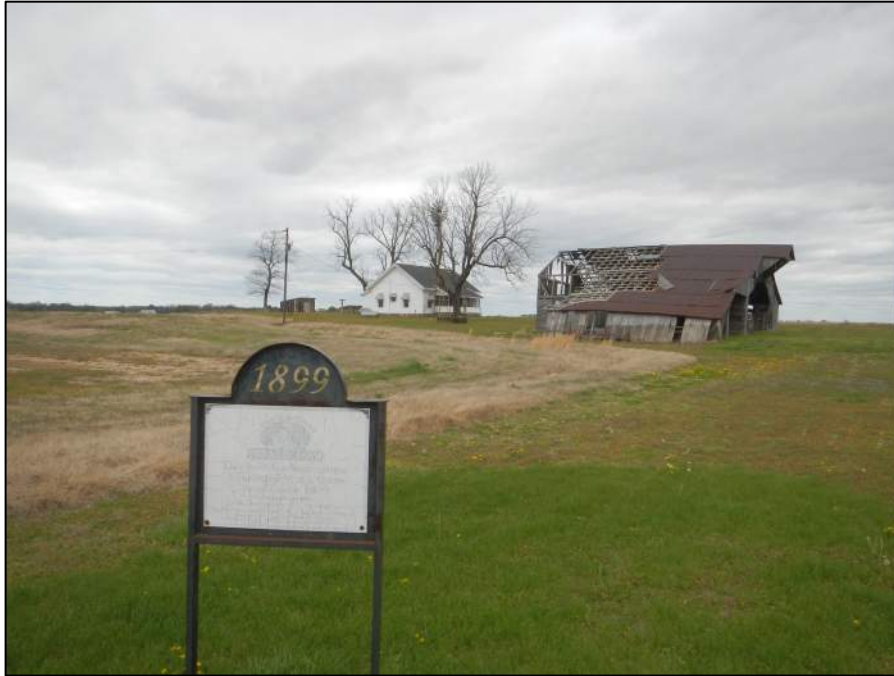
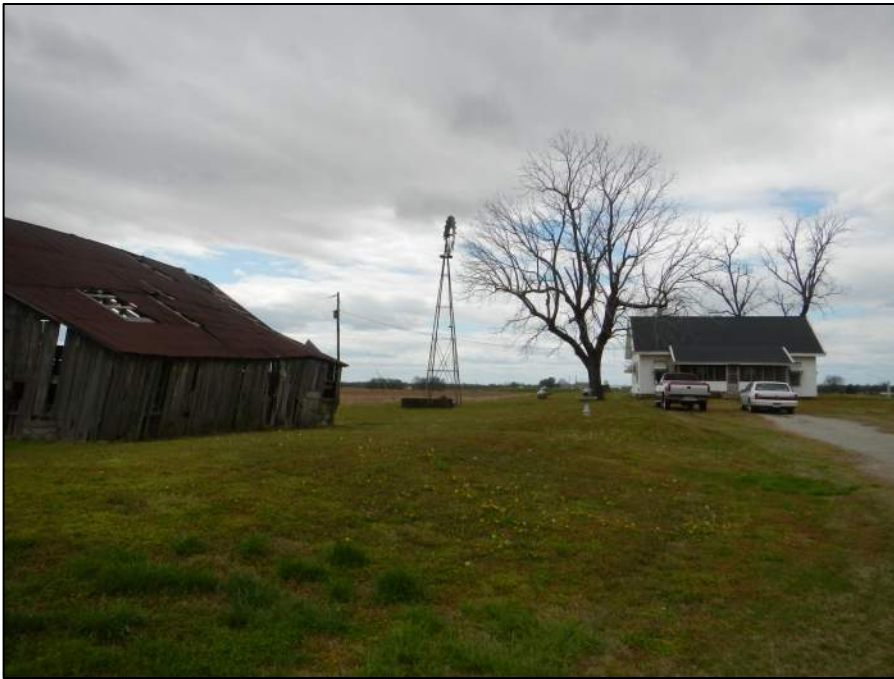
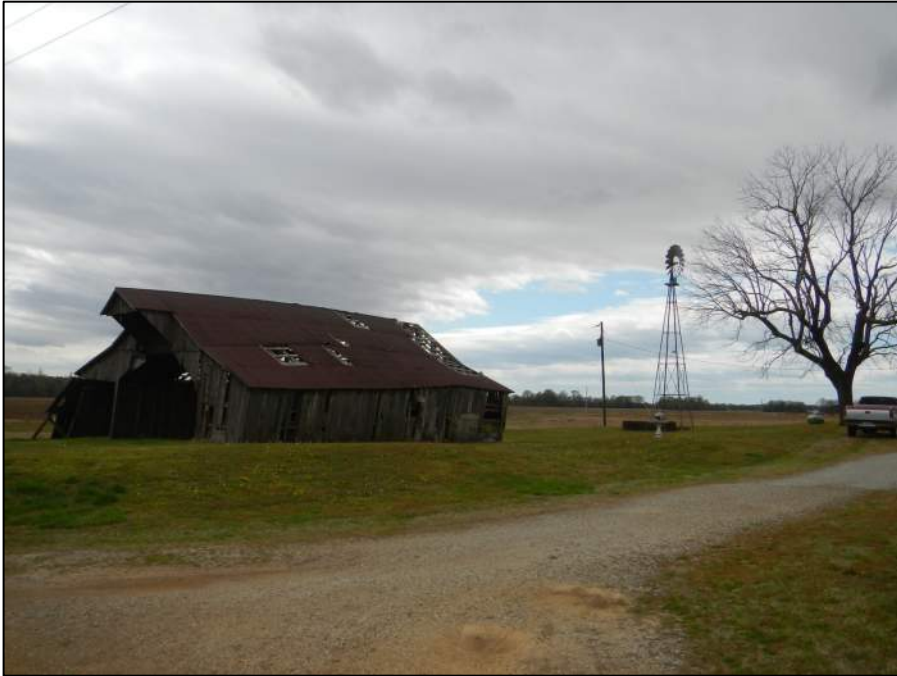
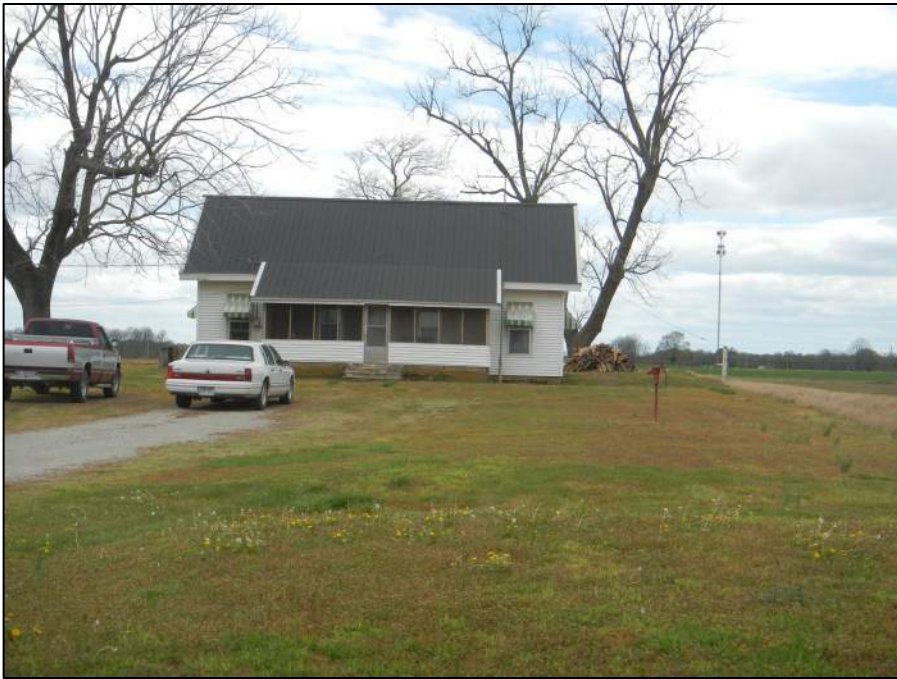
Property 35 (Dunn Farm), located at Gazaway Road (ID 001-01749-000), is a farm complex northeast of Pocahontas in the east-central portion of rural Randolph County (Figures 2-08 and 2-167–2-174). The principal buildings are situated on 30 acres and are surrounded by additional cultivated land and a small family cemetery. The faded text of the sign reads: “This farm has been owned and operated by the Dunn family since 1899 (owned by descendants of A.M. Dunn).” It is situated in the center of a planned interchange on the northern portion of the “blue” alternative.

After review of the draft ARS documentation, the opinion of ArDOT was that Property 35 was not eligible for listing in the NRHP because it “does not meet the same criteria under NR Bulletin 30–Rural Historic Landscapes . . . it is an old farm, but that does not rise to the same level of significance as required for NR eligibility.” The PCI recommendation was therefore changed to reflect the ArDOT assessment. Property 35 would be directly impacted by the construction of the “blue” I-57 alternative and interchange (Figure 2-08).

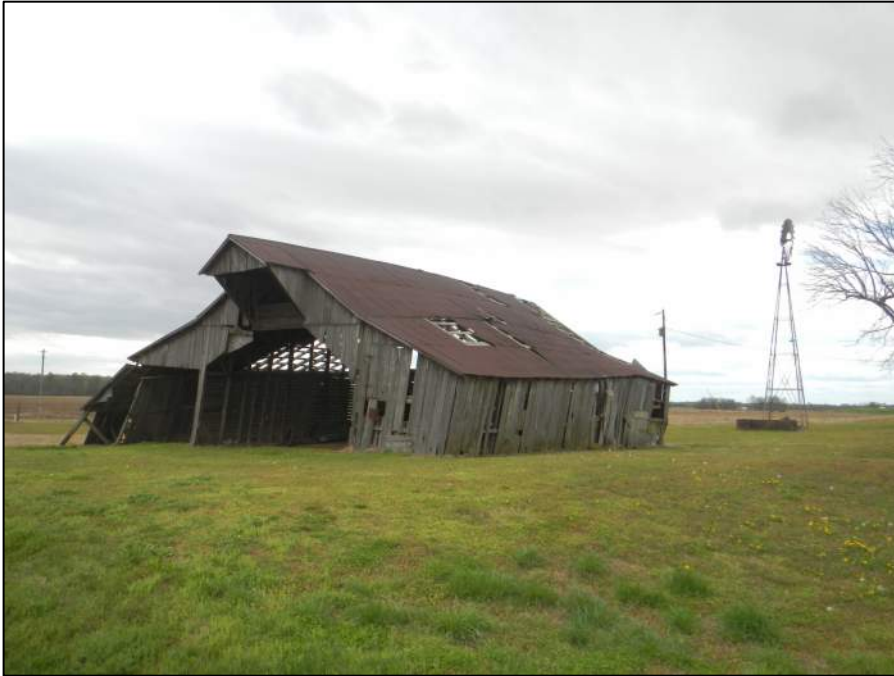
One of the oldest USGS maps of the area (1935 Reyno USGS 15-minute quadrangle) shows a large collection of houses on the parcel, most of which are no longer present on the 1968 Reyno USGS 7.5-minute quadrangle. This later map shows a house and barn, which seem to correspond to the current structures. Another house west of the house and barn had just been bulldozed during the recent fieldwork. It seems clear that none of the farm structures date to the initial period of occupation, and both the style of the main residence and its location on the 1968 7.5-minute USGS Reyno quadrangle place the construction date in the late 1950s to early 1960s (county assessor records provide a build date for the house of 1950). Upgrades to the house include the addition of vinyl siding and a fairly recent galvalume roof. The small detached outbuilding and is probably from the same period as the main residence, while the barn and windmill may be slightly older. The older quadrangle map shows this as one of the earliest cleared agricultural tracts in the immediate area.

The barn at Dunn Farm is probably the only individual building that might be considered eligible for listing in the NRHP. In the original draft report, the entire Dunn Farm complex, including the surrounding farmland and family cemetery to the south (Figure 2-08), was recommended as eligible for listing under Criteria A and C due to its significance as one of the oldest continuously operating family farms dating from the era immediately following clearance of the local bottomland timber.

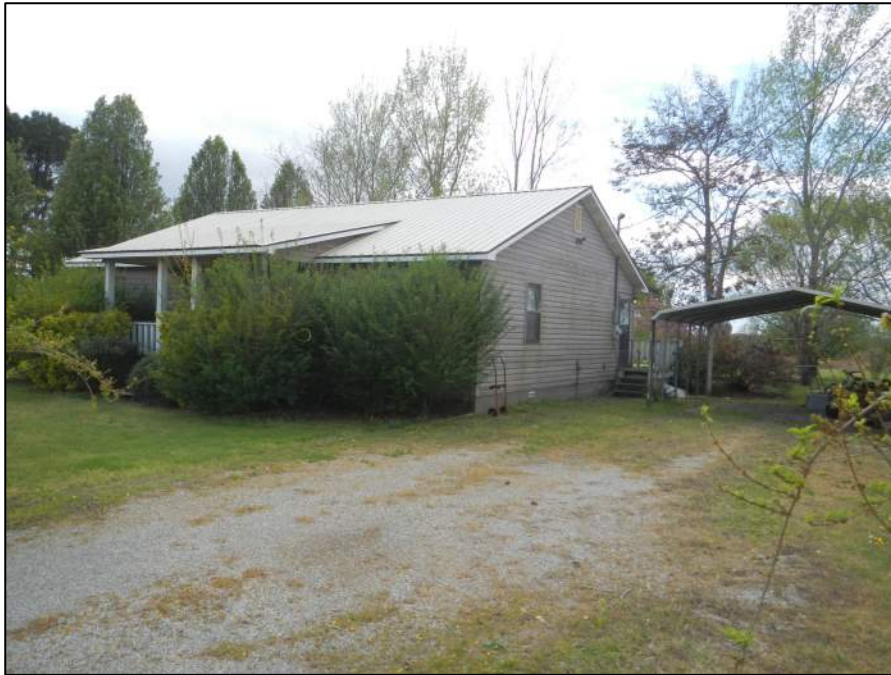
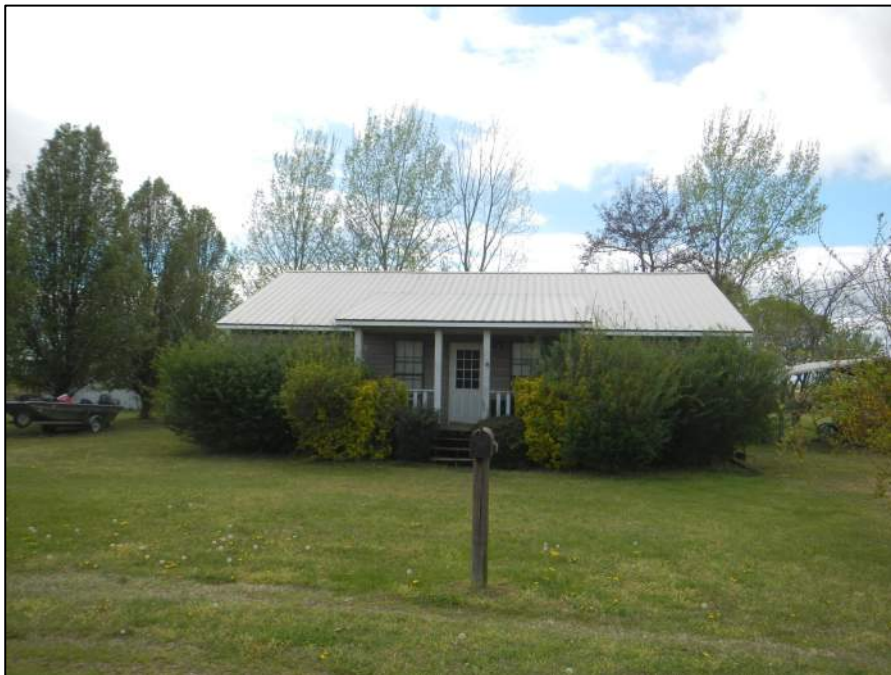
Property 36, located at 329 Quapaw Trail in Randolph County (ID 001-01757-000) is a ca. 1998 house on a small parcel just north of the Black River bottoms (Figures 2-08 and 2-175–2-176). In addition to the main house there is a stand-alone prefabricated canopy cover at the end of the driveway. The buildings are just south of the “blue” alternatives.

Map research shows houses along this road both on the 1935 Reyno 15-minute USGS quadrangle and the 1968 Reyno USGS 7.5-minute quadrangle. These older structures are now gone. Satellite imagery does not show the current house until after 1996. No historic association under Criterion A or B was found for the property.

In the opinion of Panamerican, Property 36 is not eligible for listing in the NRHP because it meets none of the established criteria. It is not known to be associated with any significant persons or event, thus Criteria A (association) and B (prominent individuals) do not apply. The buildings do not represent the distinctive characteristics of a type, the work of a master, nor do they possess any high artistic value (Criterion C Design/Construction). While Criterion D (Information Potential) can be applied to buildings, Property 36 appears to offer little future research potential, thus Criterion D is not applicable.

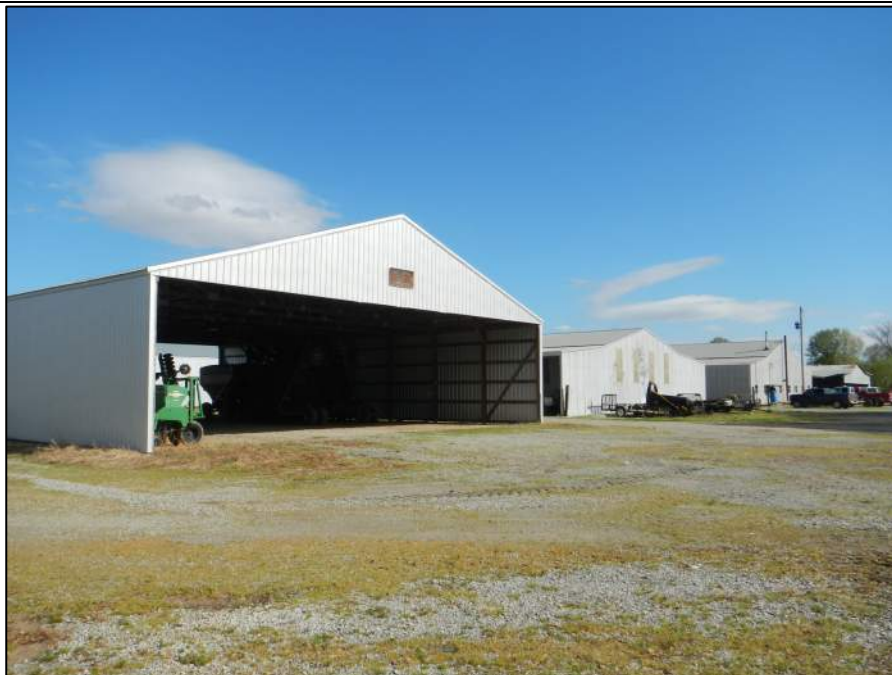
Figure 2-177. Property 37, view south-southeast (DSCN1772).

Property 37, located at 514 Clay County Road 109 (ID 022-00335-000) is 1980-2000 farm complex (Cole Farms) along Vinegar Hill Road just north of the Black River bottoms (Figures 2-09 and 2-177-2-183). It consists of a large assemblage of grain silos, equipment sheds, and office buildings. The buildings are within and just north of the “blue” alternative near a proposed interchange at “Old Reyno.”

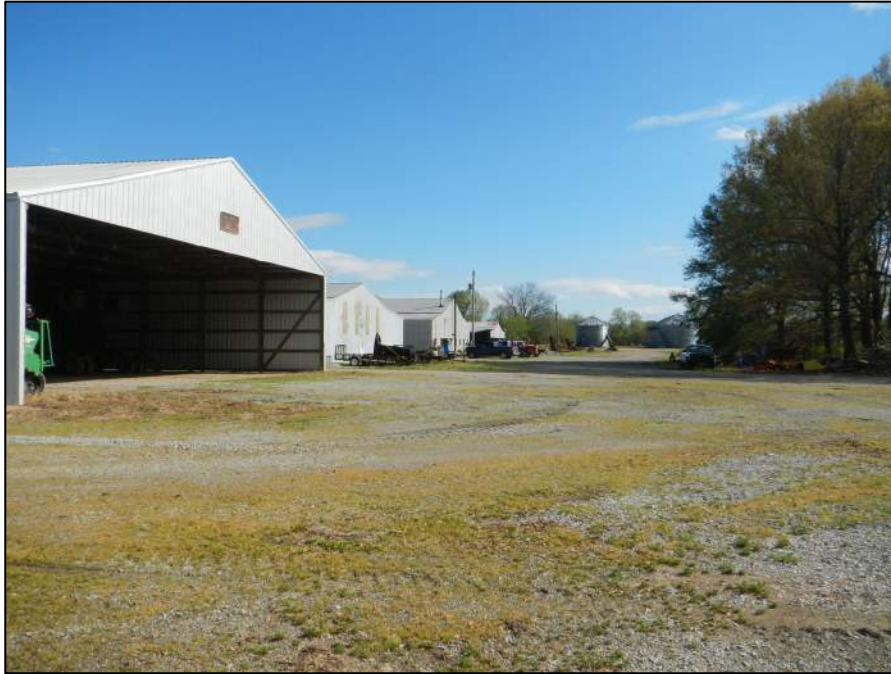
Figure 2-178. Property 37, view south (DSCN1773).

The house/office is a rectangular frame structure with 6-over-6 aluminum sash windows and a asphalt shingle covered roof. There is a small stoop at the front entrance. All of the agricultural buildings are sheet metal.

In the opinion of Panamerican, Property 37 is not eligible for listing in the NRHP because it meets none of the established criteria. It is not known to be associated with any significant persons or event, thus Criteria A (association) and B (prominent individuals) do not apply. The buildings do not represent the distinctive characteristics of a type, the work of a master, nor do they possess any high artistic value (Criterion C Design/Construction). While Criterion D (Information Potential) can be applied to buildings, Property 37 appears to

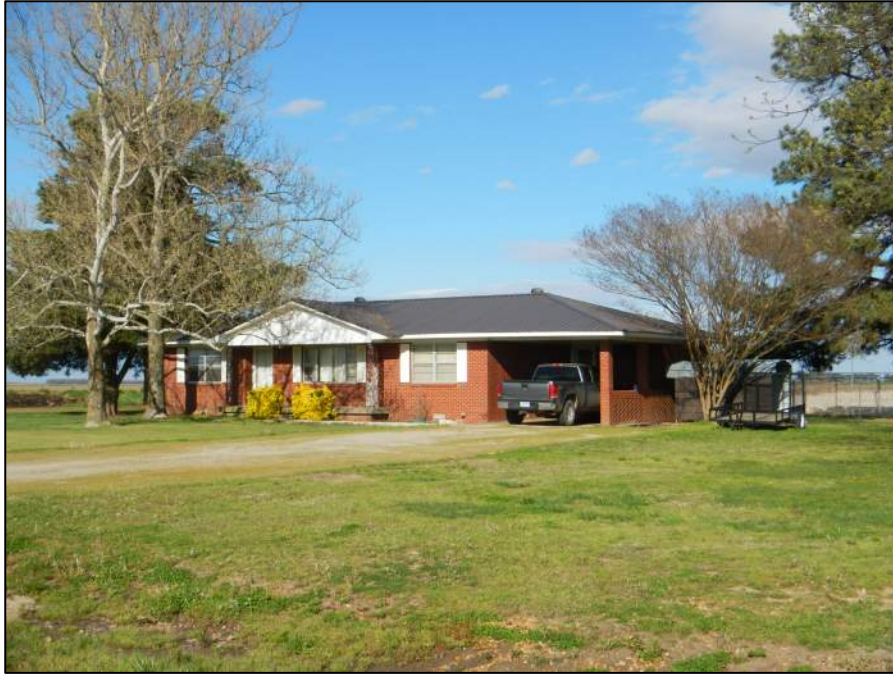
Figure 2-184. Property 38, view northeast (DSCN1783).

Property 38, located at 576 Clay County Road 125 (ID 022-01342-000) is a ca. 1993 house northeast of Heelstring (Figures 2-10 and 2-184–2-185). Again, note the posts, which are more consistent with 1950s-1960s style which contrasts the Assessor’s site date. In addition to the main house there is a stand-alone prefabricated “yard barn” at the end of the driveway. The buildings are just south of the “blue” alternatives.

PROPERTY 38: IN THE OPINION OF PCI, THE PROPERTY IS NOT ELIGIBLE
